REPORT ON THE CHICAGO TORNADO
OF MARCH 4, 1961

Rodger A. Brown and Tetsuya Fujita

Research Paper #1

Technical Report to the U. S. Weather Bureau
(Contract No. 9931)

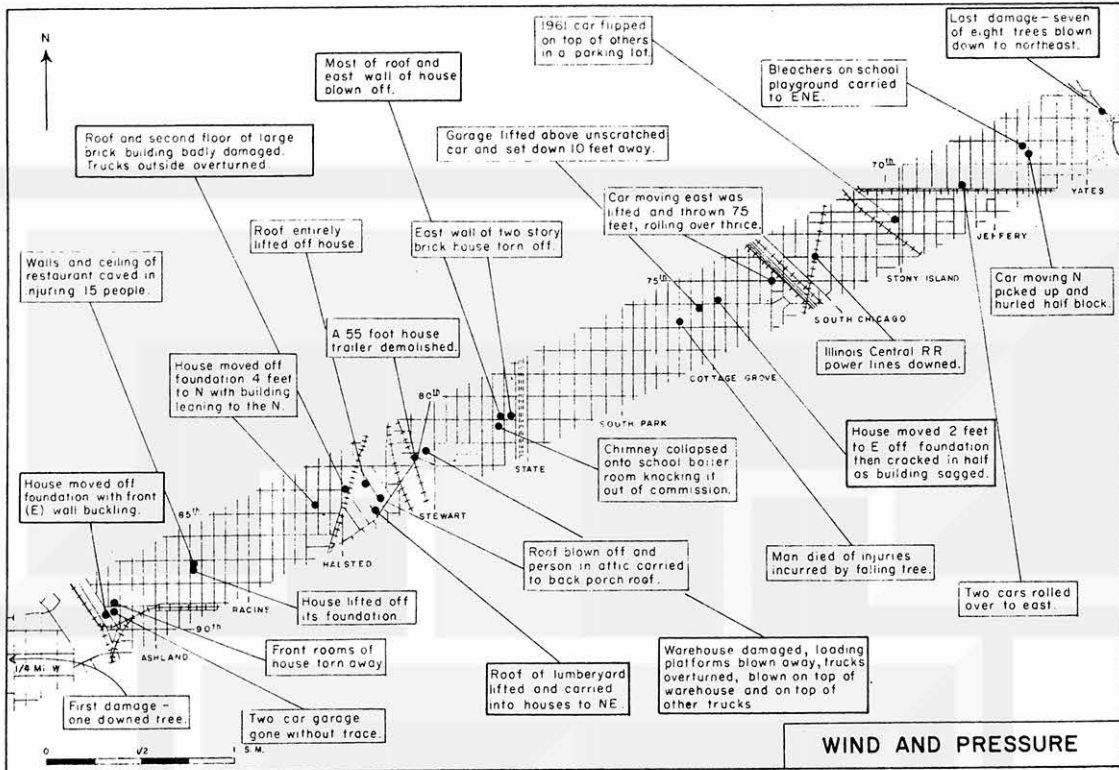
The most noteworthy accounts of damage caused by wind and pressure effects are shown in Fig. 6; the thicker borders around some of the descriptions indicate that Fig. 5 contains photographs of the described damage.

Fig. 6 Accounts of wind and pressure effects caused by the Chicago tornado. The wider borders indicate that pictures of the descriptions can be found in Figure 5.

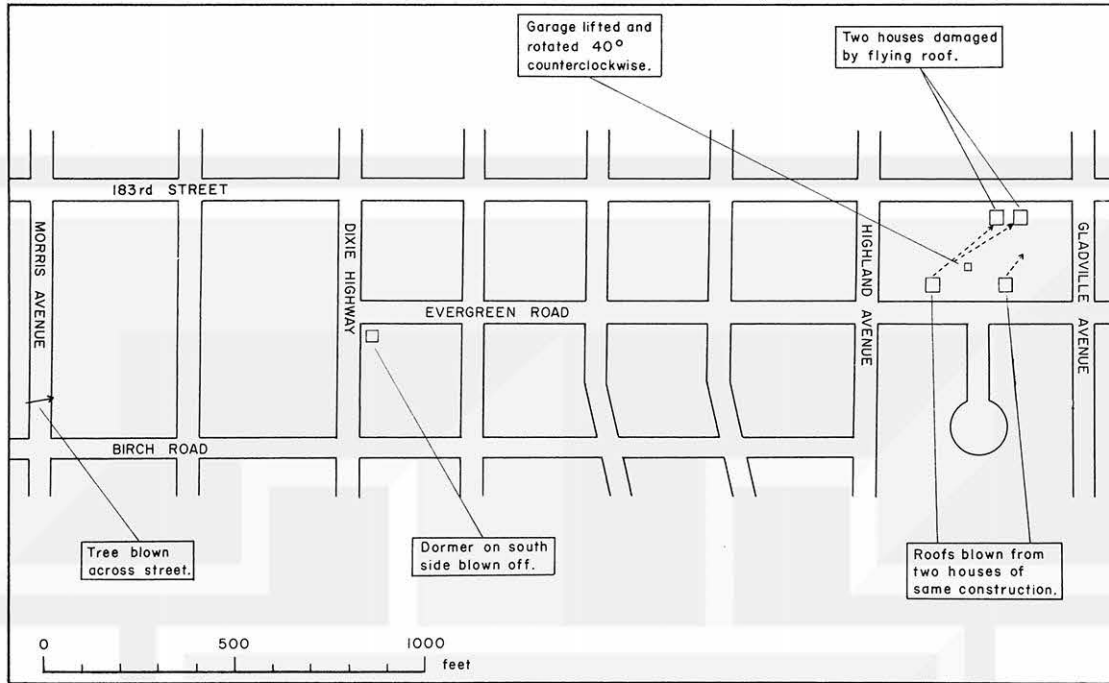
Figure 12a shows the extent of the damage in Homewood. The type of damage indicated little likelihood that a tornado had occurred. In addition, no one saw a funnel or heard any sounds other than the downpour that was occurring at the same time.

It appears that the damage was caused by a gust of straight-line wind. A tree was blown down toward the east-northeast and a dormer under construction on the south side of a house was blown away. The rest of the damage, estimated at \$8,000, was due to poor construction. In the 1700 block of Evergreen Road, the two houses constructed like the one (with roof replaced) shown in Fig. 12b had their roofs lifted intact. One roof flew into two houses on 183rd Street. The other hit a utility pole and dropped into the backyard of a nearby house on 183rd Street. Also, a garage on Evergreen Road was lifted, rotated 40° counterclockwise (apparently because of the placement of nearby buildings) and dropped just at the northeast corner of the concrete garage floor. It should be pointed out that the garage was held down by fewer than a dozen nails.

Fig. 12a Damage caused by the Homewood storm of March 4, 1961.

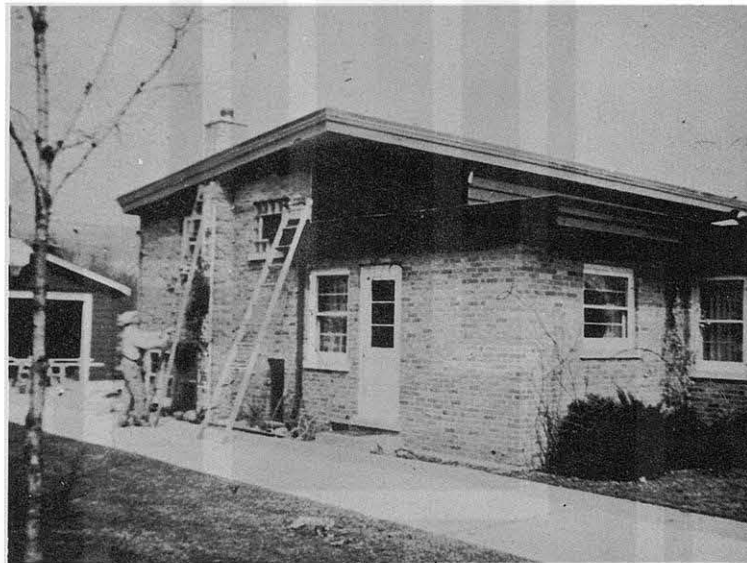
Fig. 12 One of the two houses on Evergreen Road that had its roof blown off. (Picture taken during placement of new roof.)
