An Analysis of Three Weather-Related Aircraft Accidents

T. THEODORE FUJITA AND FERNANDO CARACENA

Reprinted from BULLETIN OF THE AMERICAN METEOROLOGICAL SOCIETY,
Vol. 58, No. 11, November 1977

Two aircraft accidents in 1975, one at John F. Kennedy International Airport in New York City on 24 June and the other at Stapleton International Airport in Denver on 7 August, were examined in detail. A third accident on 23 June 1976 at Philadelphia International Airport is being investigated. Amazingly, there was a spearhead echo just to the north of each accident site. The echoes formed from 5 to 50 min in advance of the accident and moved faster than other echoes in the vicinity. These echoes were photographed by National Weather Service radars, 130–205 km away. At closer ranges, however, one or more circular echoes were depicted by airborne and ground radars. These cells were only 3–5 km in diameter, but they were accompanied by downdrafts of extreme intensity, called downbursts. All accidents occurred as aircraft, either descending or climbing, lost altitude while experiencing strong wind shear inside downburst cells.

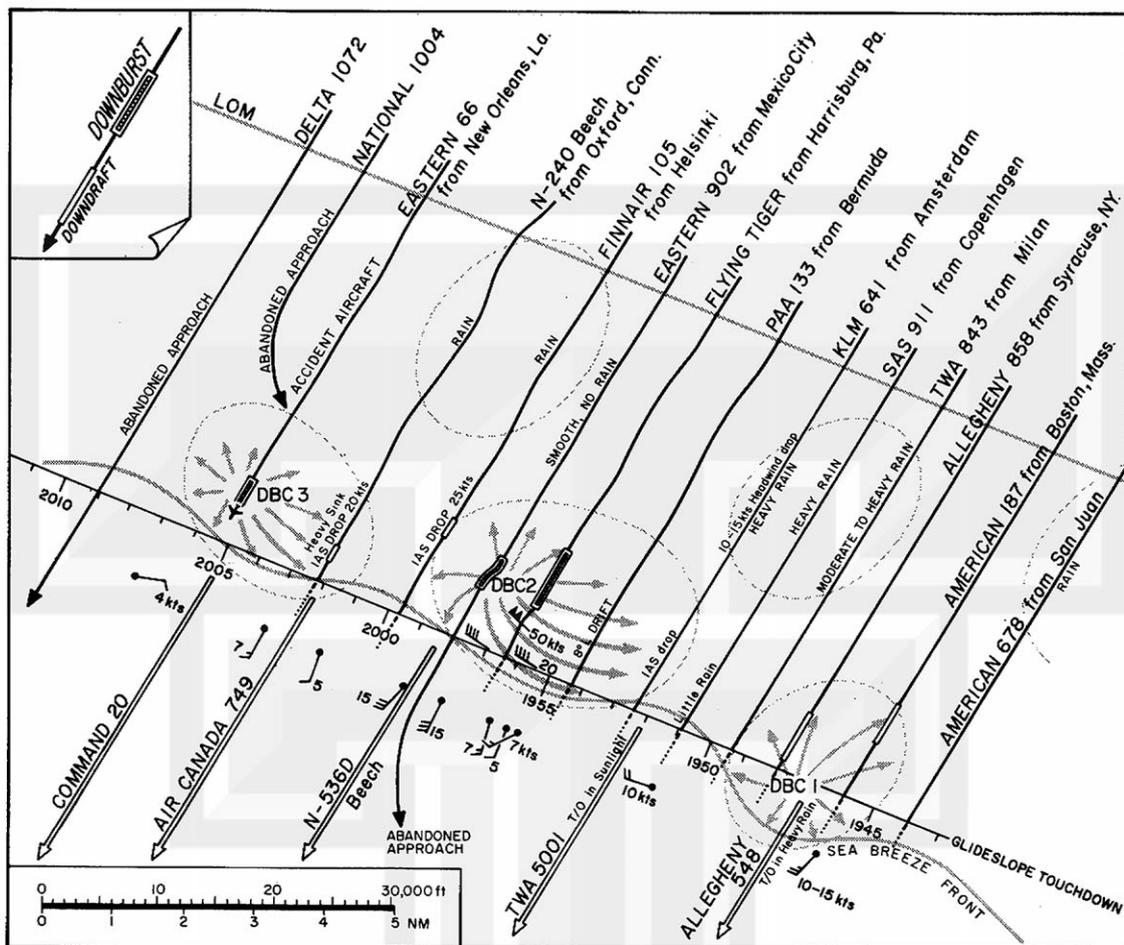
FIG. 8. Paths of 14 aircraft in 25 min at JFK Airport on 24 June 1975. Each path was shifted toward the WNW at 15 m s^{-1} (30 kt) to convert the time into the space relative to the spearhead echo. The echo, as seen by the Atlantic City radar, was 32 km (20 mi) long and 13 km (8 mi) wide, covering the entire area between LOM (Localizer Outer Marker) and the north end of runway 22-L. There were downburst cells (DBC) along the south edge of the spearhead echo. Five aircraft took off inside the sea breeze without being affected by downbursts.

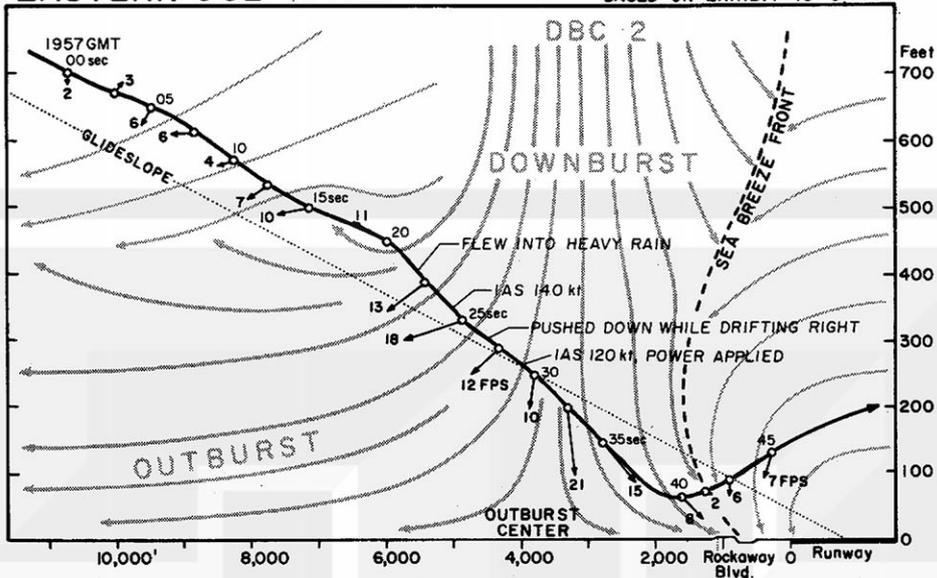
FIG. 9. The path of Eastern 902 on 24 June 1975 in the vertical plane including the glide slope of runway 22-L at JFK.

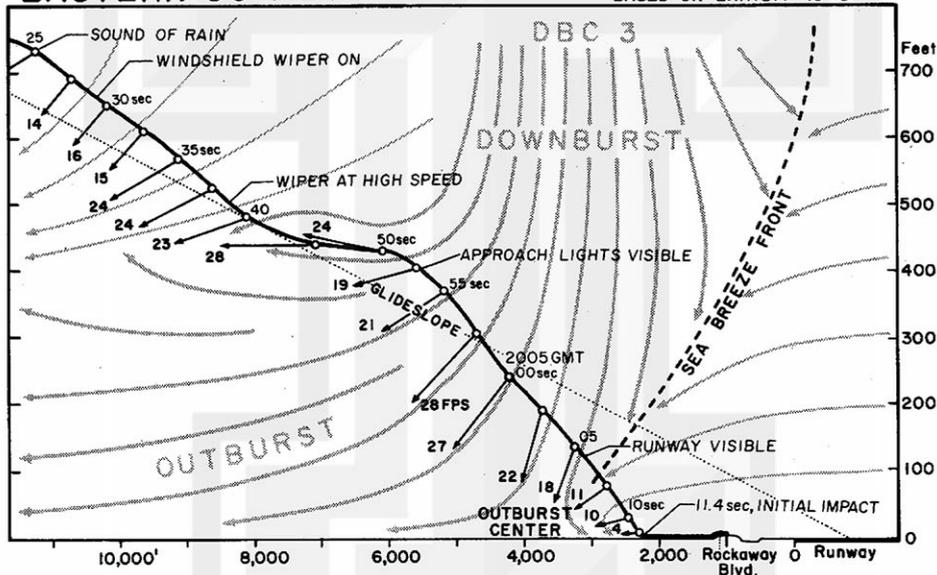
EASTERN 66 (727)

FIG. 10. The path of Eastern 66 on 24 June 1975 in the vertical plane including the glide slope of runway 22-L at JFK.

12) *Eastern 66 from New Orleans (4:05 p.m.)*. It encountered heavy rain at 150 m (500 ft) altitude, and the wiper was operated at high speed. The approach lights were visible at 120 m, and then the airspeed dropped from 71 to 63 m s⁻¹ (138–122 kt) in 7 s. The plane sank in a 6.7 m s⁻¹ (22 ft s⁻¹) downburst at 60 m (200 ft) altitude and hit the approach lights at 2005 GMT (4:05 p.m.), about 730 m (2400 ft) short of the runway (see Fig. 10).

Eastern 66 lost airspeed suddenly at 91 m (300 ft) when an 8 m s^{-1} (16 kt) headwind changed into a 6.4 m s^{-1} (22 ft s^{-1}) downburst. Evidently the aircraft flew straight into the

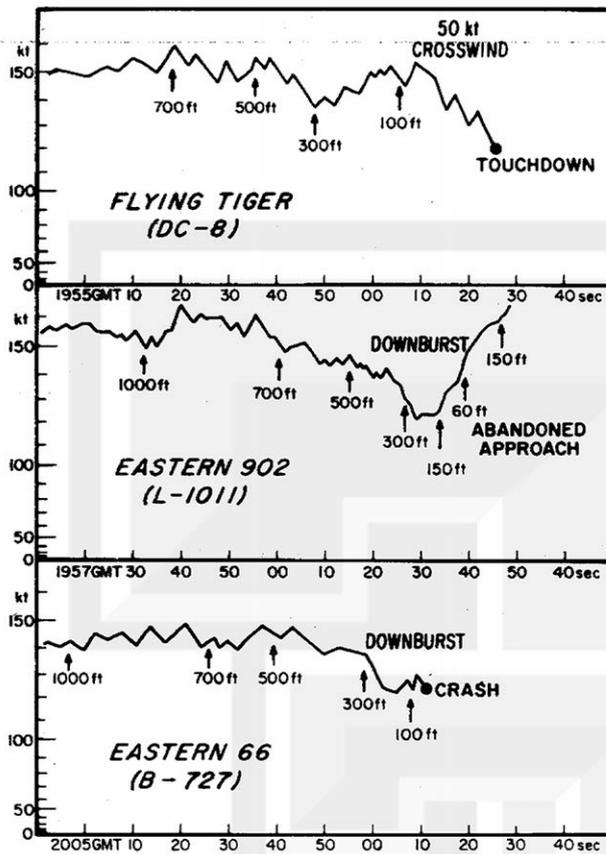
FIG. 11. Indicated airspeed of three aircraft landing at JFK on 24 June 1975. The vertical scale is proportional to the square of the indicated airspeed.

Of the 14 aircraft that flew through the spearhead echo, only 3 encountered serious difficulties. The wind shear—the time variation of vector winds along the flight path—was determined to be the cause. What the Flying Tiger had encountered was crosswind shear (time variation of crosswind). The aircraft flew into the outburst that was distorted by the sea-breeze front. The front held back the advancement of the outburst air into the runway area. The aircraft did not lose airspeed (see Fig. 11).

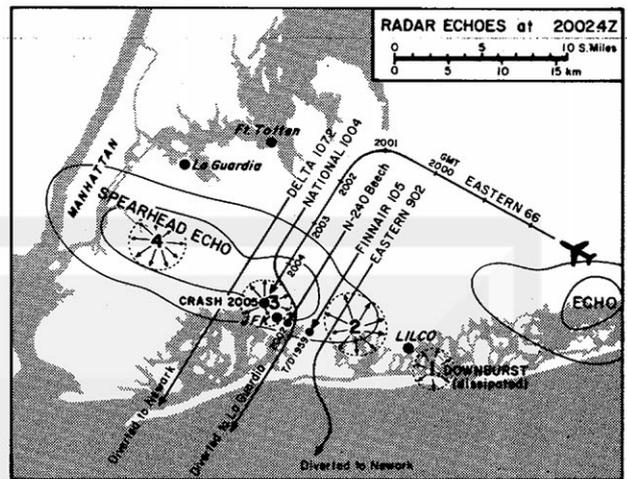
FIG. 12. The paths of five aircraft on 24 June 1975, drawn relative to the spearhead echo at 2002.4 GMT. Although the NWS Atlantic City radar showed a large spearhead echo, the airborne radar of approaching aircraft painted a circular, small echo near the approach end of runway 22-L. The radar beam altitude of the echo from Atlantic City, 0.2° elevation at 148 km (80 n mi), was ~2100 m (7000 ft).

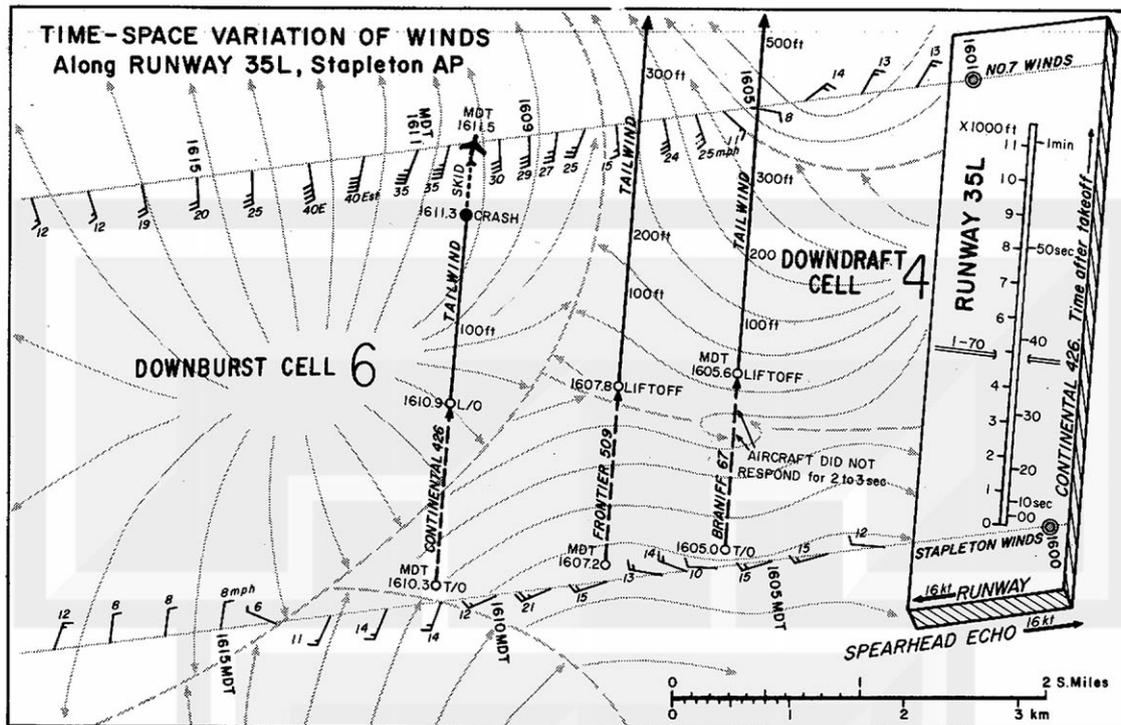
The time-space coordinates of the three aircraft in Fig. 15 were constructed by moving runway 35L relative to the spearhead echo. The pattern shows clear evidence for the impact of a strong downdraft just west of the center of runway 35L. The winds from the Stapleton wind tower, 500 m (0.3 mi) east of the runway threshold, and from wind tower No. 7, located 800 m (0.5 mi) northwest of the north end of the runway, were added in the figure. Following are the conditions encountered by the three aircraft during their takeoff and climb-out period (for details, refer to National Transportation Safety Board (1976), Kadlec *et al.* (1975), and J. B. Pittman (personal communication to NTSB, 1975)):

FIG. 15. Three aircraft that took off from runway 35L of Stapleton Airport between 1605 and 1610 MDT on 7 August 1975. In constructing these time-space coordinates, the runway and two wind towers were moved, at 8 m s^{-1} (16 kt), in the opposite direction of the spearhead echo. One minute was added to the time of wind tower No. 7 to take into account the travel time of the aircraft from takeoff to the end of the runway.

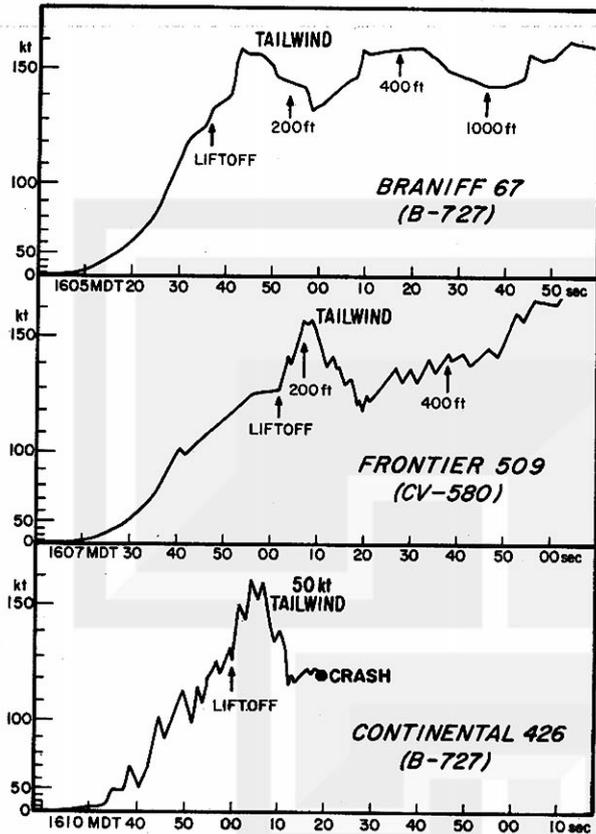
FIG. 16. Variation of indicated airspeed of three aircraft that took off from runway 35L of Stapleton Airport on 7 August 1975. The airspeed scale was plotted in proportion to the square of the speed.

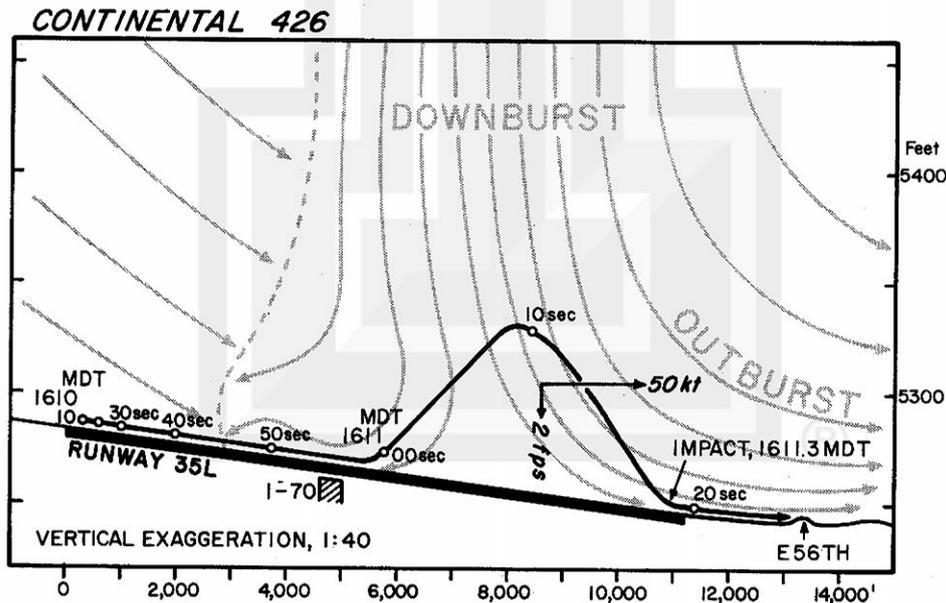
The maximum divergence at the surface, as estimated by the authors, was $150\text{--}250 \text{ h}^{-1}$ ($0.04\text{--}0.07 \text{ s}^{-1}$). This implies that Continental 426 flew through the base of what was undoubtedly a strong downdraft. The outburst was strong enough to cause an uncontrollable rate of airspeed loss, 4 m s^{-2} (8 kt/s). It should be noted also that the outburst was not symmetric with respect to the outburst center. The outburst was strong toward the north but weak toward the south, the direction of preexisting downdraft air.

FIG. 17. A schematic figure showing the path of Continental 426 in relation to the downburst cell on 7 August 1975. The maximum height of the aircraft is approximate because the altimeter was affected by the aerodynamic characteristics of the pitot tube during the climb. The height scale is in feet at MSL.

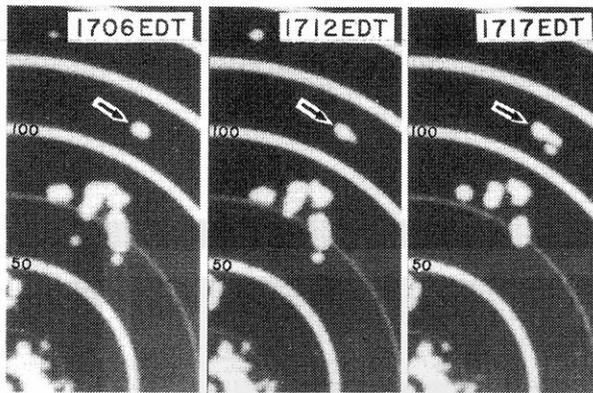
FIG. 23. Rapid development of a small spearhead echo over Philadelphia Airport. Three pictures were taken by NWS Patuxent River, Md., radar at 1706, 1712, and 1717 EDT on 23 June 1976. Heavy range marks are 50, 100, 125, and 150 n mi. Time of accident was 1712 EDT.

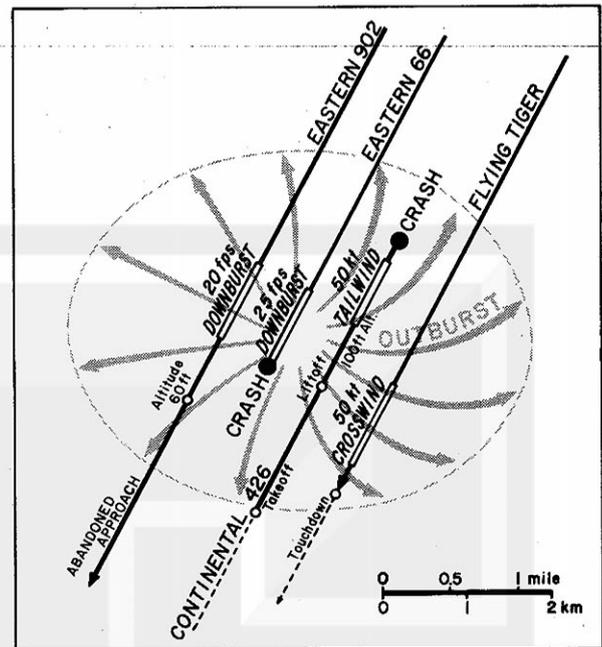
FIG. 24. Composite paths of aircraft relative to downburst cell for Flying Tiger, Eastern 66, and Eastern 902 at JFK on 24 June 1975, and Continental 426 at Stapleton on 7 August 1975. Allegheny 121 at Philadelphia on 23 June 1976 flew through the downburst center from right to left, experiencing a $25\text{--}30\text{ m s}^{-1}$ (50–60 kt) headwind, calm, and 3 m s^{-1} (6 kt) tailwind before it crashed on the runway.
