Streamwood Microburst

Final Report to NCAR
NSF/UCAR Grant S9129

WRL Report 236

Streamwood Microburst of

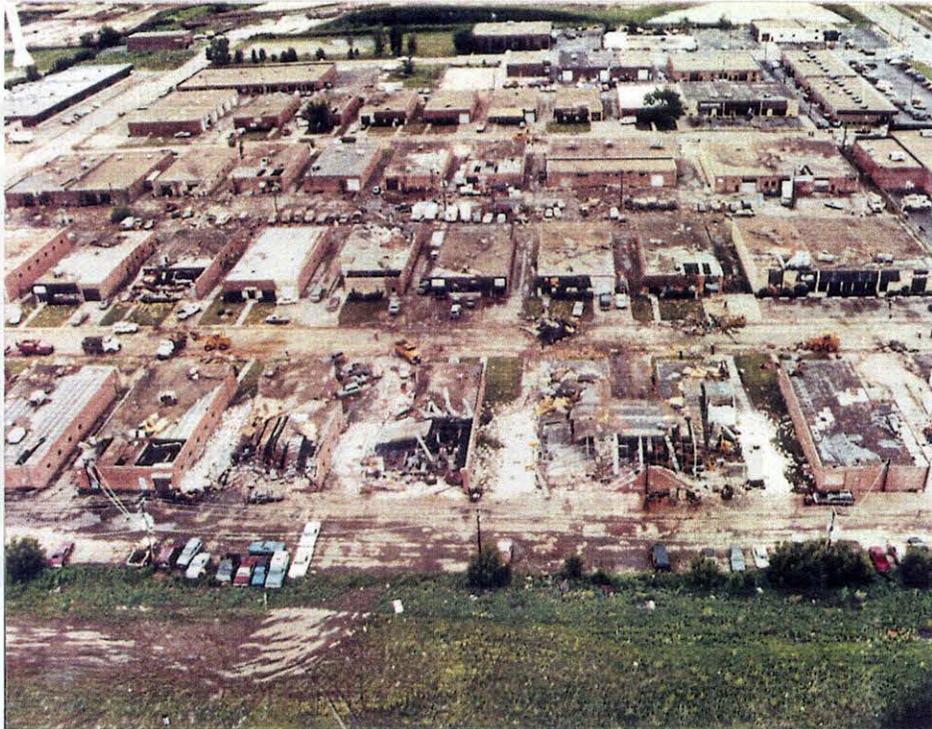
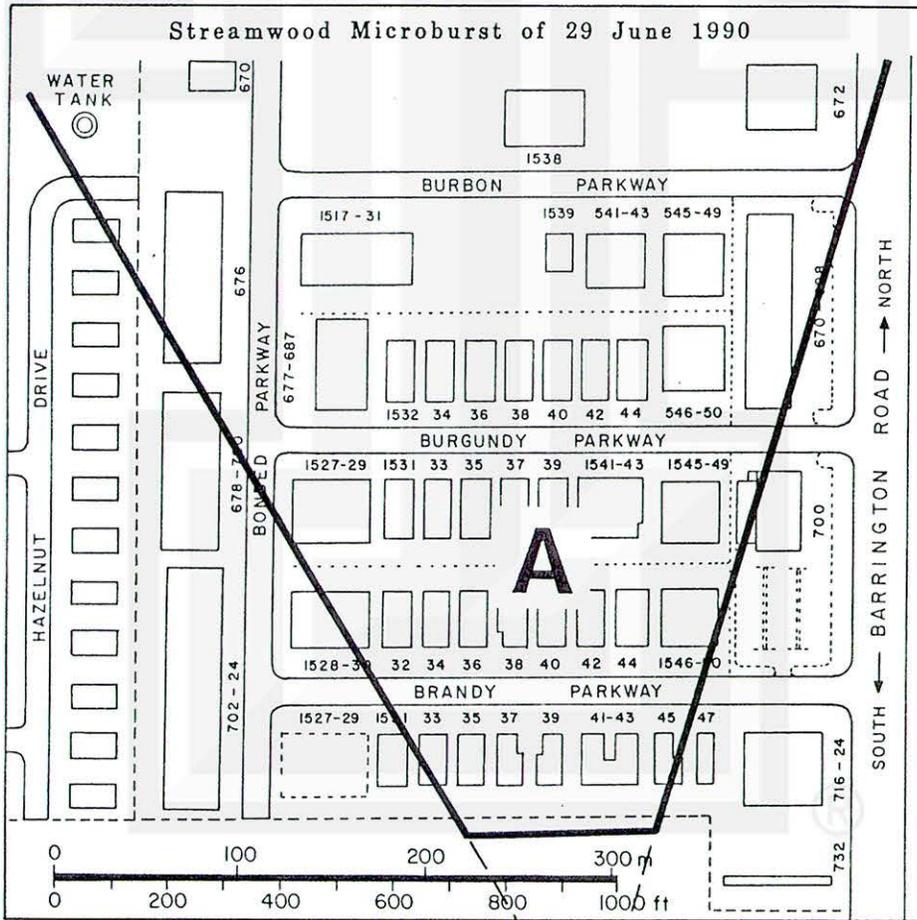
In order to substantiate the nature of the microburst winds, both direction and speed, five aerial photographs, A through F, used in producing the damage map (Fig. 2) were located on the detailed map of the industrial park. The overall photo A (Fig. 3) reveals the abrupt increase in the southerly winds at the south edge of the industrial park. Photos B and C show the southwest section of the industrial park damaged by the 100 to 120 mph winds from the south-southeast (Figs. 4 and 5).

Fig. 3 Aerial photo A showing the sudden increase in the microburst winds along the south edge of the industrial park.

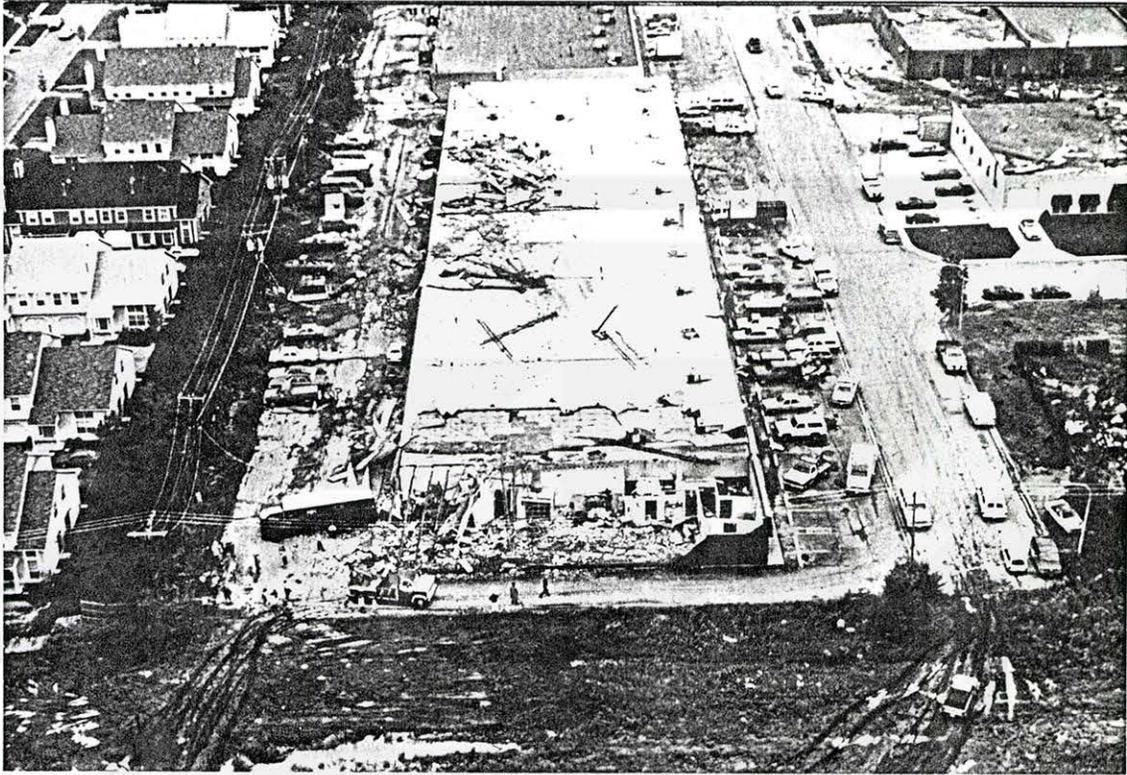
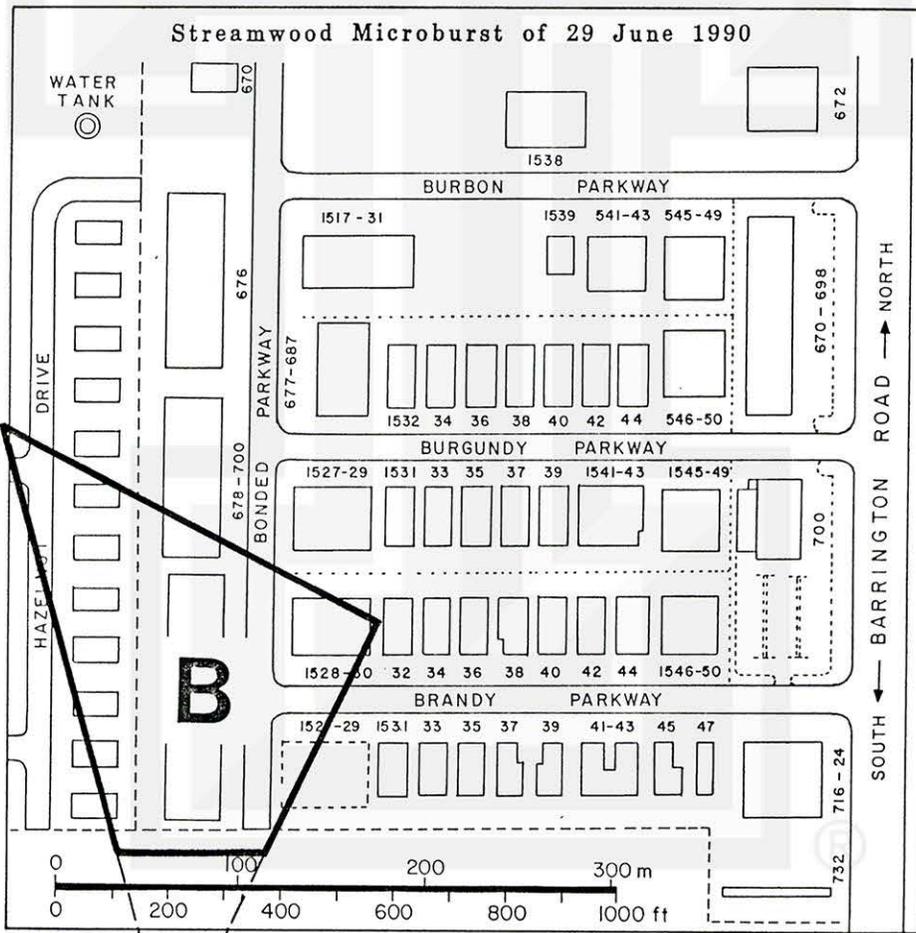
Fig. 4 Damage of a large commercial building at 702-724 Bonded Parkway. A truck was pushed over near the southwest corner of the building.

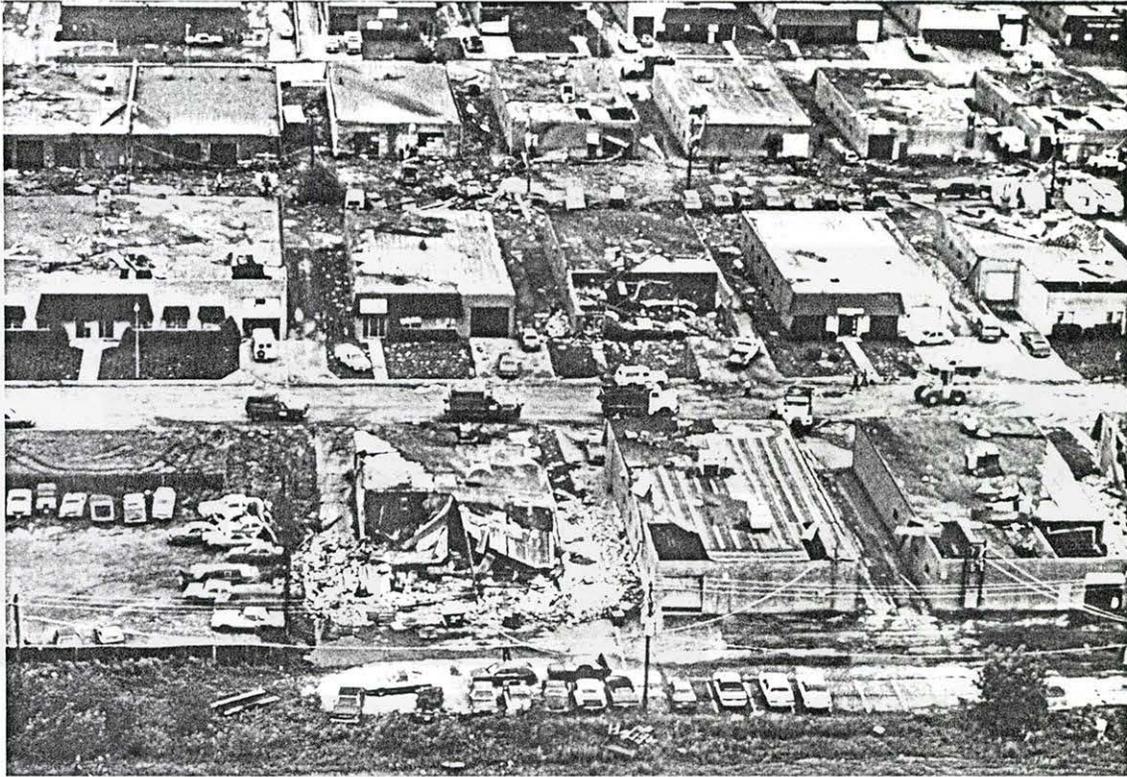
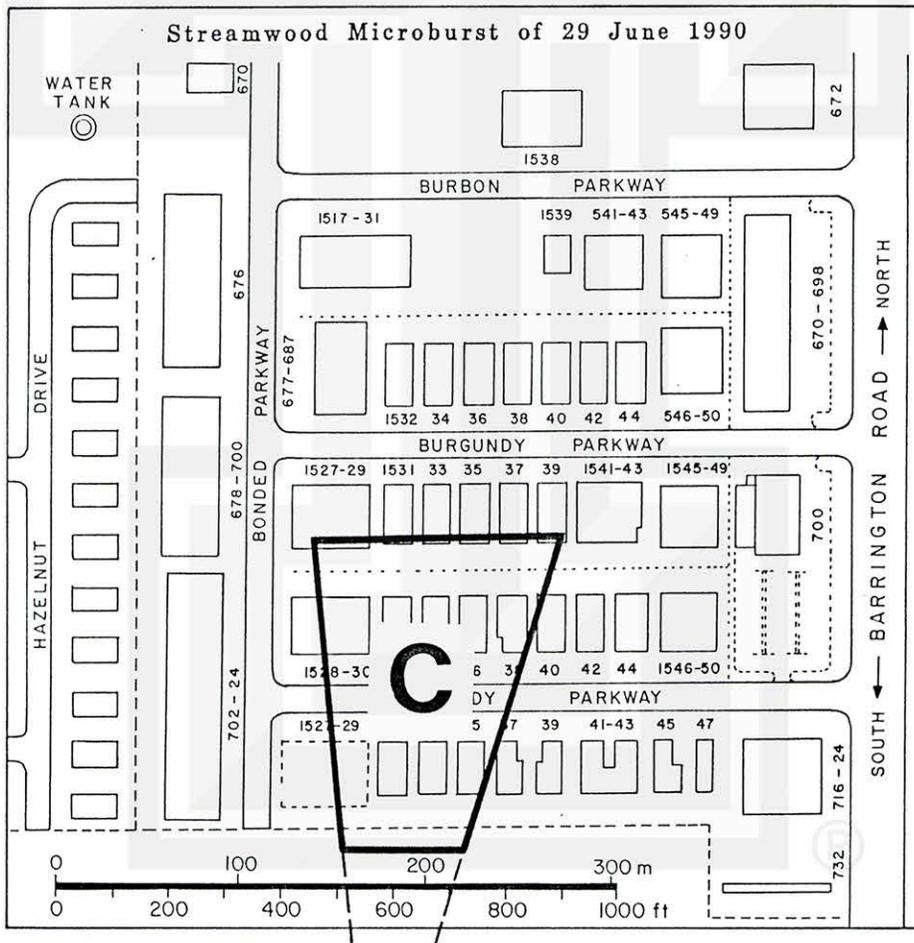
Fig. 5 Stores and shops at 1531 and 1534 Brandy Parkway damaged by estimated 120 mph winds.

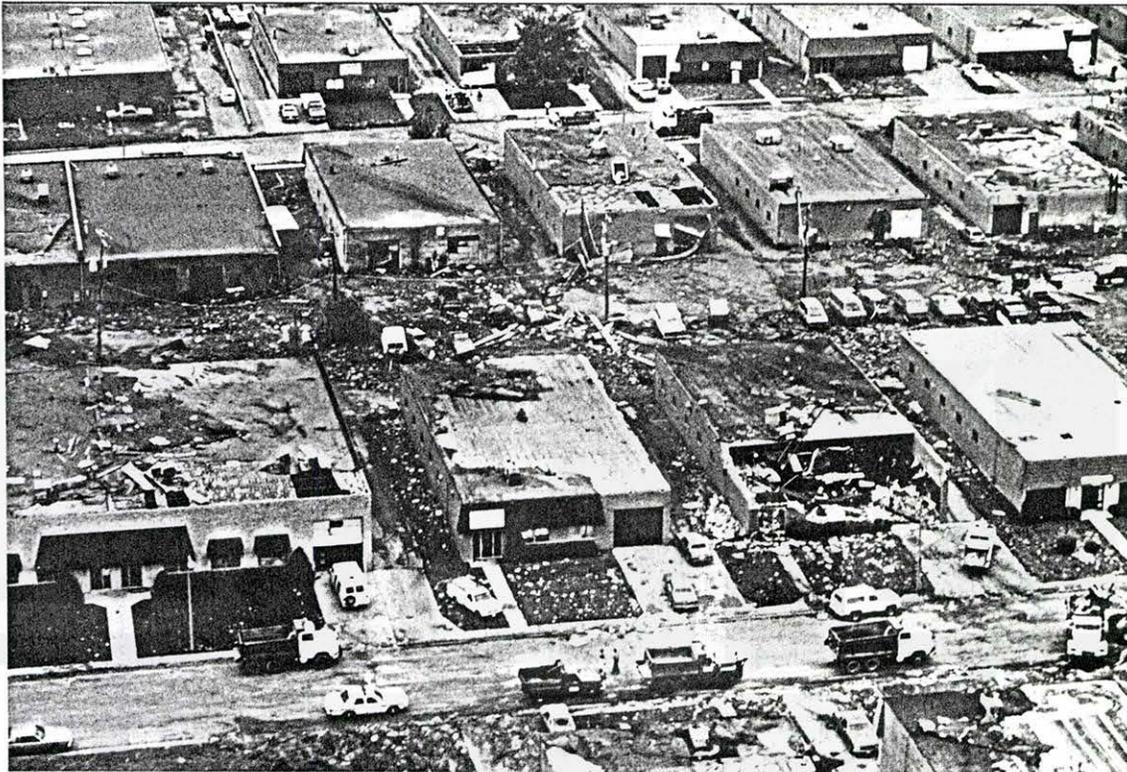
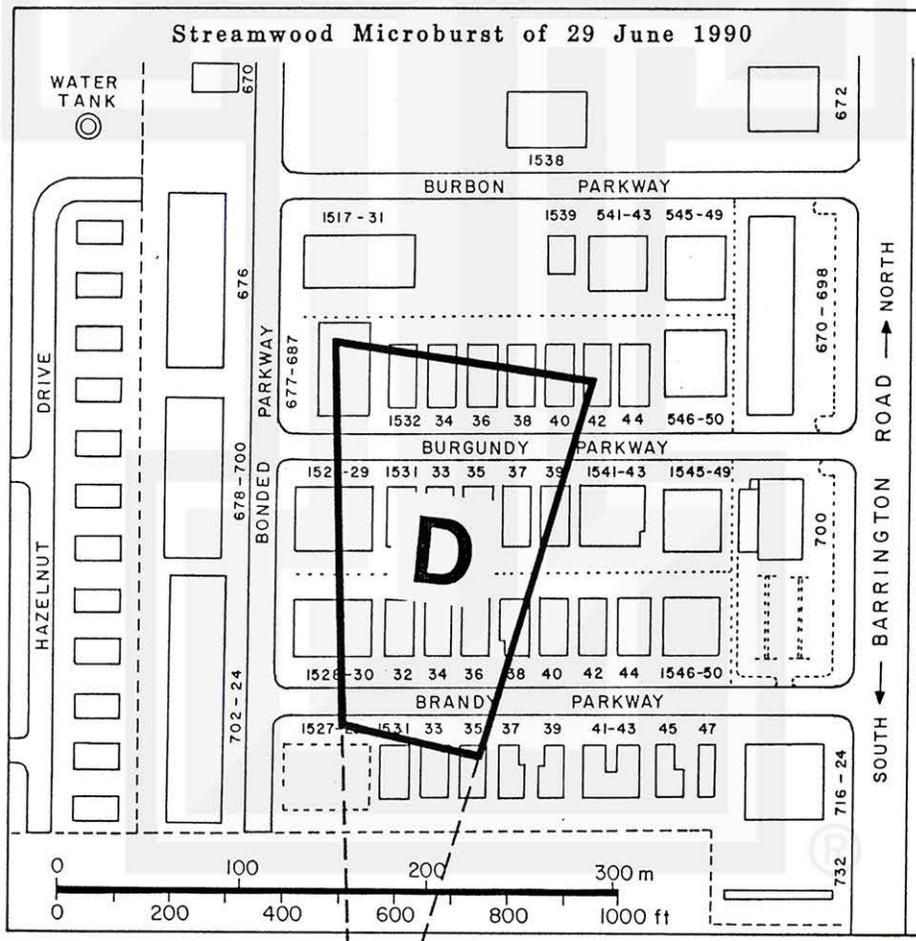
Streaks of high winds on roofs, made visible by the thin deposits of wind-driven dirt, are seen on many structures. Photo D shows one of the best examples seen on the roof at 1531 Burgundy Parkway (Fig. 6). The worst damage is seen in photo E looking west (Fig. 7). The roof of a large square building at 1546-50 Brandy Parkway was peeled off by the near-horizontal winds from the south (Fig. 8). Winds are estimated at 100 to 110 mph.

Fig. 6 Building at 1531 Burgundy Parkway showing a high-wind streak on the roof extending from the southeast to northwest corners.

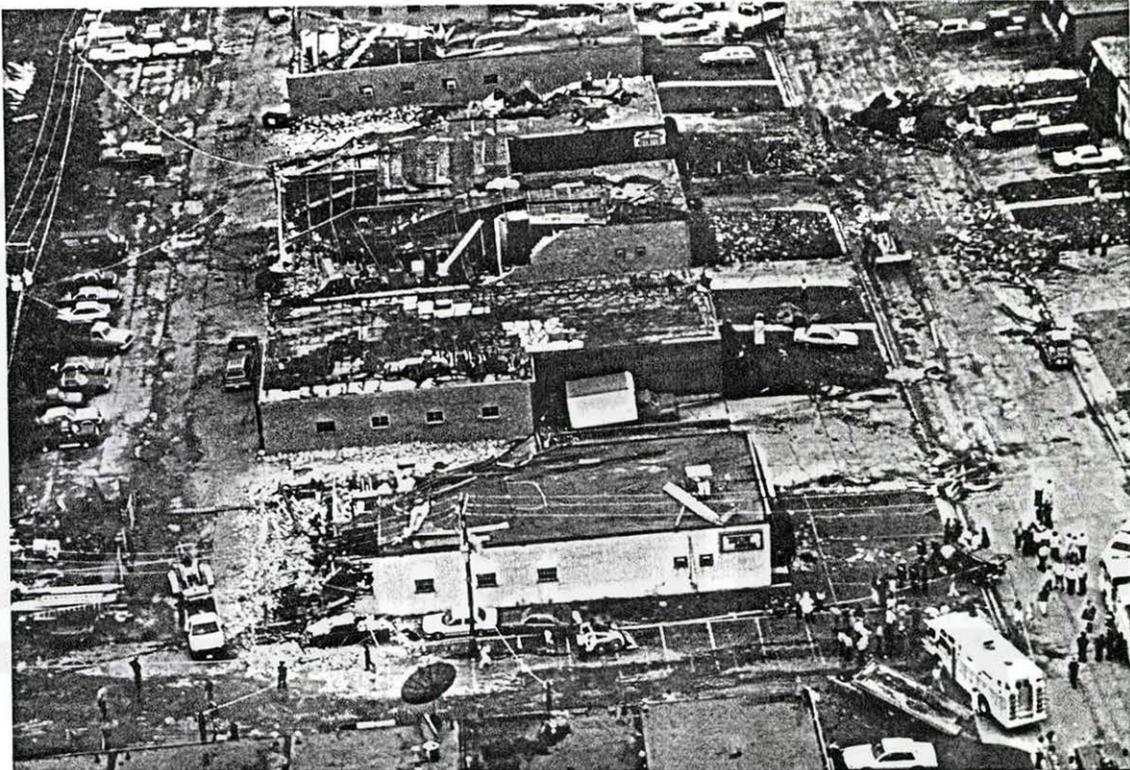
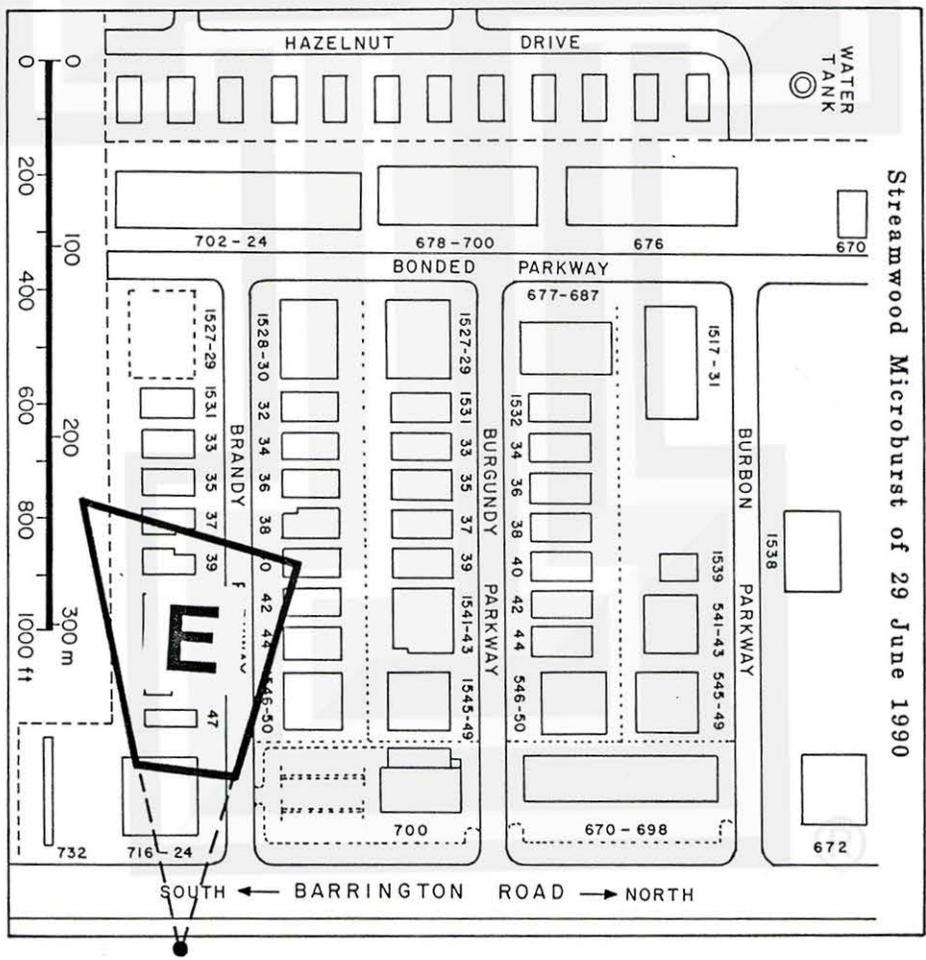
Fig. 7 The worst damage in the industrial park seen in the southeast section. The damage-causing winds are estimated at 130 mph from the south to south-southeast.

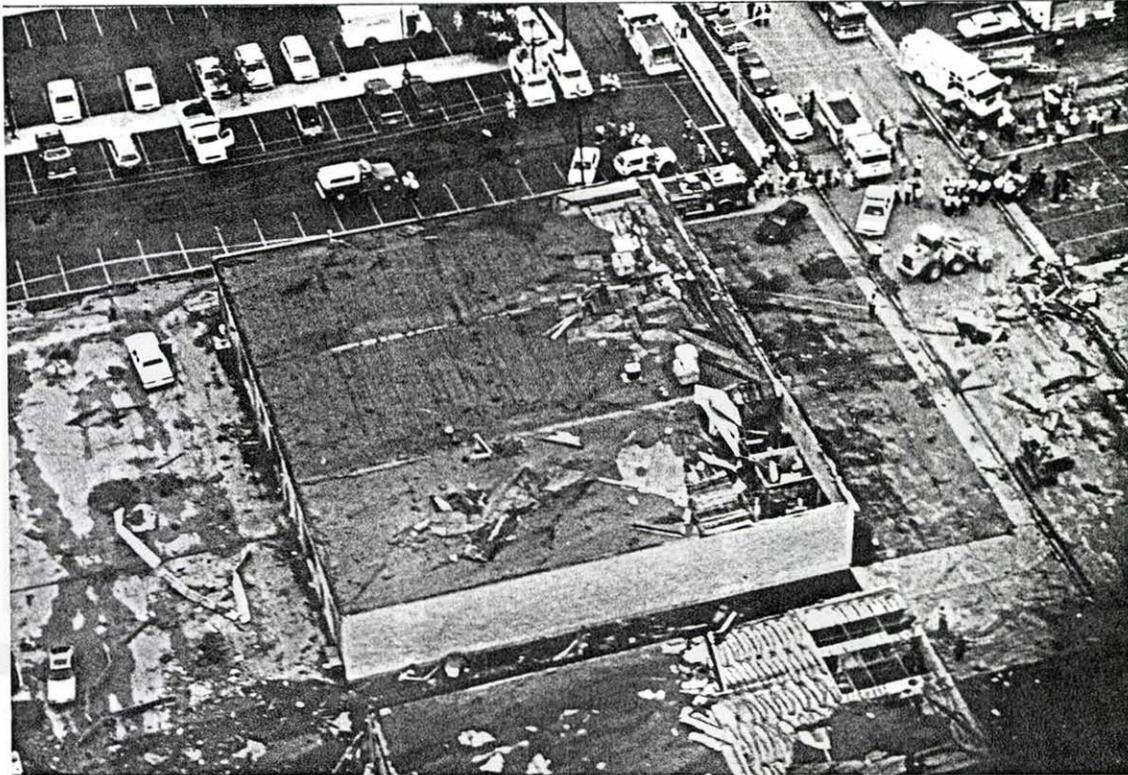
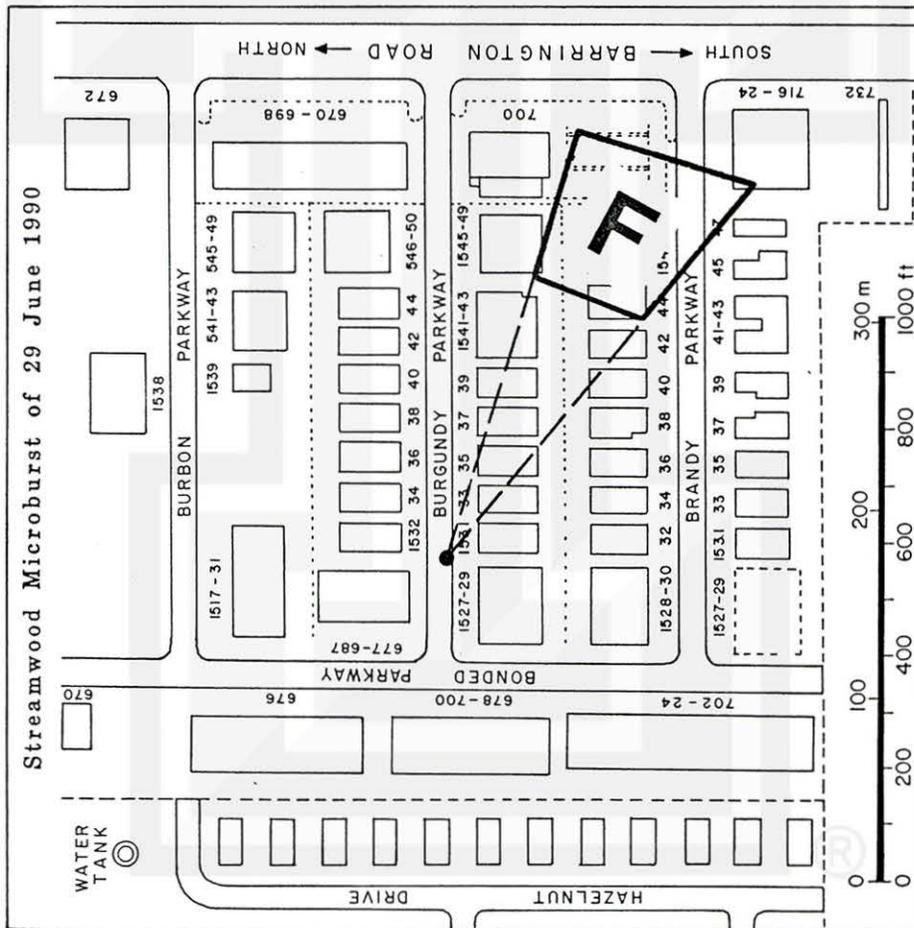
Fig. 8 The peeled-off roof of a large square building at 1546-50 Brandy Parkway.

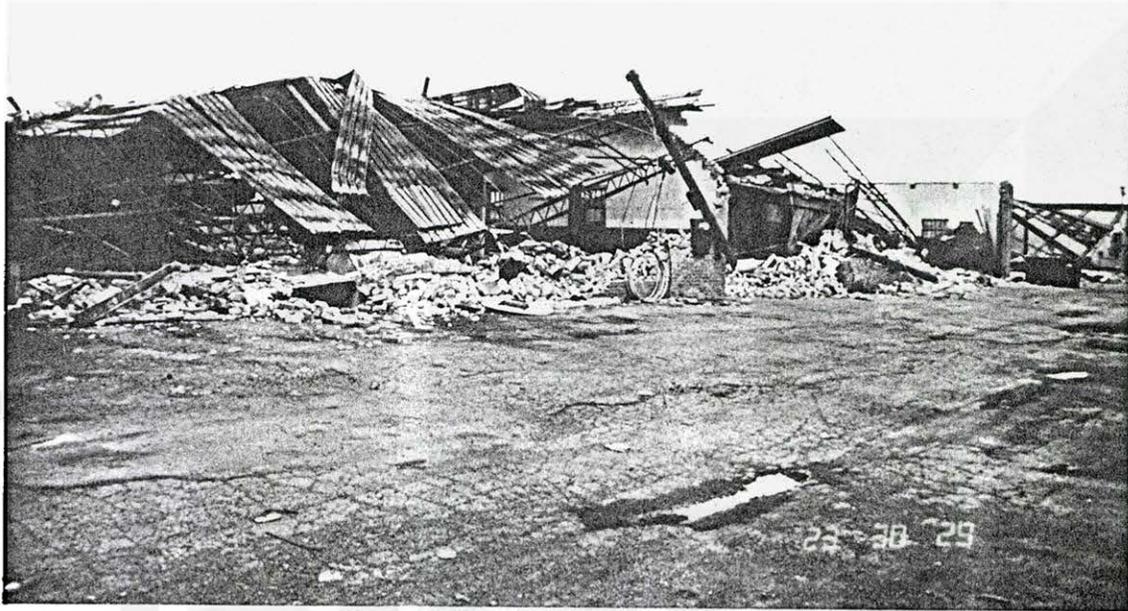
Fig. 9 The south wall of the building at 1537 Brandy Parkway smashed by the microburst winds in the touchdown area.

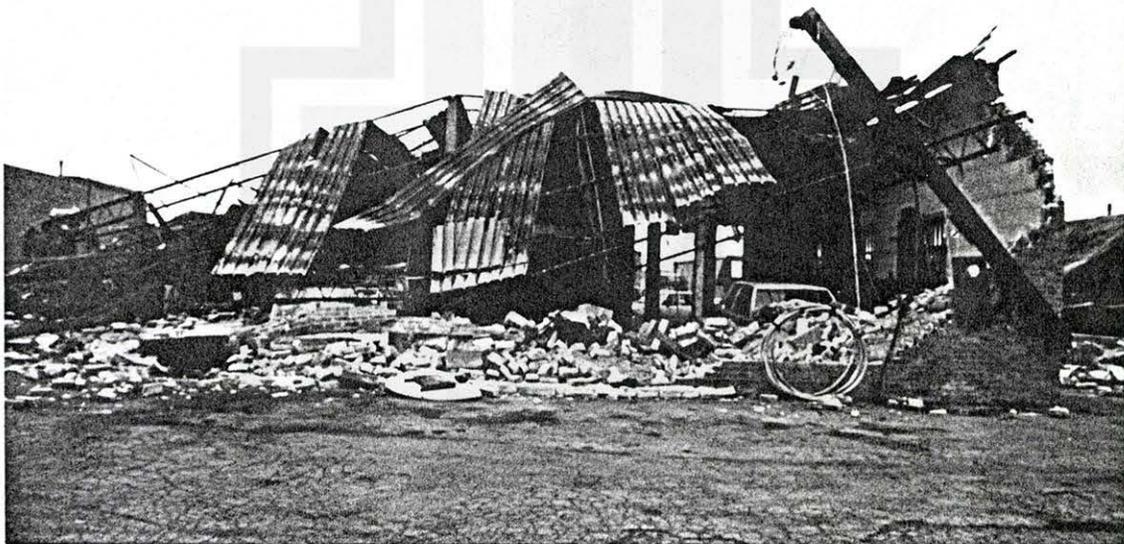
Fig. 10 A close-up view of the building at 1537 Brandy Parkway.

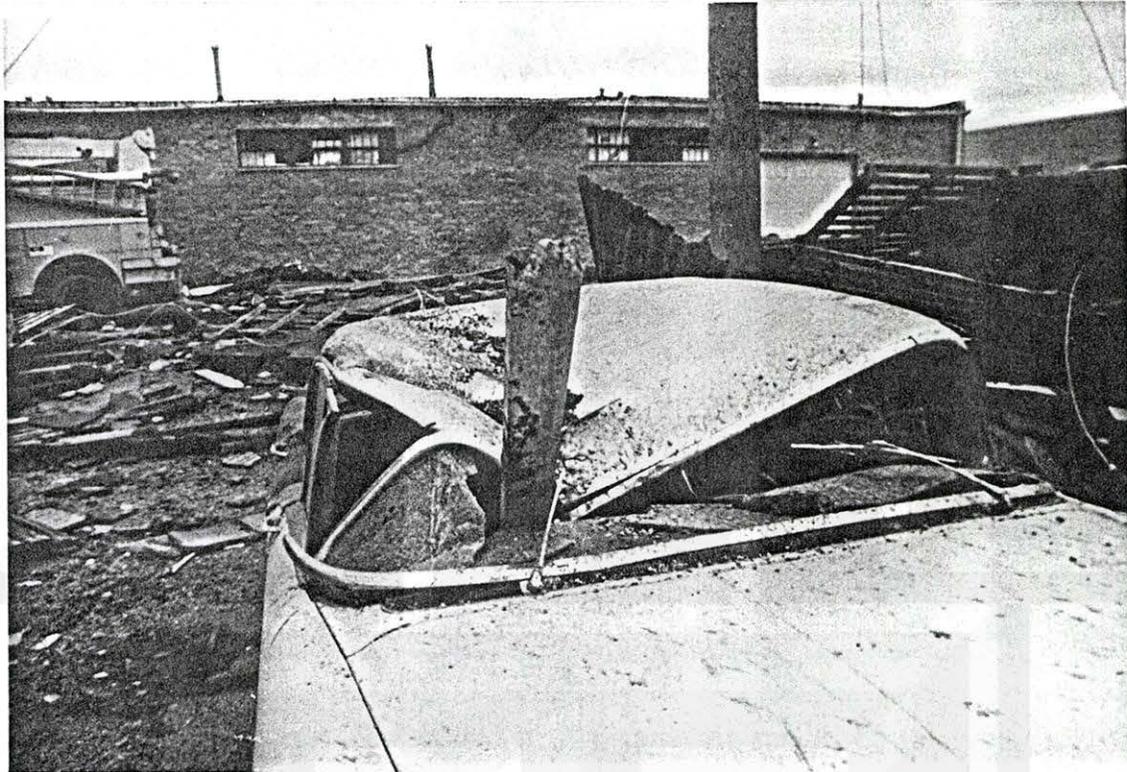
Fig. 11 An automobile with a 2X4 piece of lumber penetrating the front windshield.

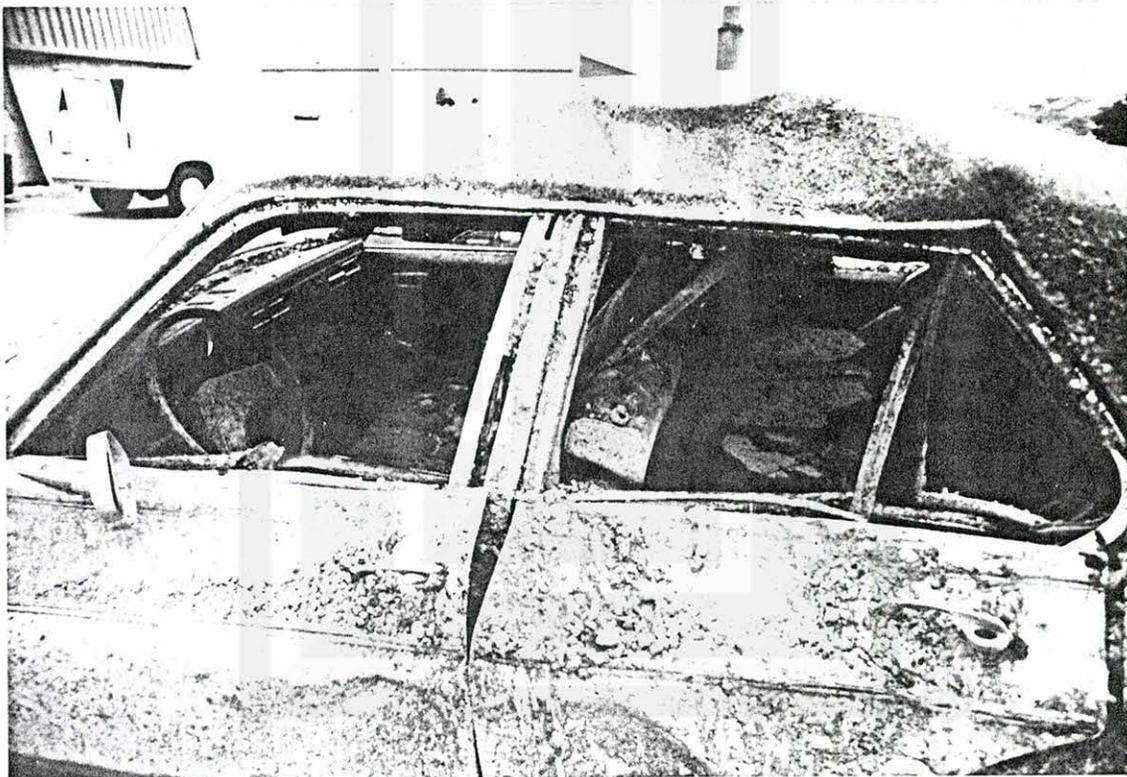
Fig. 12 Debris blown into the above automobile.

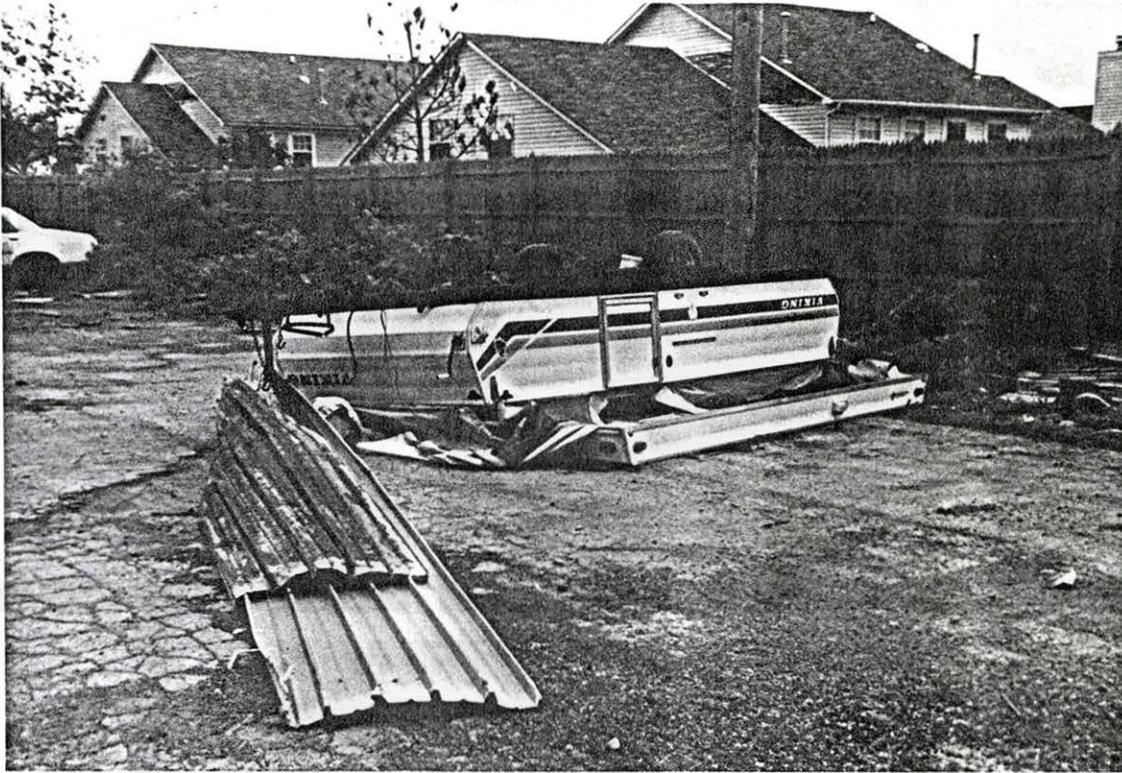
Fig. 13 A light-weight trailer overturned behind the store building at 702-724 Bonded Parkway.

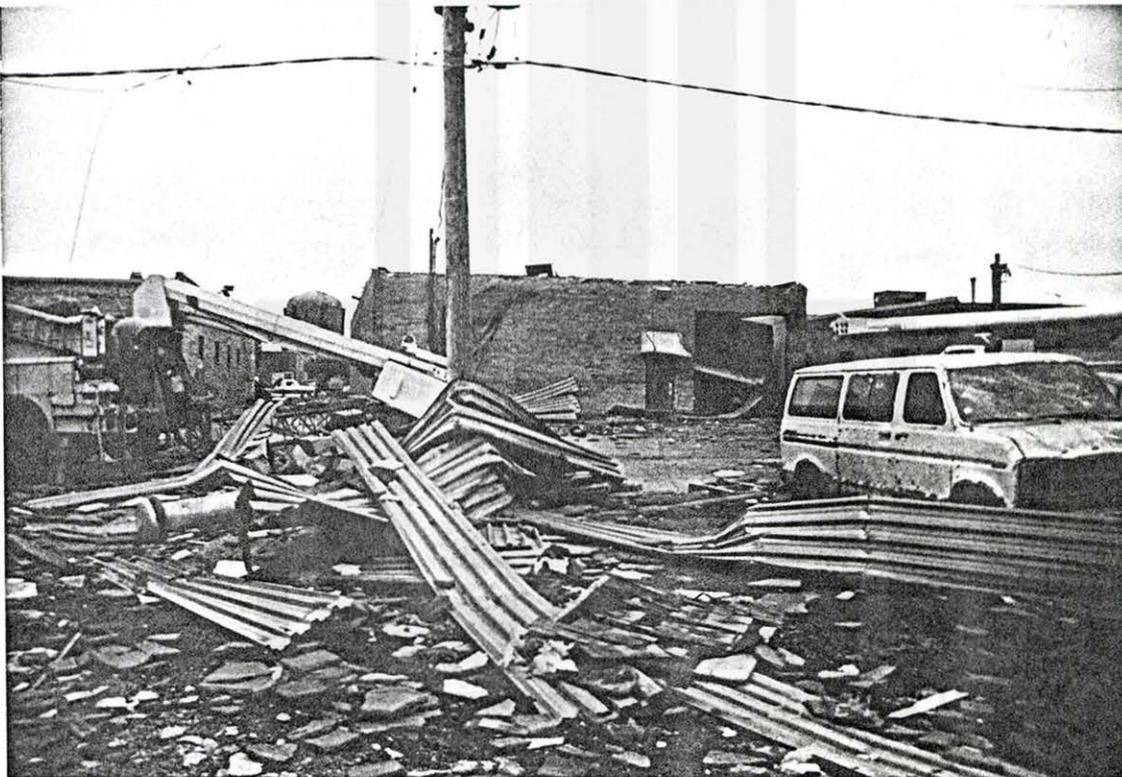
Fig. 14 Parking area behind buildings at 1531-33 Burgundy Parkway and 1532-34 Brandy Parkway where numerous tin roofings piled up around a power pole.

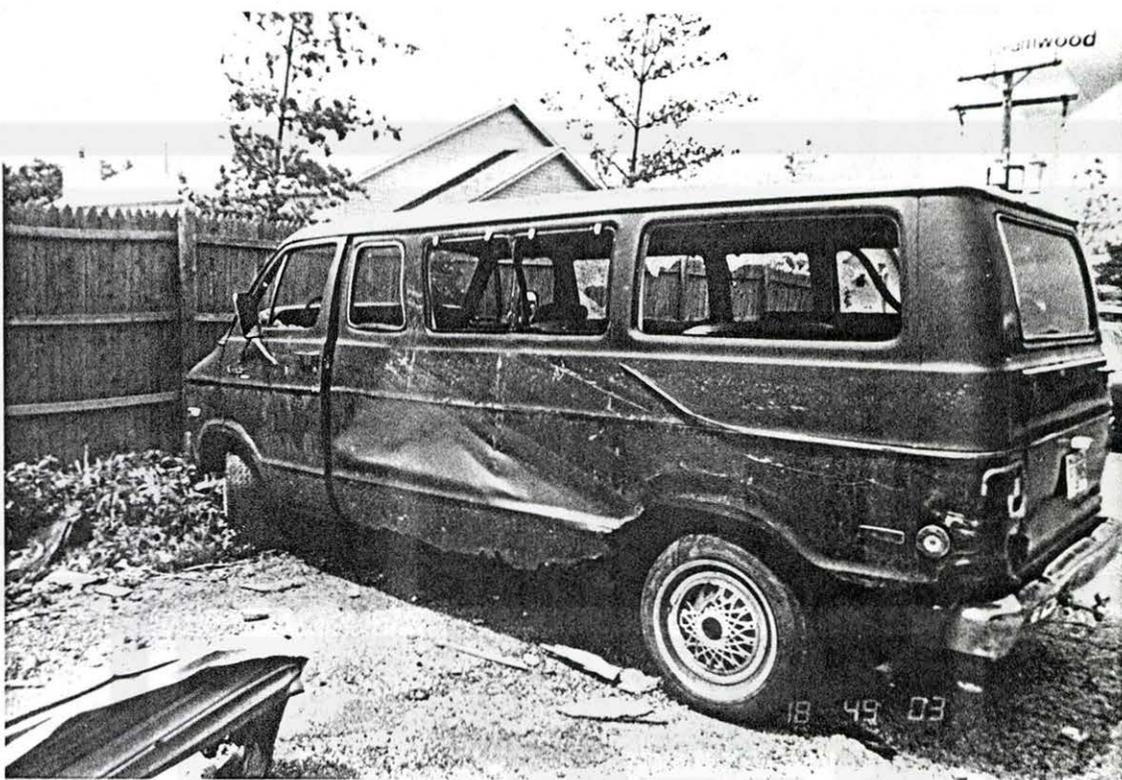
Fig. 15 A truck which lost all windows on the upwind side. Photo taken from the direction of the impinging winds.

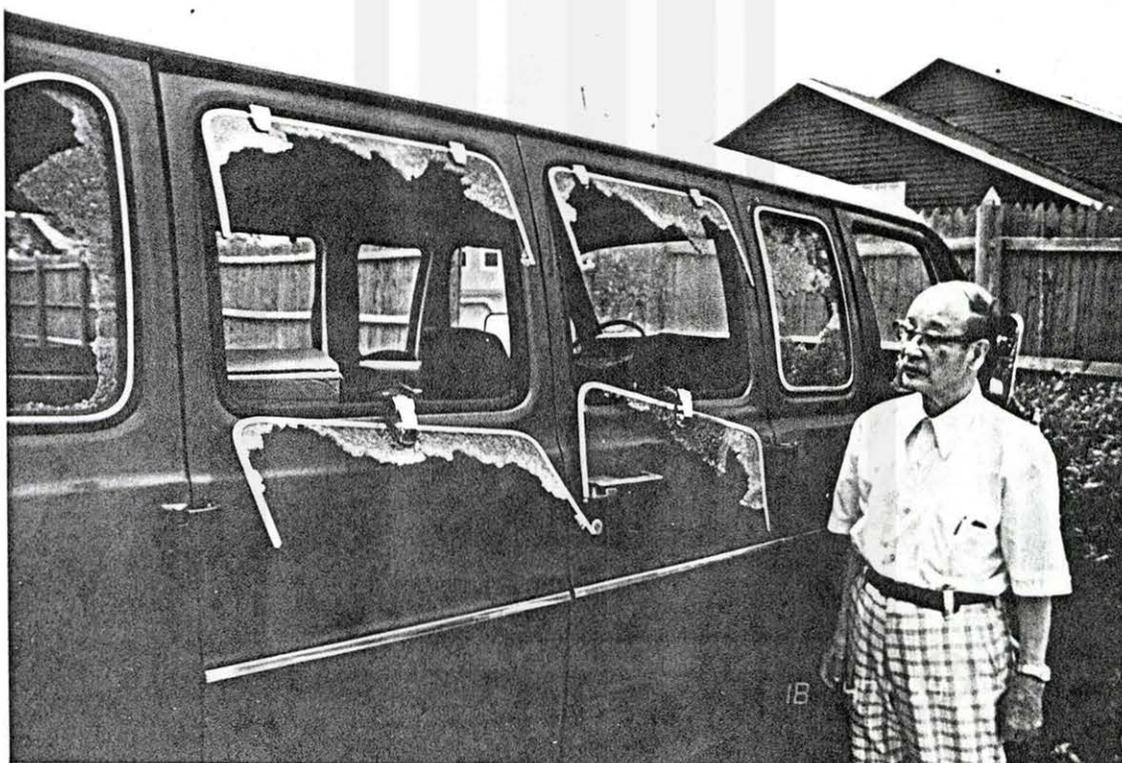
Fig. 16 The above truck seen from the opposite direction. All windows were blown out when the microburst winds blew through the truck.

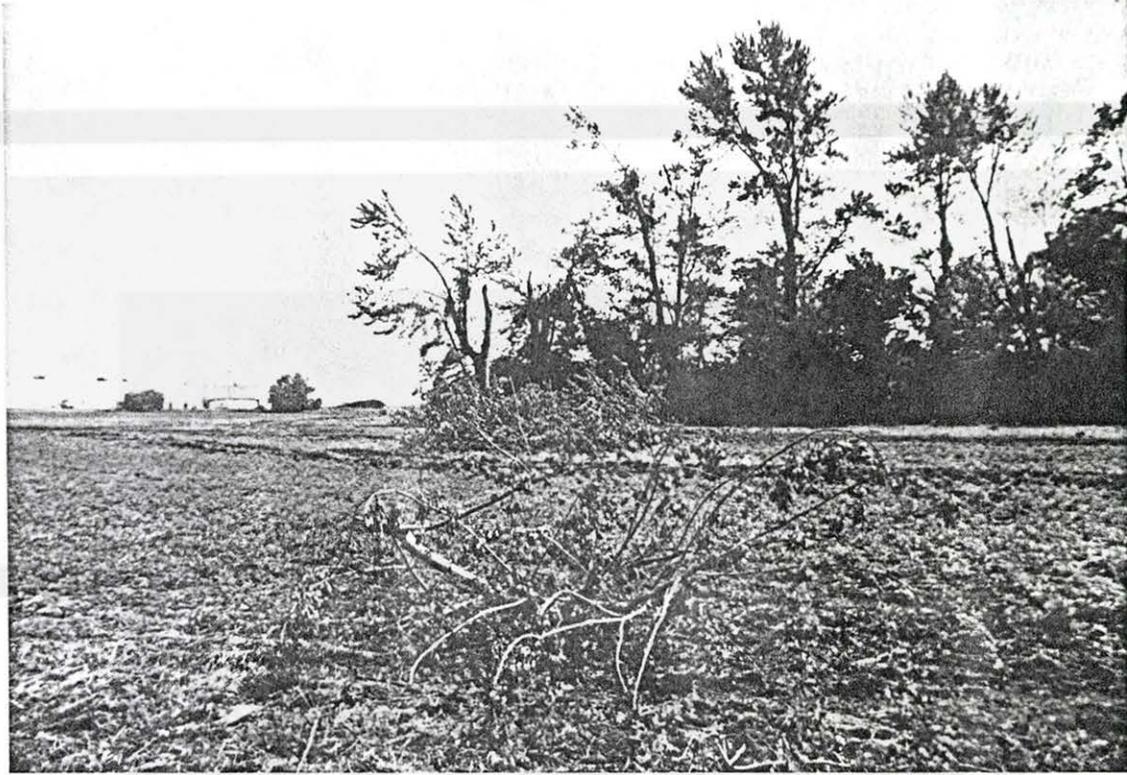
Microburst No.2 which descended on a small forest was small in size and weak in winds, but it blew large twigs off trees (Fig. 17) and uprooted large trees (Fig. 18). There were a number of twig streets extending from the forest toward the north-northwest.

Fig. 17 Large twigs scattered downwind from the east edge of a small forest where a small microburst descended.

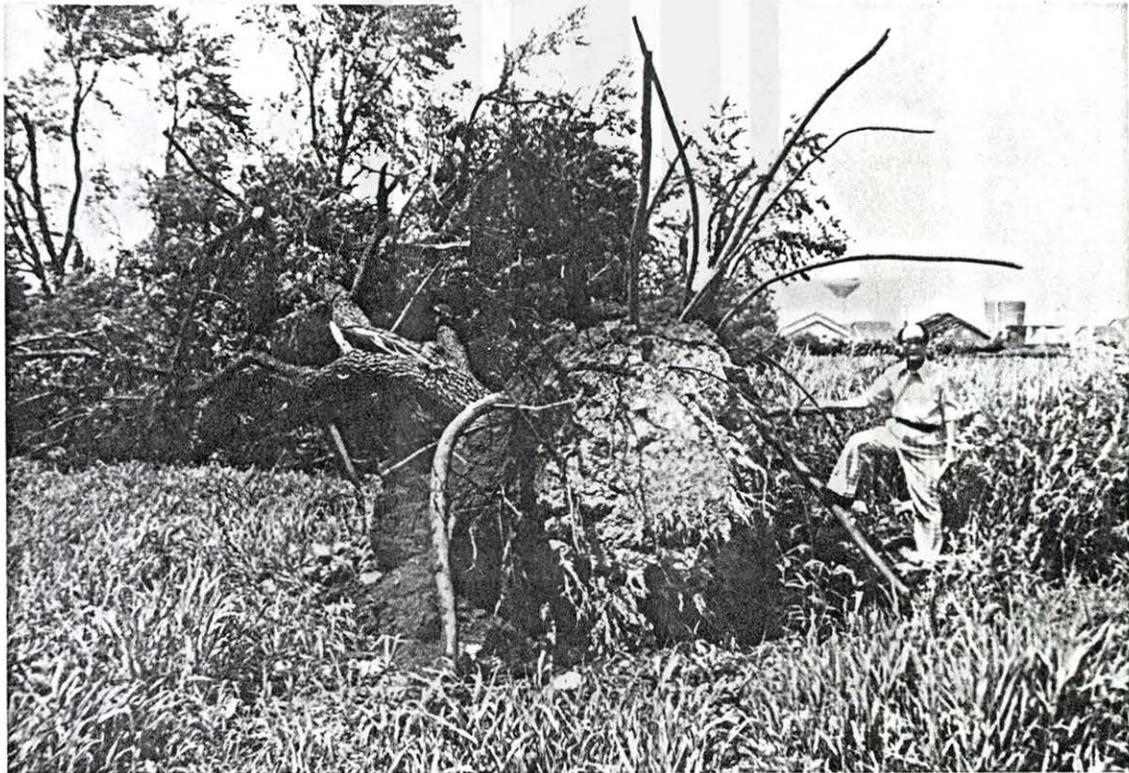
Fig. 18 A large tree in the forest uprooted by Microburst No.2 winds.
