MESOSCALE DAMAGE PATTERNS OF HURRICANE FREDERIC IN RELATION TO ENHANCED SMS IMAGERY

T. Theodore Fujita, Roger M. Wakimoto, and Duane J. Stiegler

The University of Chicago
Chicago, Illinois

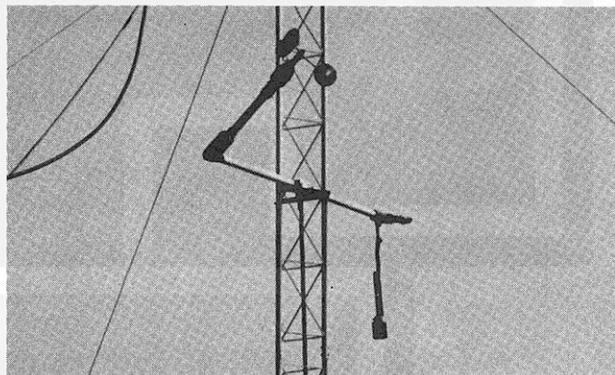
Figure 1. The anemometer at the Ingalls Shipbuilding Yard. The wind vane was broken and the 3-cup anemometer tilted toward the south.

The wind-direction sensor became inoperative at 2107 CST while the windspeeds continued to be recorded. Post storm inspection of the site revealed that the wind vane had been blown off and the 3-cup anemometer had tilted 49 degrees towards the south from its original, vertical position (see Figure 1). Unfortunately, no one witnessed how and when these sensors were disturbed during the storm.

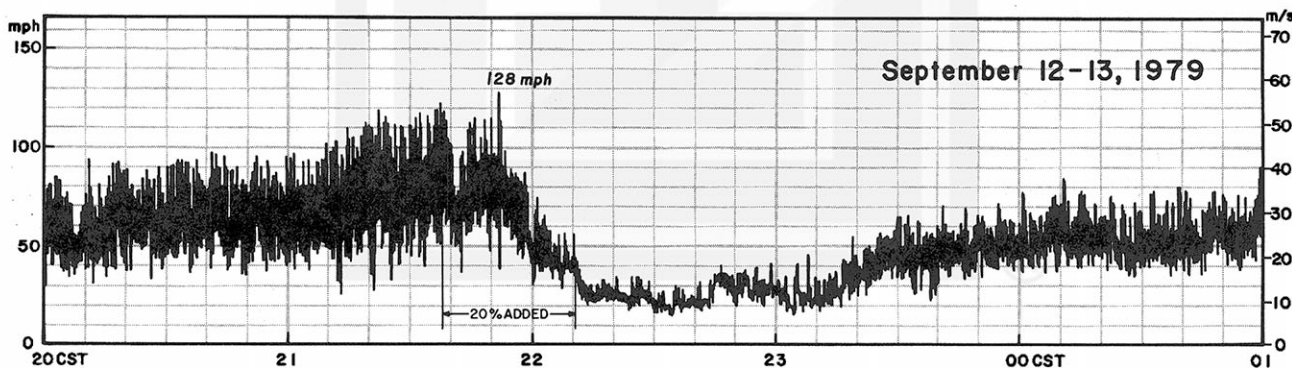
Figure 2. Wind trace obtained from the Ingalls Shipbuilding Yard. Note the windspeed correction applied between 2138 CST to 2210 CST. The 128 mph peak windspeed is associated with the inner eye.

Under the assumption that a tilted anemometer rotates slower than a vertical one, for winds that are nearly parallel to the direction of tilt of the anemometer (i.e. north or south winds), 20 percent of the wind speed was added to the original values to compensate for the tilt. The onset of the tilt was chosen to be at 2138 CST when peak gusts, which had increased gradually, suddenly began decreasing rapidly. During this time the estimated wind direction was from the north.

As the wind speed decreased in the eye, the wind direction shifted from north to west. If it is assumed that the anemometer cups rotate normally in westerly winds, no correction need be applied after 2210 CST (see Figure 2).

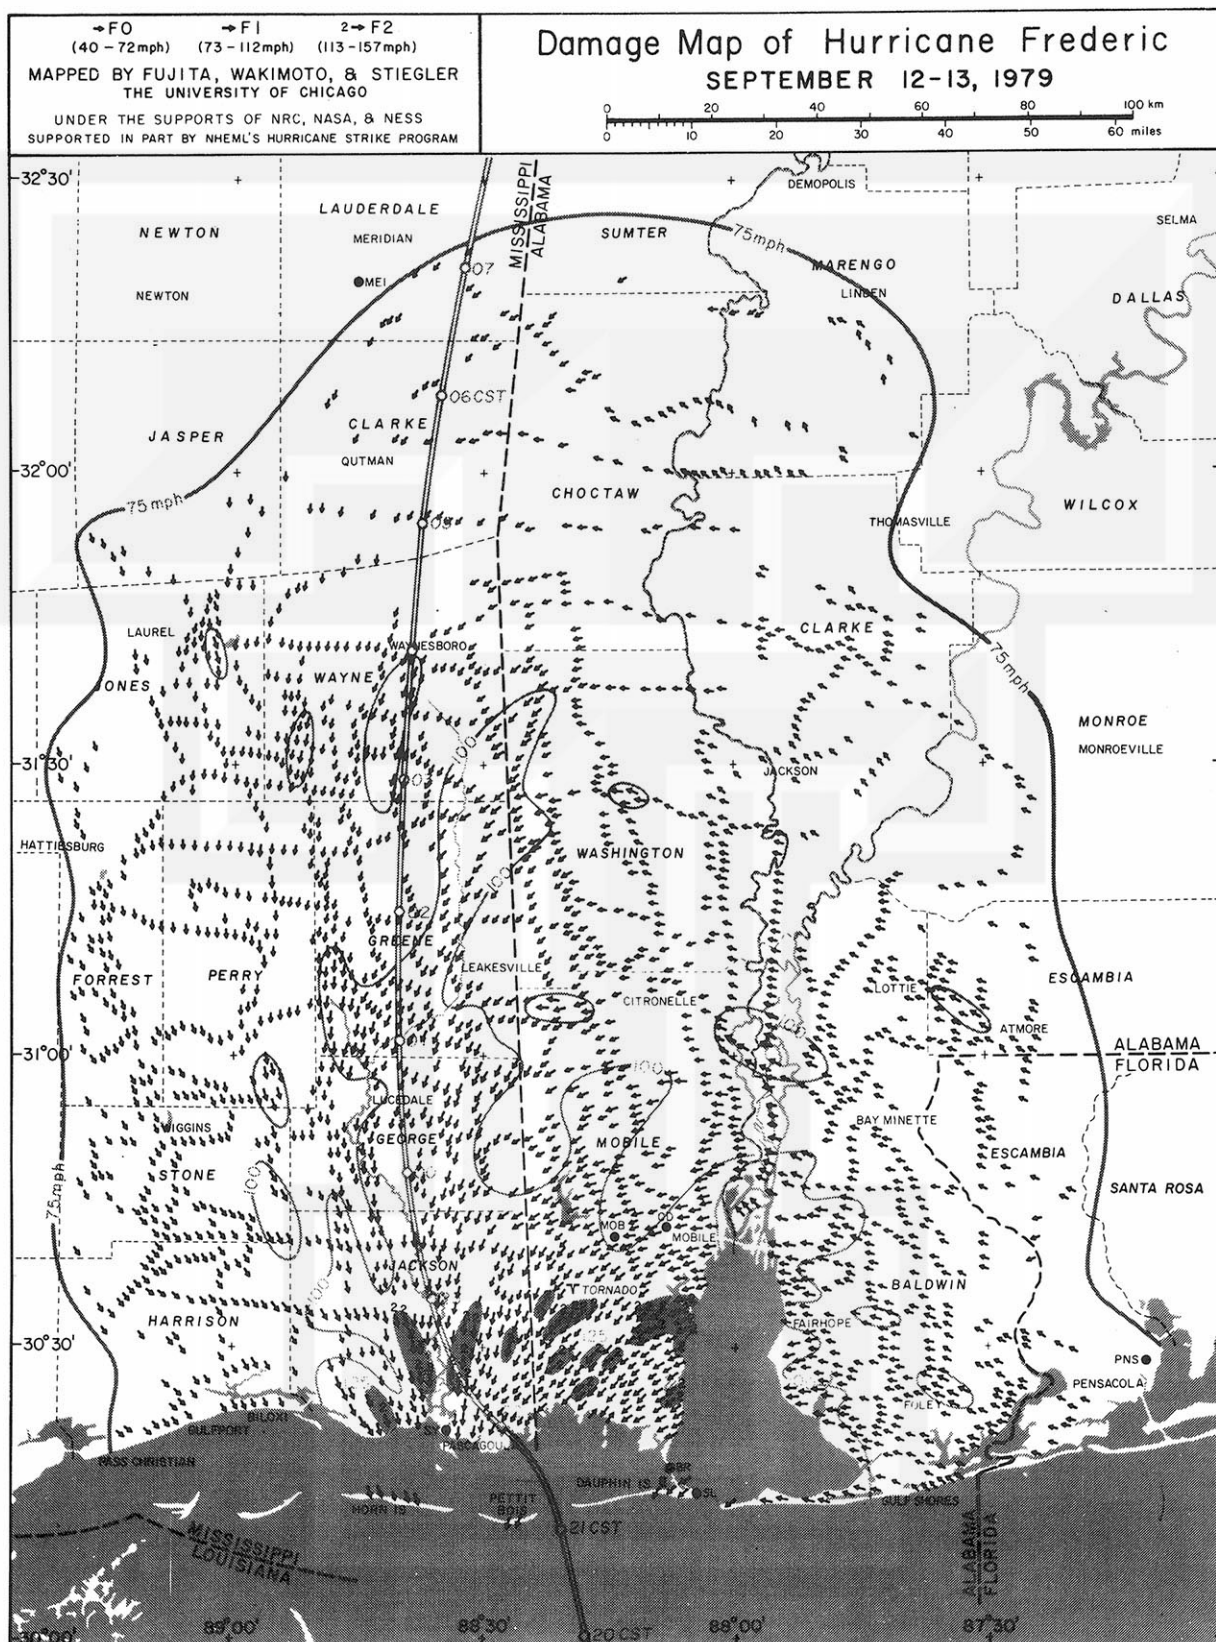
Figure 3. F-scale analysis of Hurricane Frederic. The arrows represent vectors of the tree and structural damage. See the above legend for the windspeed classification. The path of the storm's center is shown by the double line. Color copies of this map are available at the conference.

The resultant damage map is shown in Figure 3. The center of Hurricane Frederic passed directly between Pettit Bois and Dauphin Island as it headed for the coast. The anemometer on the Dauphin Island bridge (BR), was located 14 miles to the east of the center, just outside the eye.

The damage map in Figure 3 includes isolines of the F-scale wind speeds contoured with 75, 100, and 125 mph speeds. The areas where the wind speed was 125 mph or greater are shaded dark.

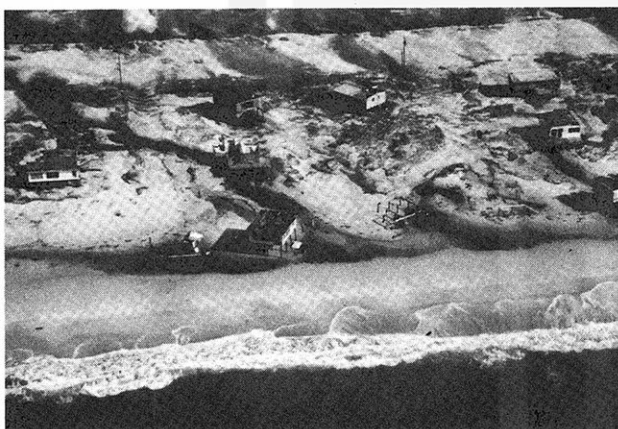
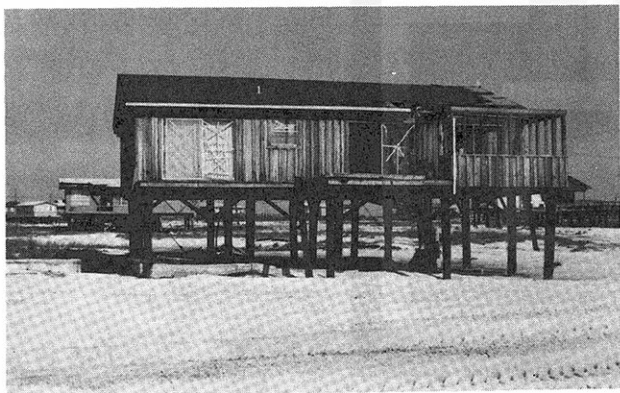
Figure 5A. Aerial photo of beach houses along the south shore of Dauphin Island after the storm.

Figure 5B. Typical elevated beach house on Dauphin Island.

Numerous summer and year round houses are located along the shore line south of the island. Most of these houses escaped water damage because of the building code established after Hurricane Camille of 1969, which stated that the floor must be 10 feet above the mean high water level (see Figures 5A and 5B).

Wind effects on the beach houses were minimal, and were rated from aerial surveys as being F0 or F1. If there were no recorded wind traces from the Dauphin Island Sea Lab and bridge, the estimated wind speeds based on the damage would have been less than 100 mph.

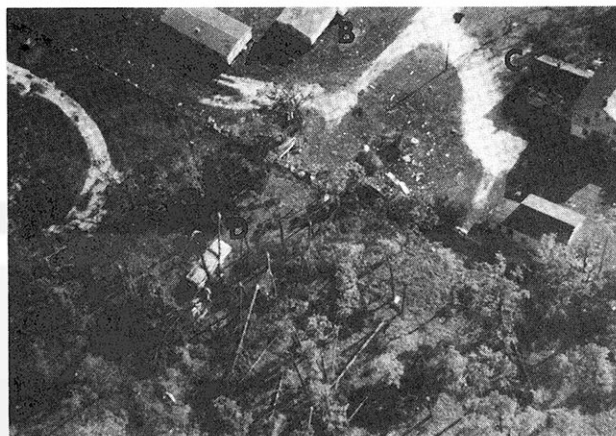
Figure 6A. Aerial view of damage near the Dauphin Island Sea Lab.

Many of these frame houses did not appear to be damaged when seen from the air. Figure 6A, looking northeast, shows barrack-like houses labeled A and B. These houses, as seen from the ground (see Figure 6B), are built on posts 3 to 4 feet high. Building C is a two story frame house which received minor roof damage. The roof of the small trailer labeled point D was dented by snapped pine trees.

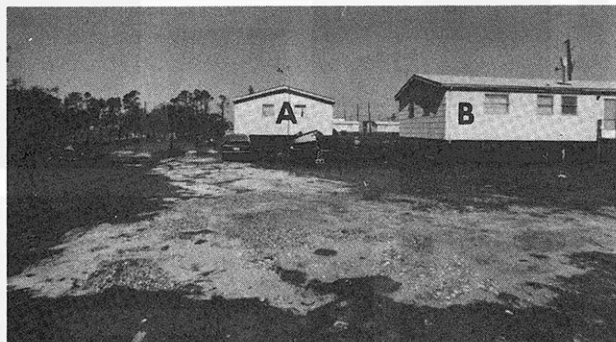
Figure 6B. Ground photo of houses shown in Figure 6A.

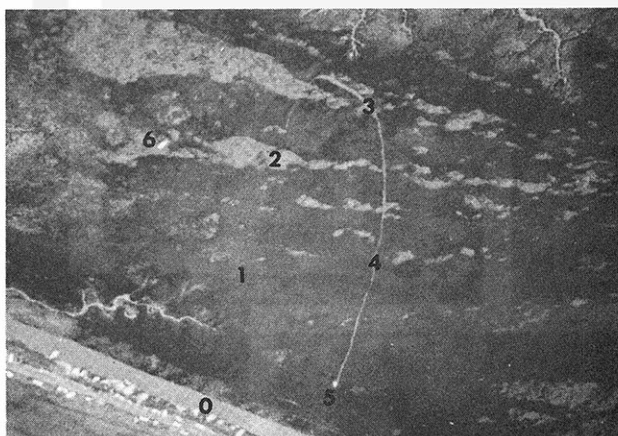
Figure 7A. Aerial photo depicting a trail of damaged grass left by a boat.

From a canal north of the Dauphin Island bridge, a boat was picked up by a combination of the high tide and wind. It was probably pushed, while afloat, towards the west-southwest (see Figure 7A) from '0' to '1' to '2'. As the water level subsided the boat began damaging the grass from '2' to '3' (see Figures 7A and 7B). Then the wind direction reversed, pushing the boat back to near its original location. After leaving a U-turn mark on the grass, the boat came to rest at '5'.

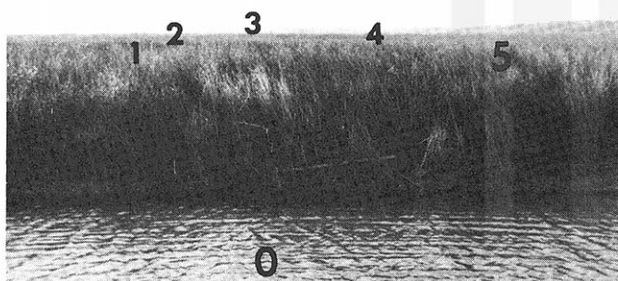
Figure 7B. Ground photo taken at '0' of Figure 7A looking across the canal.

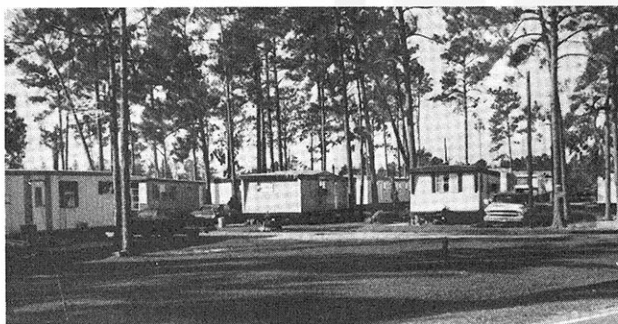
Figure 8. The trailer park sheltered by tall pines shown in Figures 9A and 9B.

A number of trailer parks were affected by the hurricane-force winds. In almost all cases, however, the mobile homes surrounded by tall pine trees (see Figure 8) received much less damage than those in open areas.

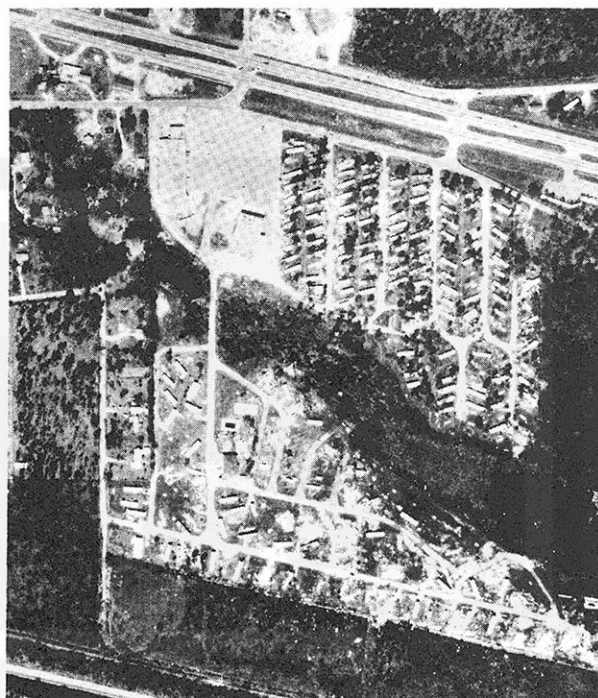
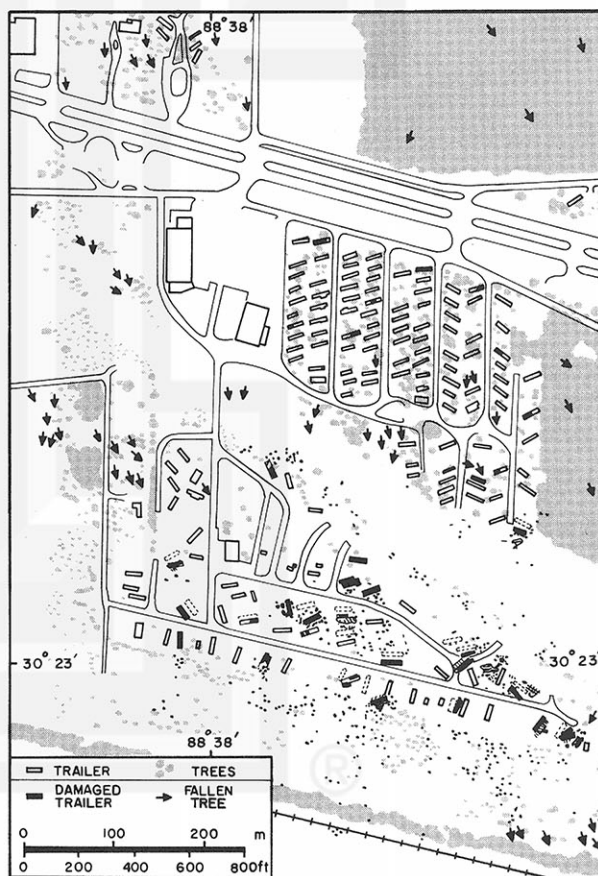
Figure 9A. NHEML photo of two trailer parks.

Figure 9B. A mapping of the damaged trailer parks shown in Figure 9A.

Figures 9A and 9B is an example of two trailer parks, 5 miles to the west of Pascagoula, where the gusts were estimated to be 100 mph from the north. In the northern trailer park which is surrounded by tall pines, practically all the mobile homes were untouched by the winds.

In the southern trailer park which is in an open area, none of the trees were tall enough to act as an effective wind break to shield the mobile homes from the strong gusts.

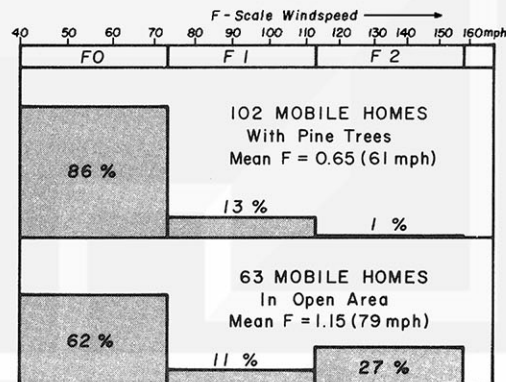
The wind break effect has been discussed in 4.3 (see Figures 9A and 9B). The F-scale distribution of mobile home damage in Figure 10 reveals that the mean F-scale was F0.65 (61 mph) for the mobile homes protected by tall pine trees, and F1.15 (79 mph) for those in the open area. This result implies that on the average, pine trees reduced the peak surface windspeeds by 18 mph.

Figure 10. F-scale distribution of the mobile home damage seen in Figures 9A and 9B.

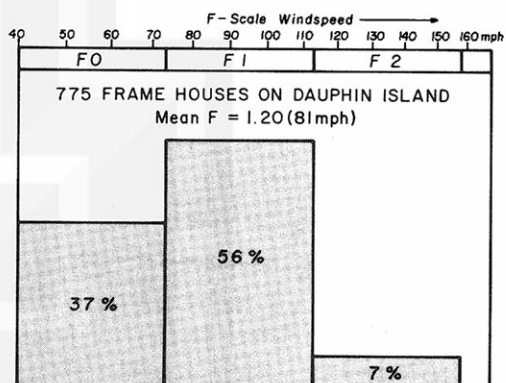
Dauphin Island provided an excellent example of estimating peak windspeeds based on hurricane damage. An F-scale assessment of 775 frame houses on the island was made from the air (see Figure 3). The resulting breakdown by scale is: 37% F0, 56% F1, and 7% F2.

The weighted average F scale is F1.20, which corresponds to an 81 mph windspeed (see Figure 11). In contrast, Table 1 shows peak windspeeds of 145 mph and 138 mph were recorded at the Dauphin Island Bridge and Sea Lab respectively.

Figure 11. F-scale distribution of frame houses on Dauphin Island.
