# **Streamwood Microburst of**

**29 June 1990**

**by T. Theodore Fujita**

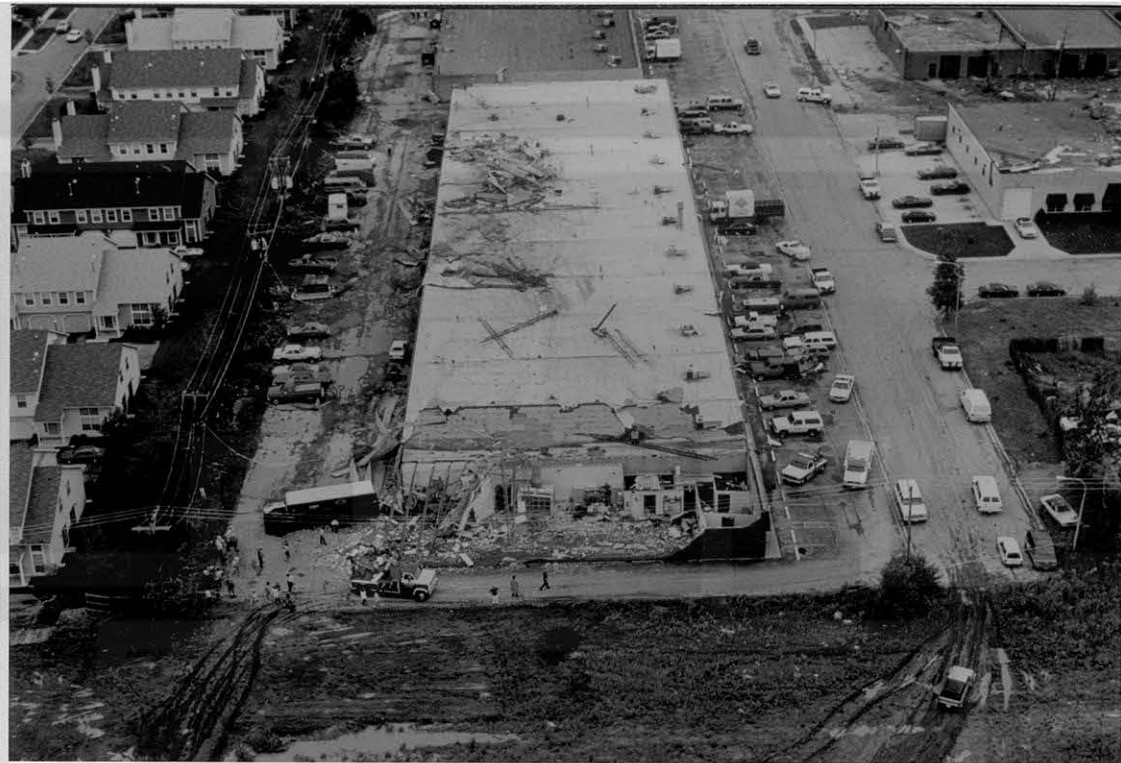
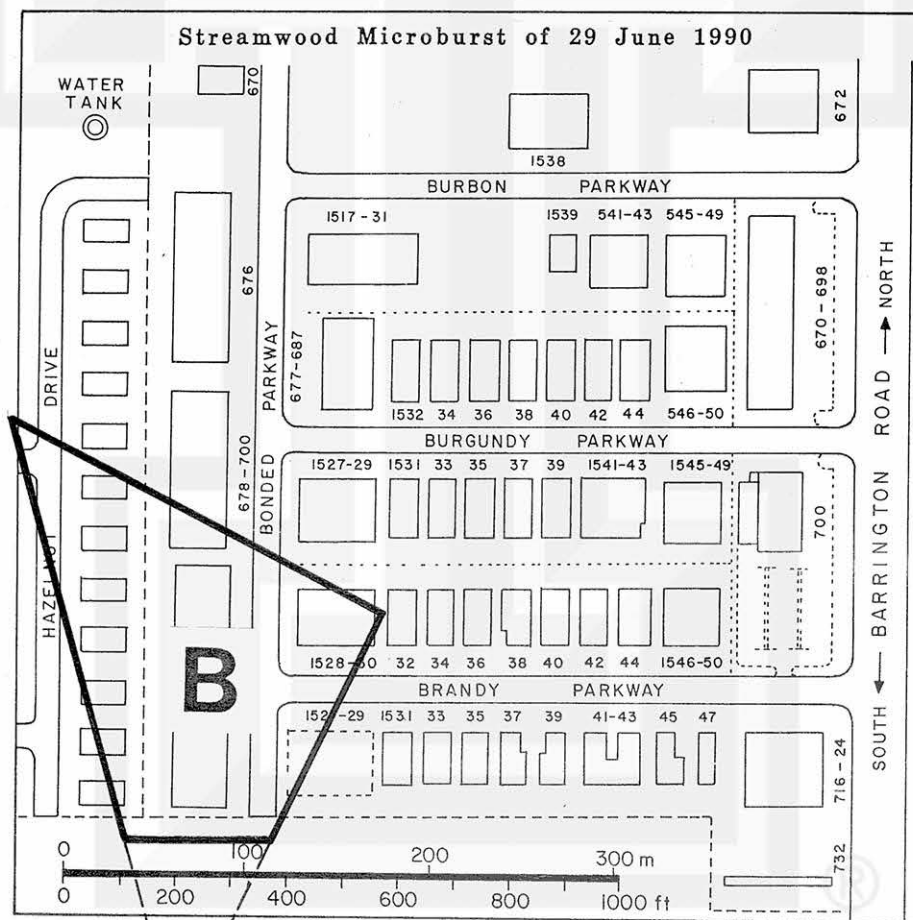
**Fig. 4** Damage of a large commercial building at 702-724 Bonded Parkway. A truck was pushed over near the southwest corner of the building.

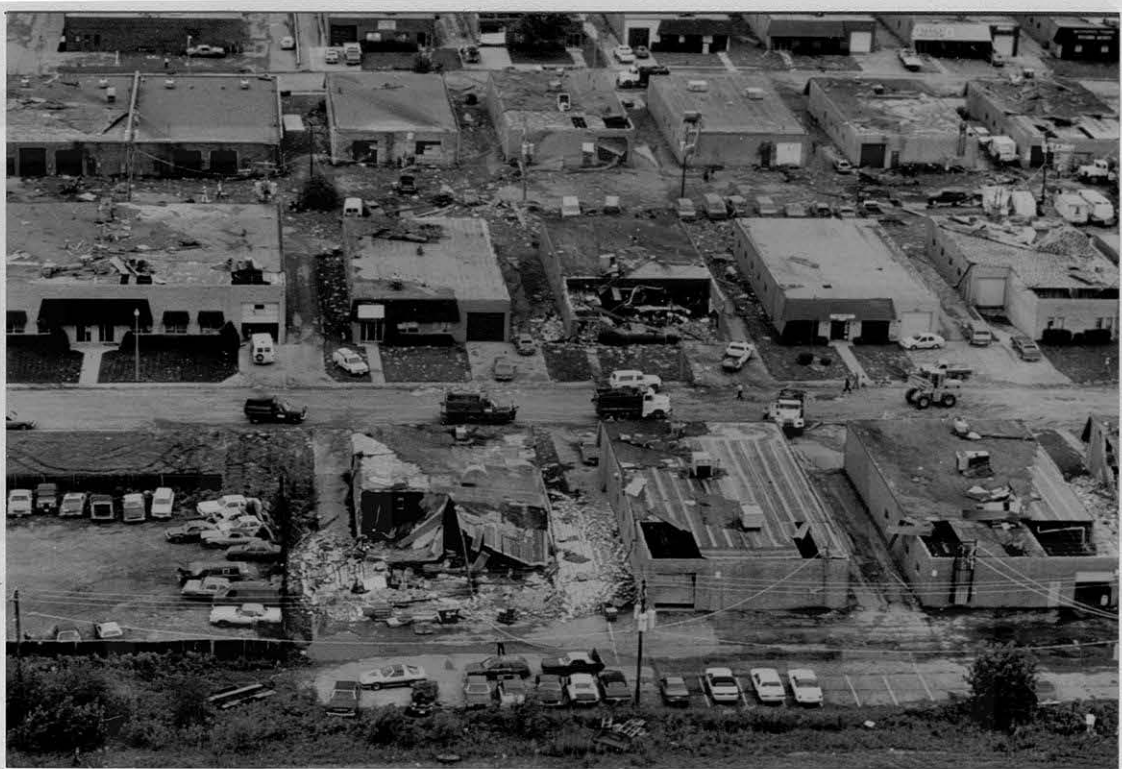
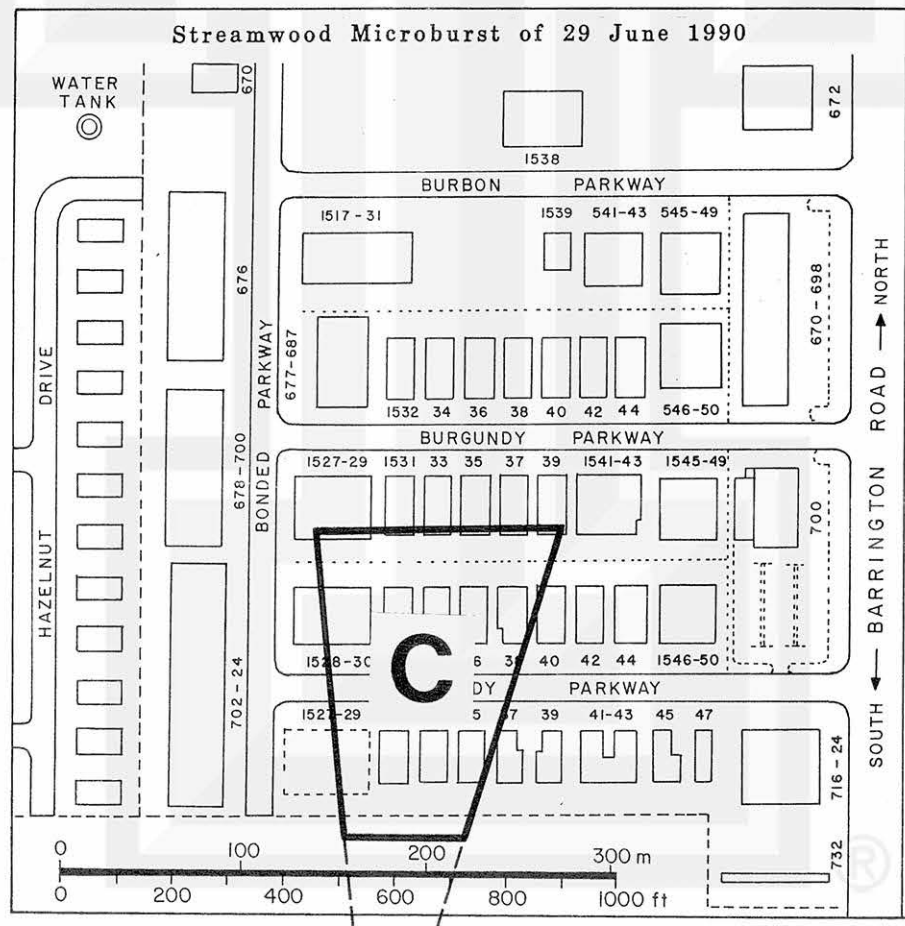
**Fig. 5** Stores and shops at 1531 and 1534 Brandy Parkway damaged by estimated 120 mph winds.

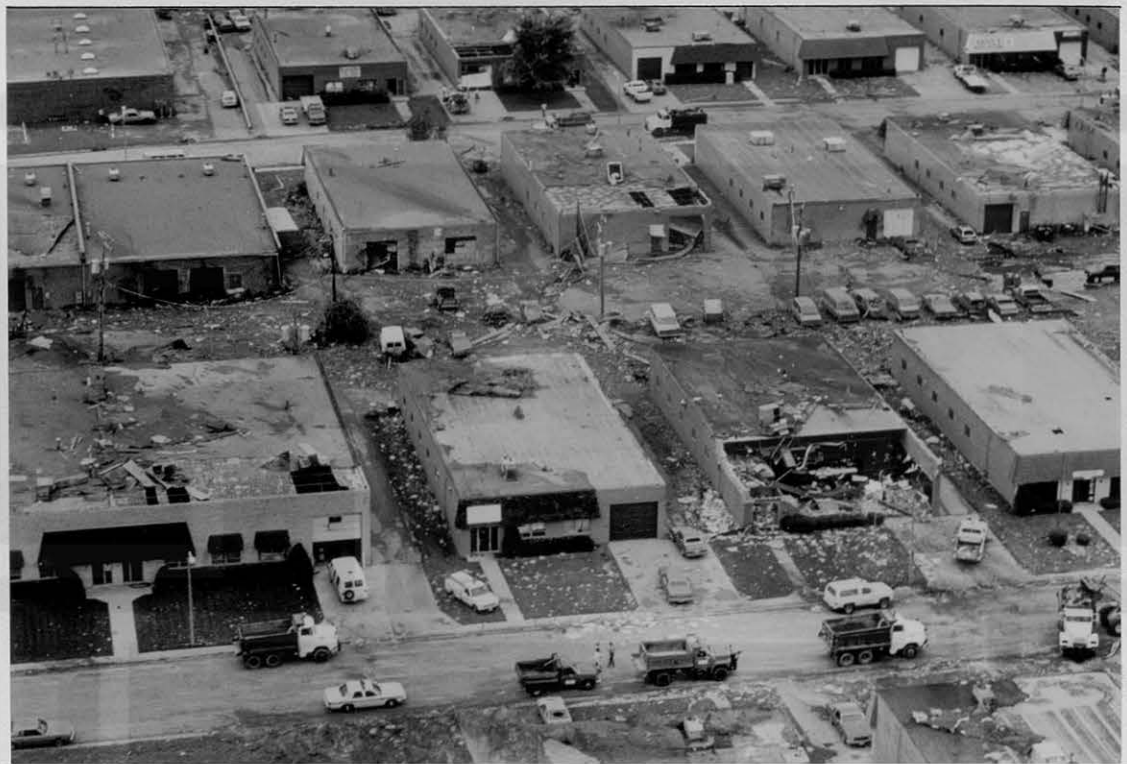
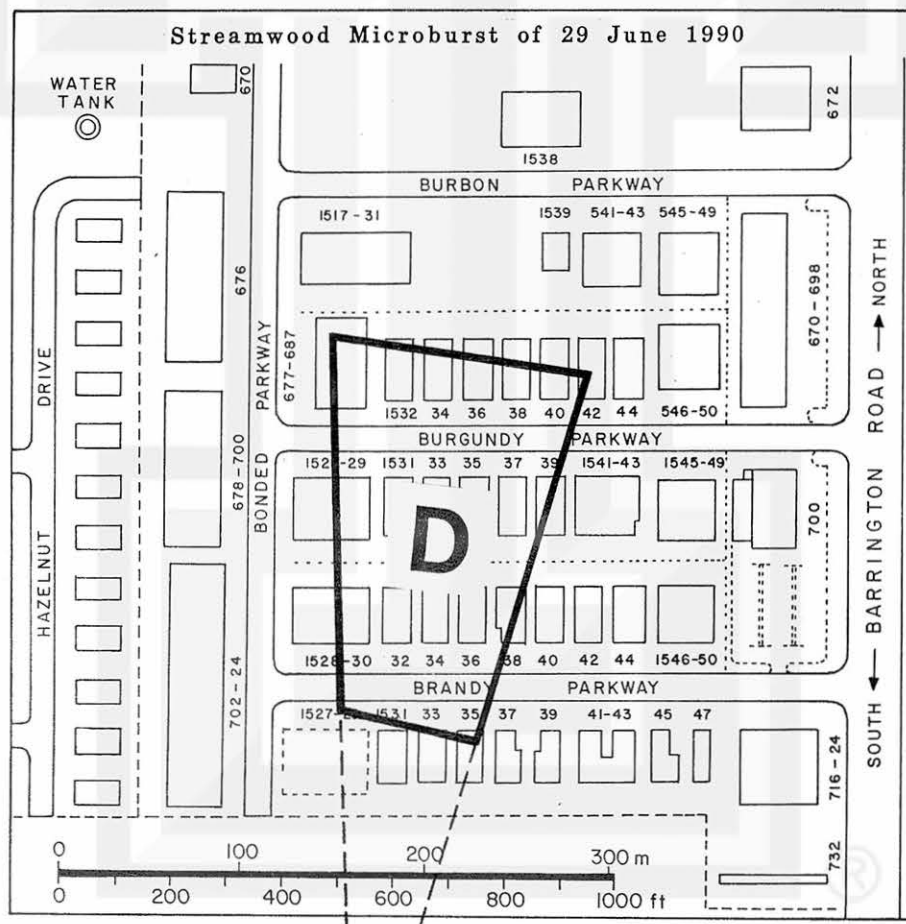
Fig. 6 Building at 1531 Burgundy Parkway showing a high-wind streak on the roof extending from the southeast to northwest corners.

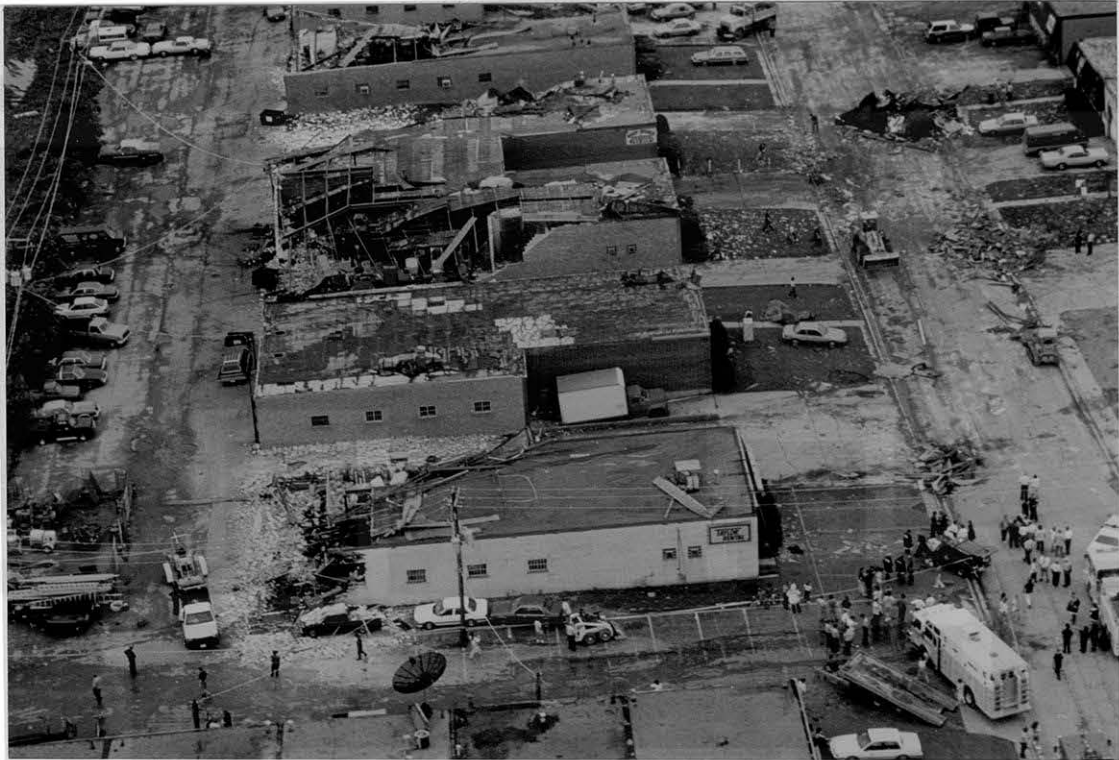
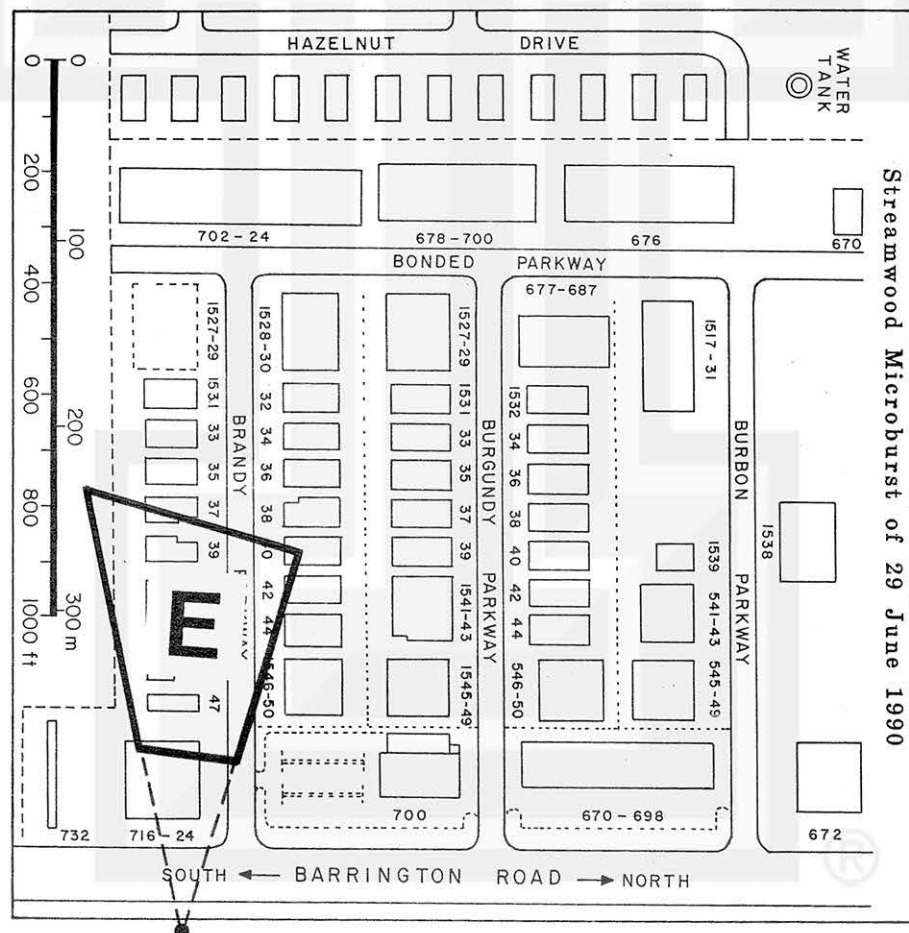
Fig. 7 The worst damage in the industrial park seen in the southeast section. The damage-causing winds are estimated at 130 mph from the south to south-southeast.

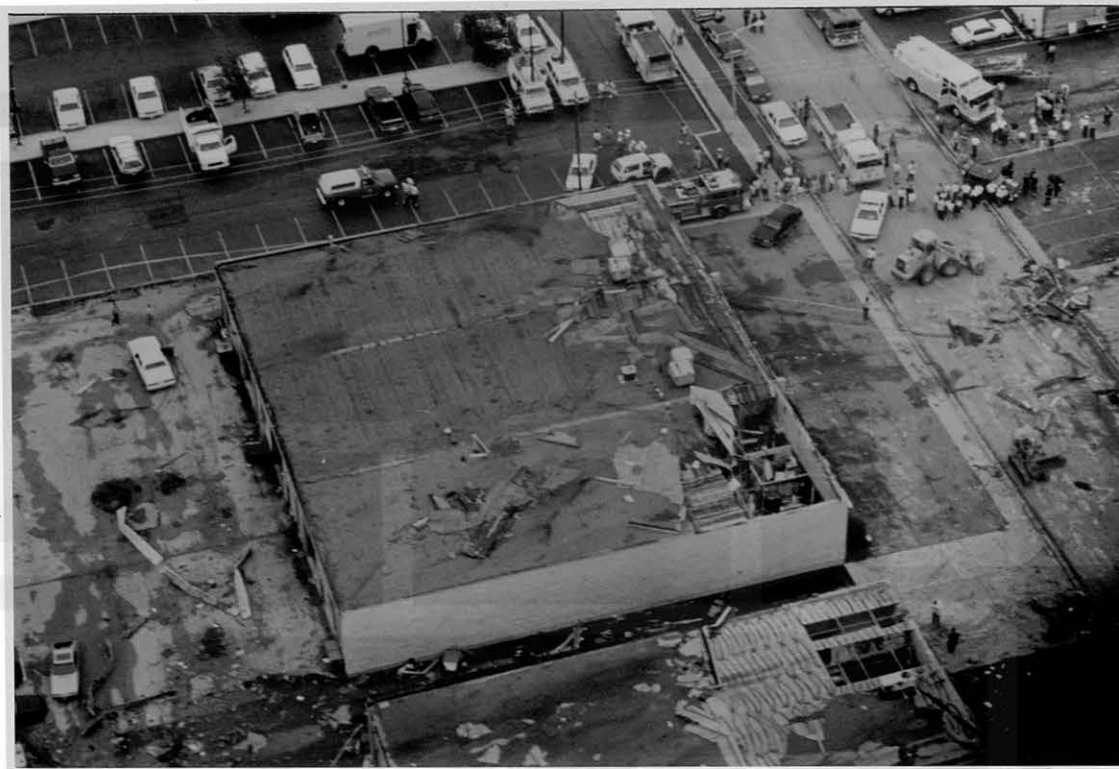
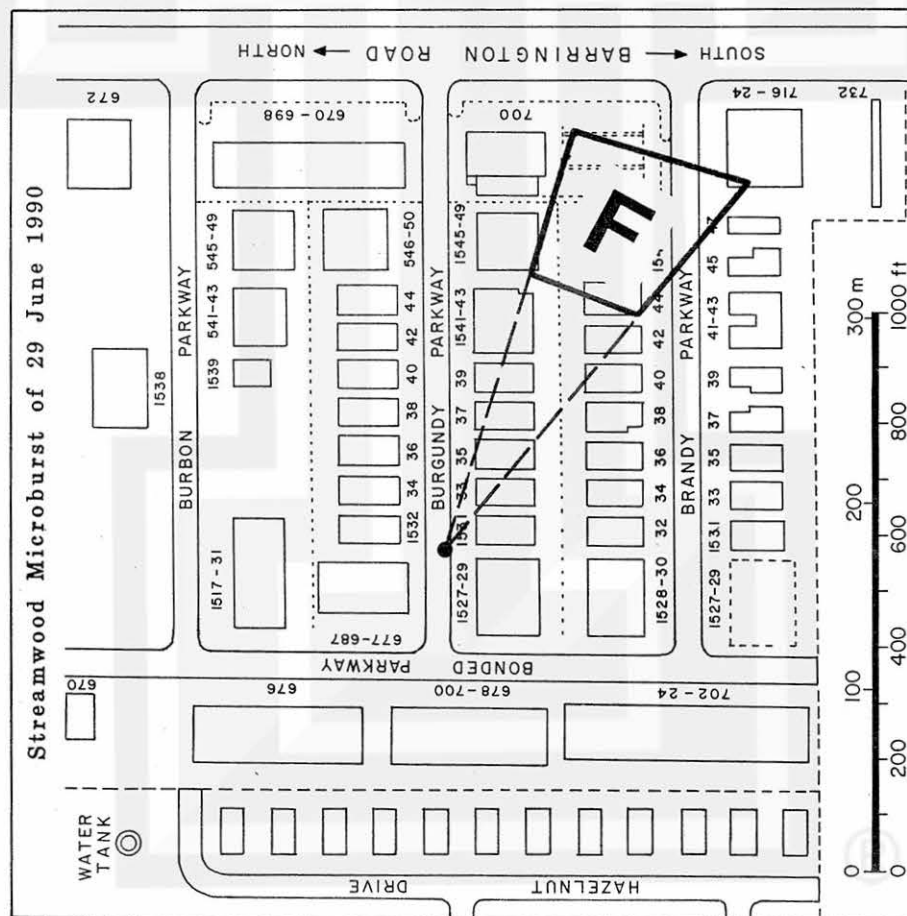
Fig. 8 The peeled-off roof of a large square building at 1546-50 Brandy Parkway.

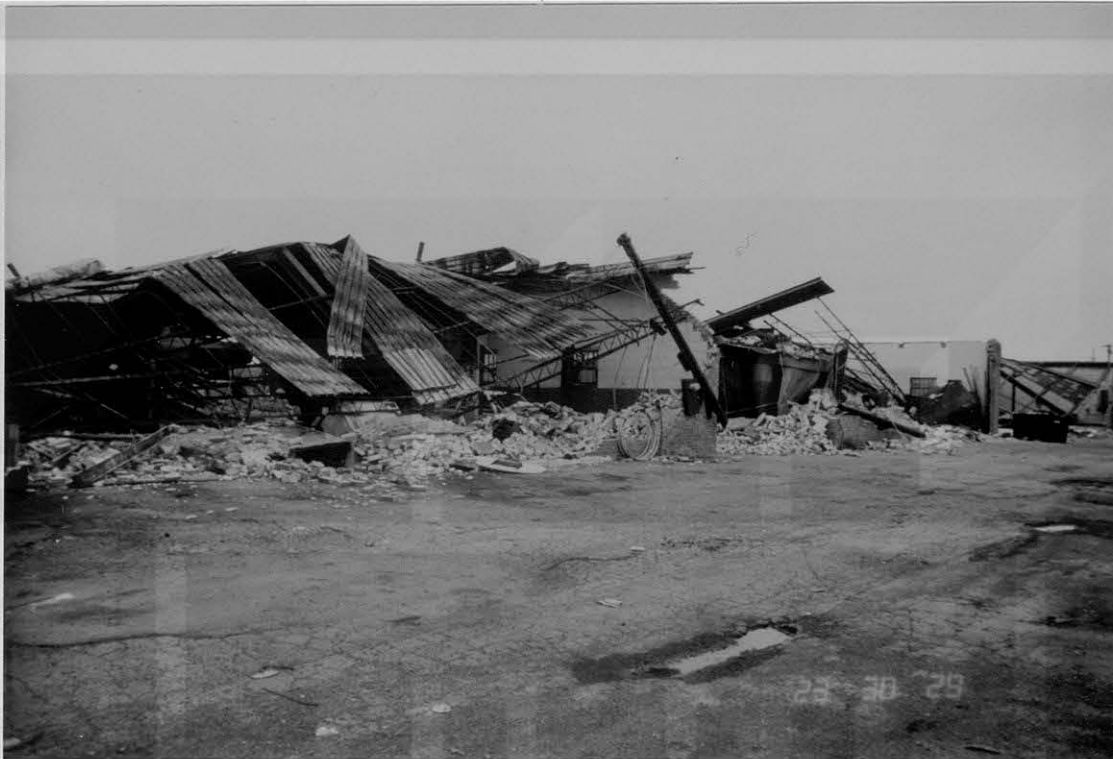
**Fig. 9** The south wall of the building at 1537 Brandy Parkway smashed by the microburst winds in the touchdown area.

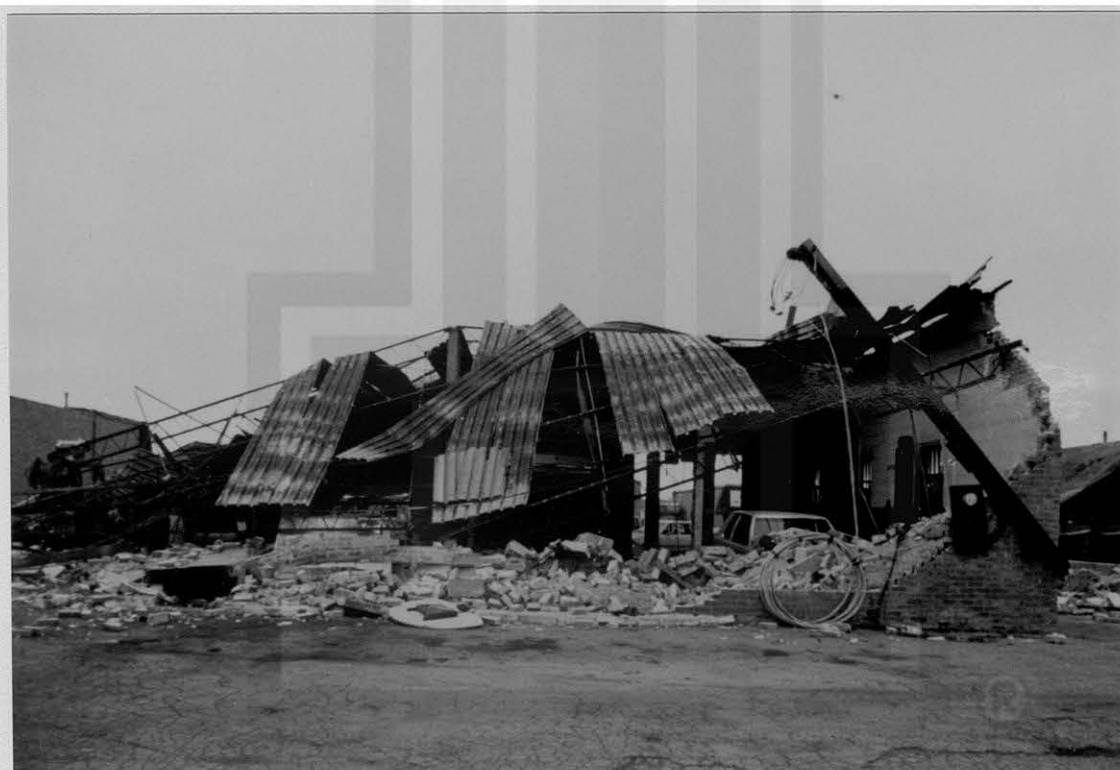
**Fig. 10** A close-up view of the building at 1537 Brandy Parkway.

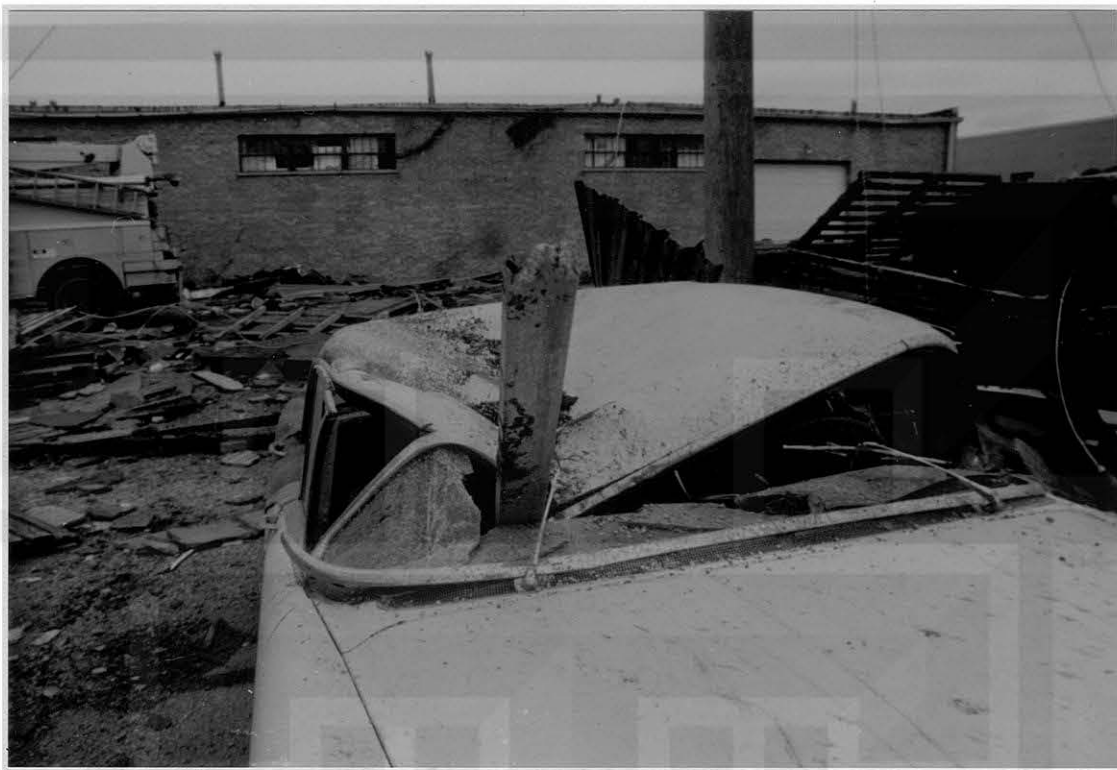
Fig. 11 An automobile with a 2X4 piece of lumber penetrating the front windshield.

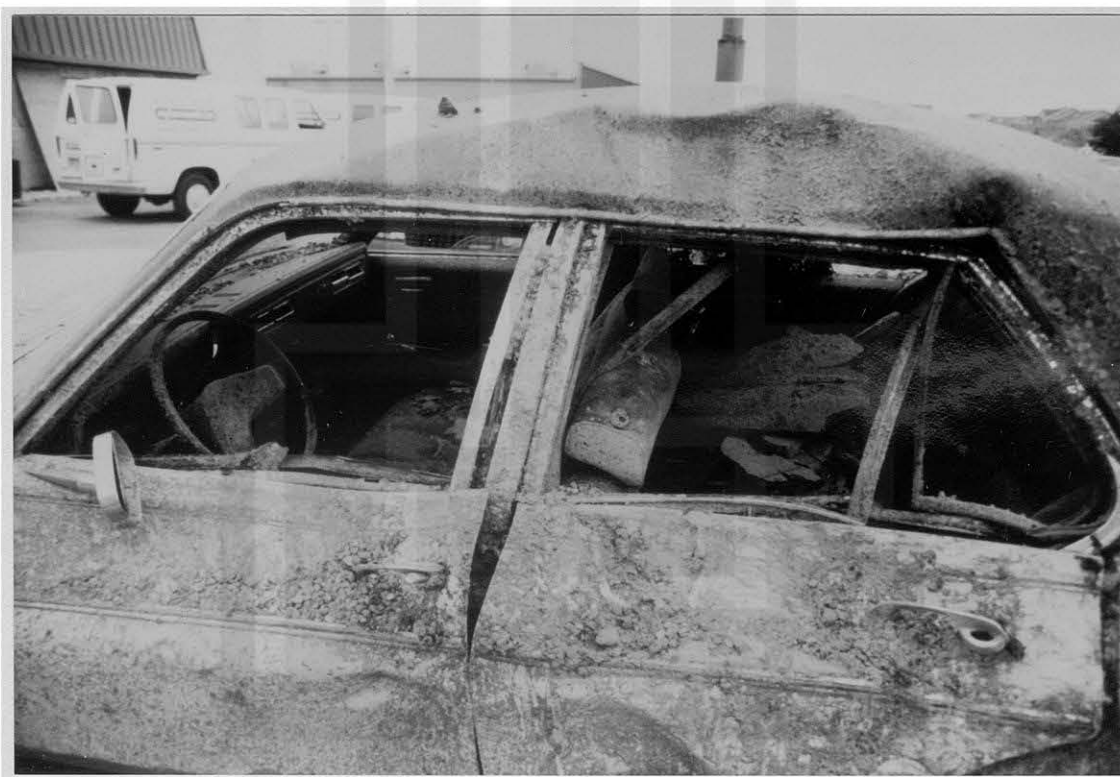
Fig. 12 Debris blown into the above automobile.

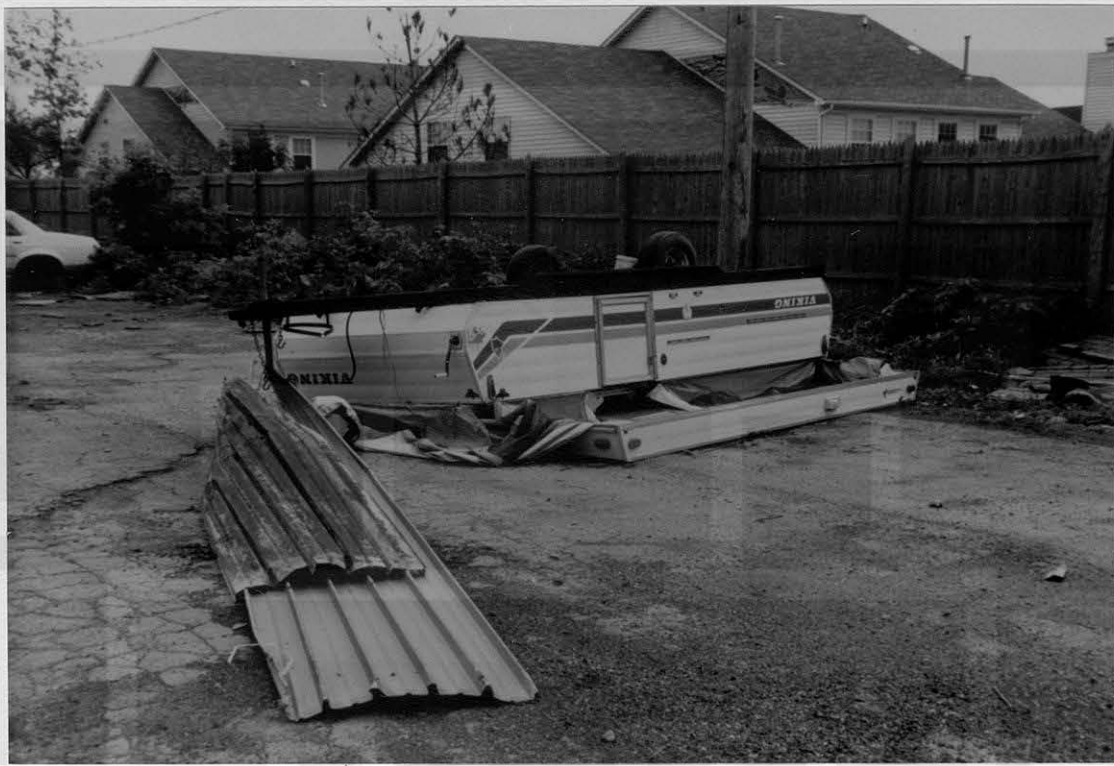
**Fig. 13** A light-weight trailer overturned behind the store building at 702-724 Bonded Parkway.

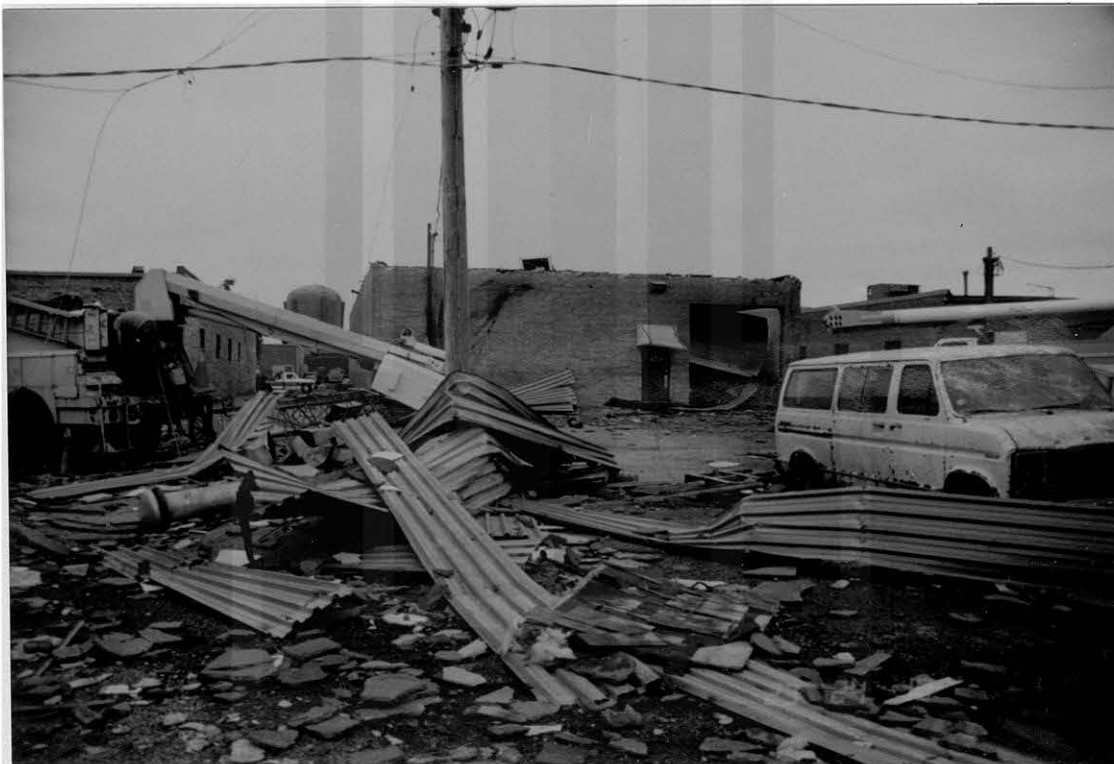
**Fig. 14** Parking area behind buildings at 1531-33 Burgundy Parkway and 1532-34 Brandy Parkway where numerous tin roofings piled up around a power pole.

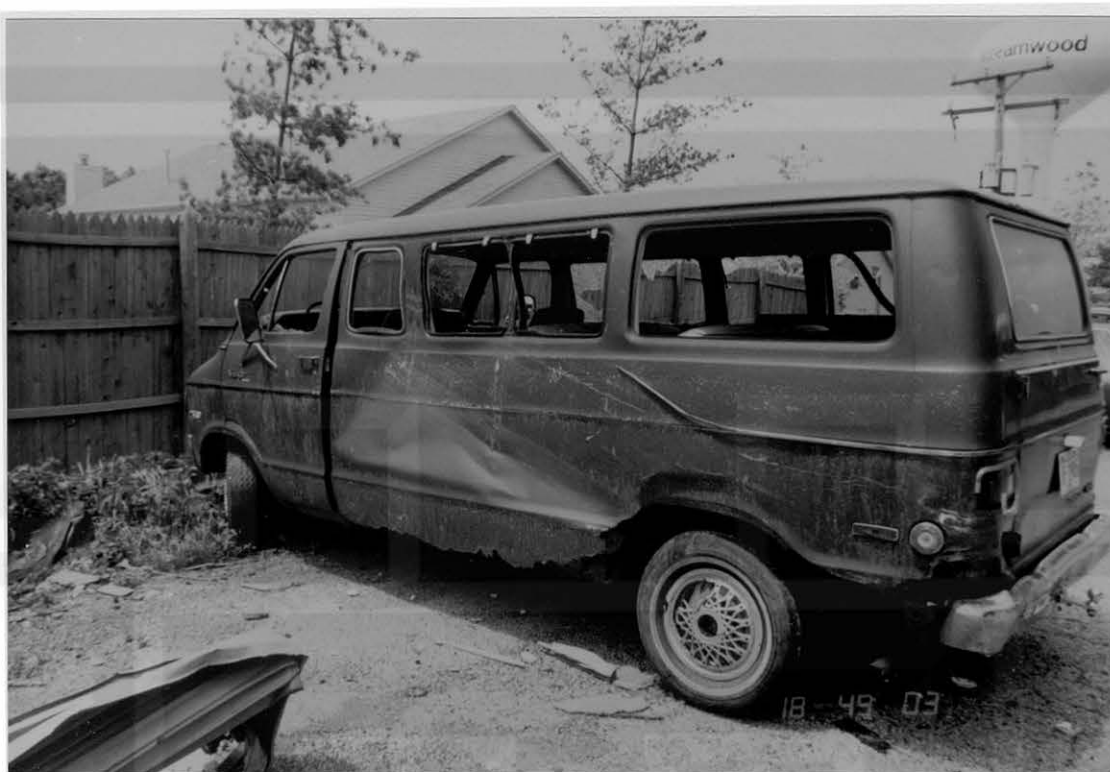
Fig. 15 A truck which lost all windows on the upwind side. Photo taken from the direction of the impinging winds.

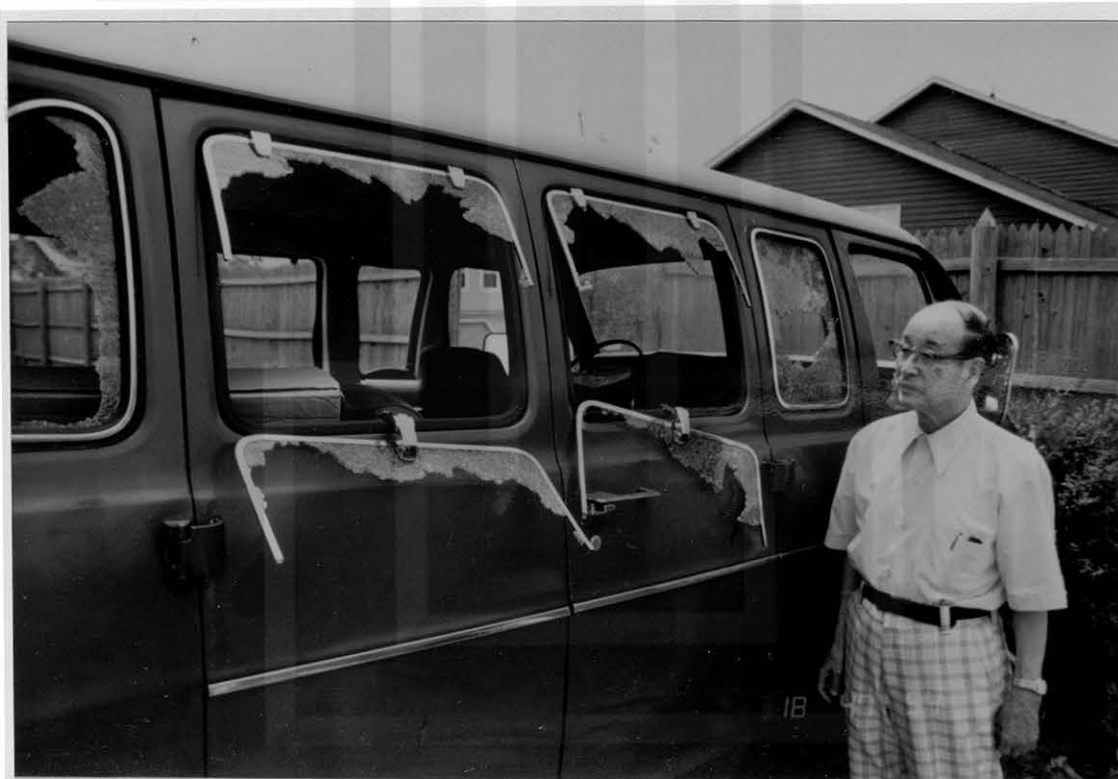
Fig. 16 The above truck seen from the opposite direction. All windows were blown out when the microburst winds blew through the truck.

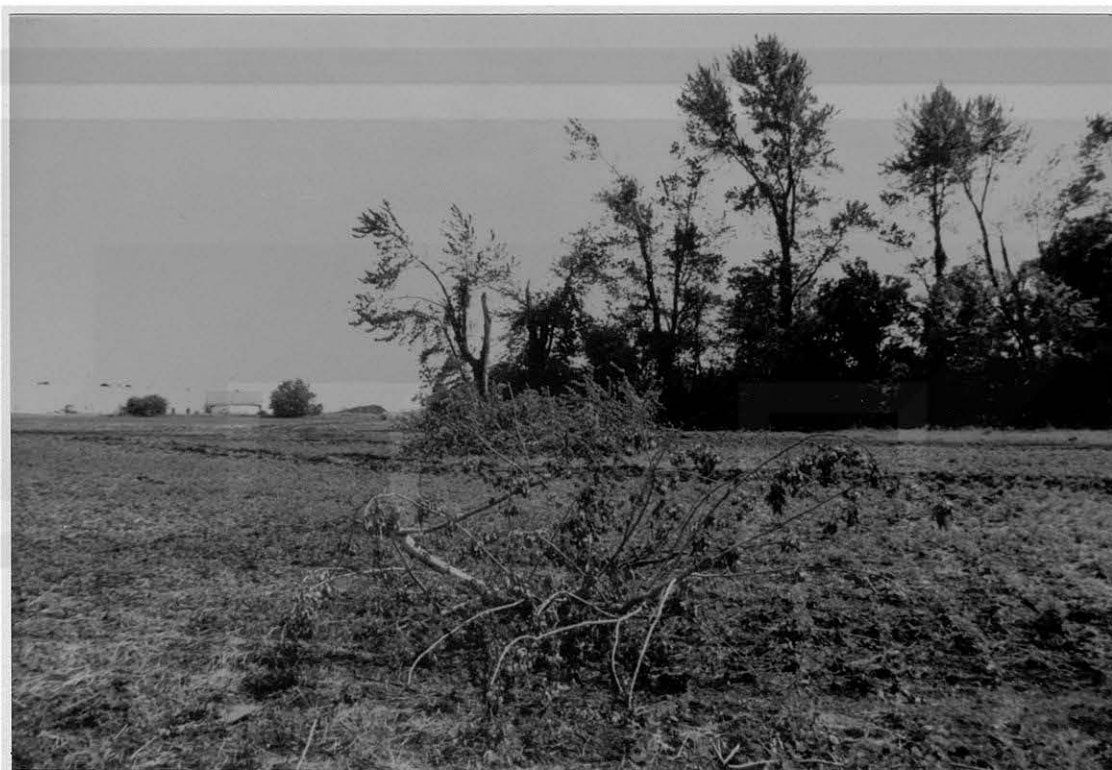
**Fig. 17** Large twigs scattered downwind from the east edge of a small forest where a small microburst descended.

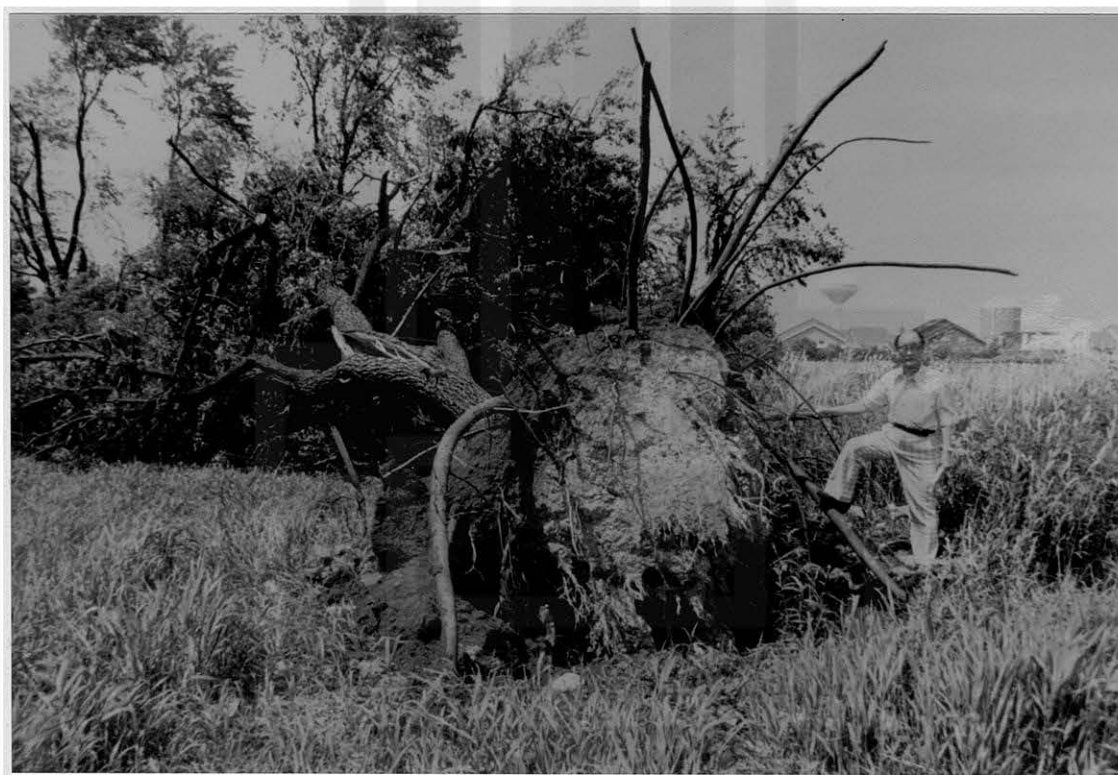
**Fig. 18** A large tree in the forest uprooted by Microburst No.2 winds.
