MESOSCALE STRUCTURE OF HURRICANE ALICIA

Duane J. Stiegler and T. Theodore Fujita

Department of the Geophysical Sciences
The University of Chicago
Chicago, Illinois 60637

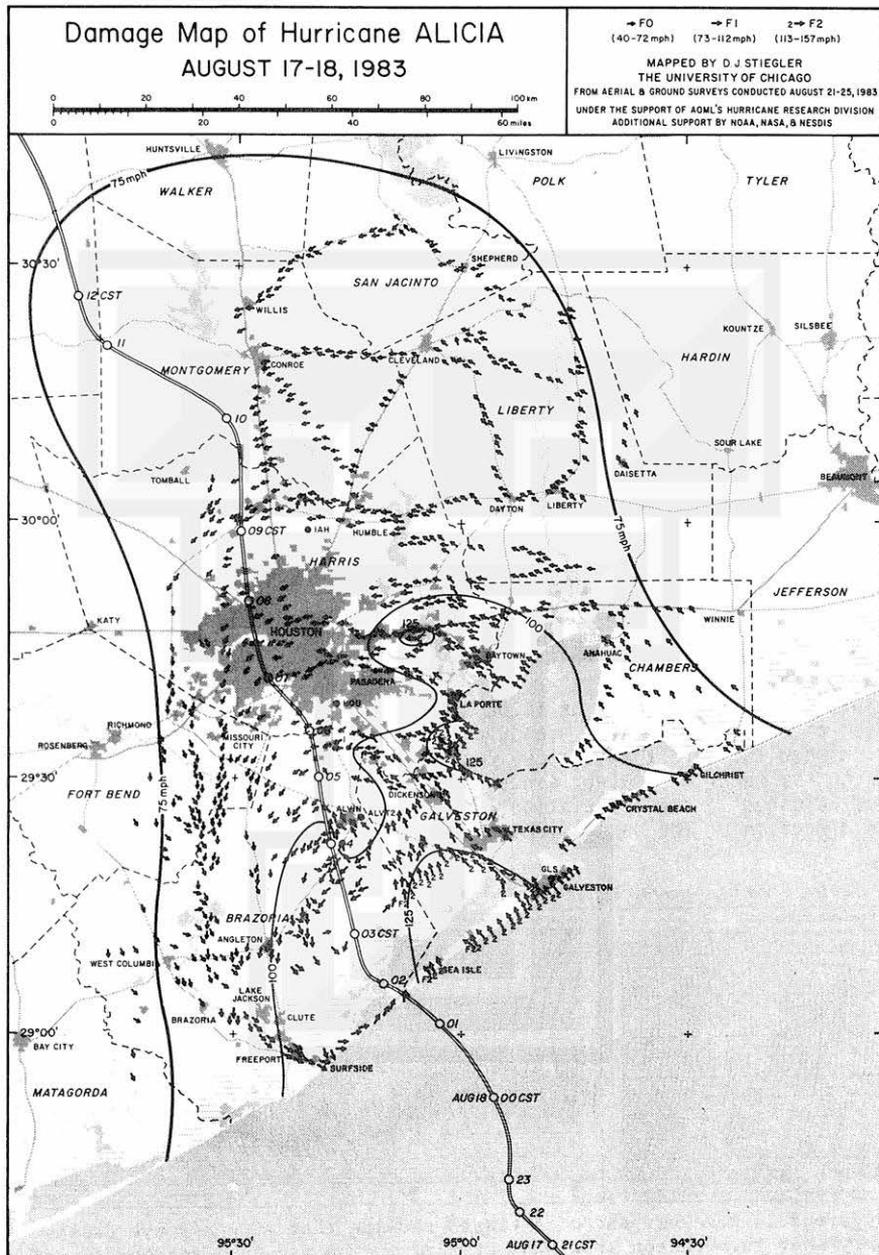
Figure 7. Damage map of Hurricane Alicia as derived from aerial and ground surveys conducted August 21-25, 1983.

As would be expected, winds were higher to the right of the eye's path, a factor resulting from the hurricane's translational motion. If one assumes that a hurricane has a symmetrical windfield when it is stationary, then a translational motion will increase windspeeds to the right of the path and reduce those to the left, a difference equalling twice the translational speed.

The overall pattern of the vectors show the cyclonic windflow of the storm, with a few discontinuities allowing for time variability and imbedded mesoscale phenomena. The possibility of a downburst (a localized thunderstorm downdraft that produces damaging surface winds) is apparent in the diffluent pattern of vectors within the 125 mph zone on the west edge of Trinity Bay, just south of LaPorte. However, the possibility also exists that the higher winds could have resulted from the air having been driven over the long fetch of the near-frictionless surface of Trinity Bay.

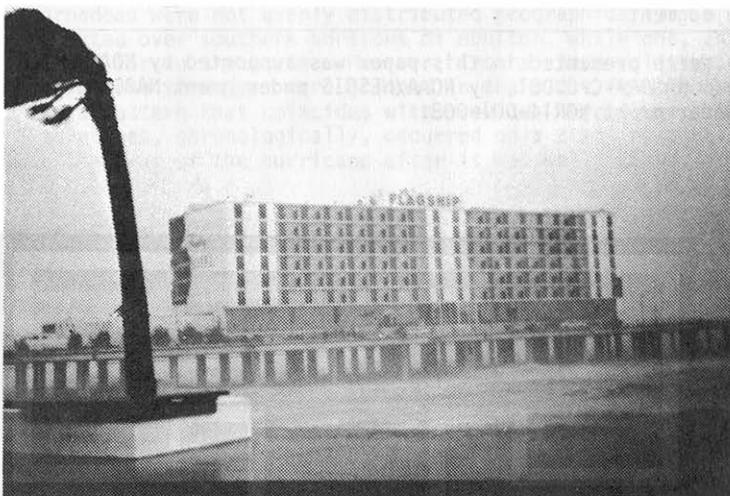
Figure 12. The Flagship Hotel at 0630 CST on August 18th after a nightlong battle with Alicia resulted in part of its exterior wall being blown off.

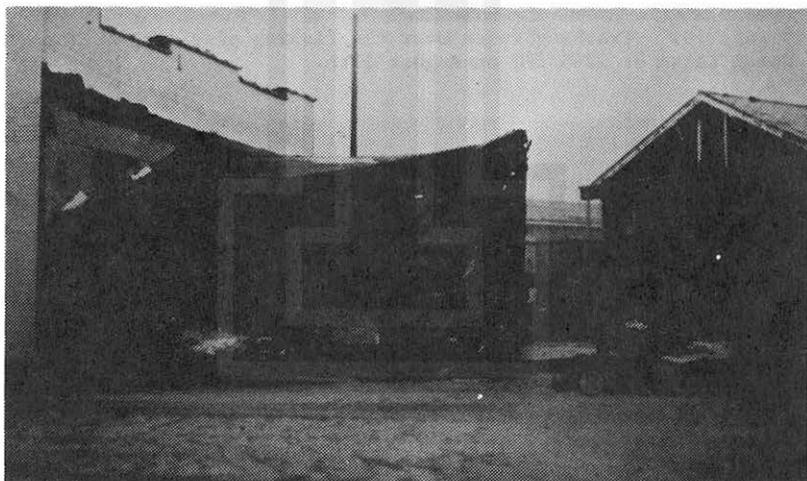
Figure 13. A man attempts to walk in intense wind and rain past a damaged building along Seawa'll Boulevard, immediately paralleling the shore. Time: 0700 CST, August 18th.

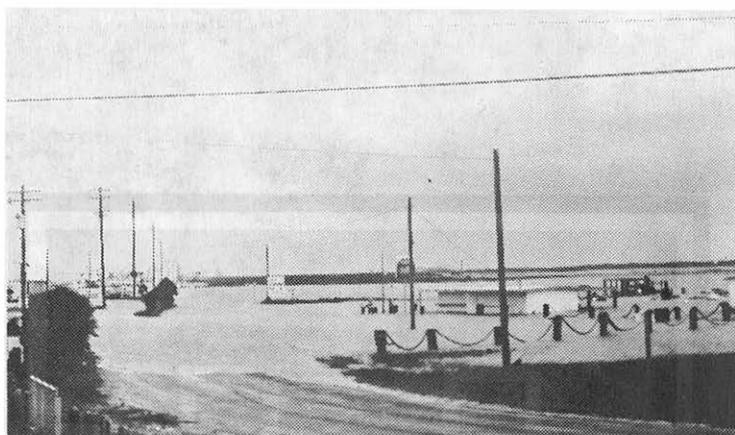
Figure 14. A bait and tackle shop engulfed in tidal flooding before the storm at 1100 CST on August 17th. The shop was completely washed away by the following morning.

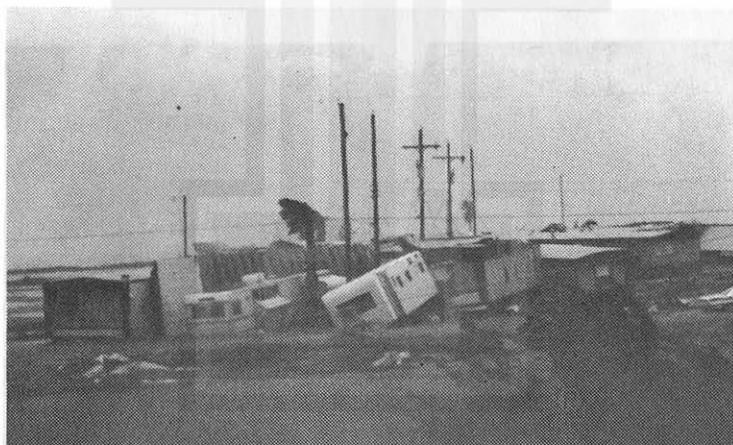
Figure 15. A trailer park, built on the beach below a protective seawall, was totally demolished by the storm surge. Time: 0725 CST, August 18th.

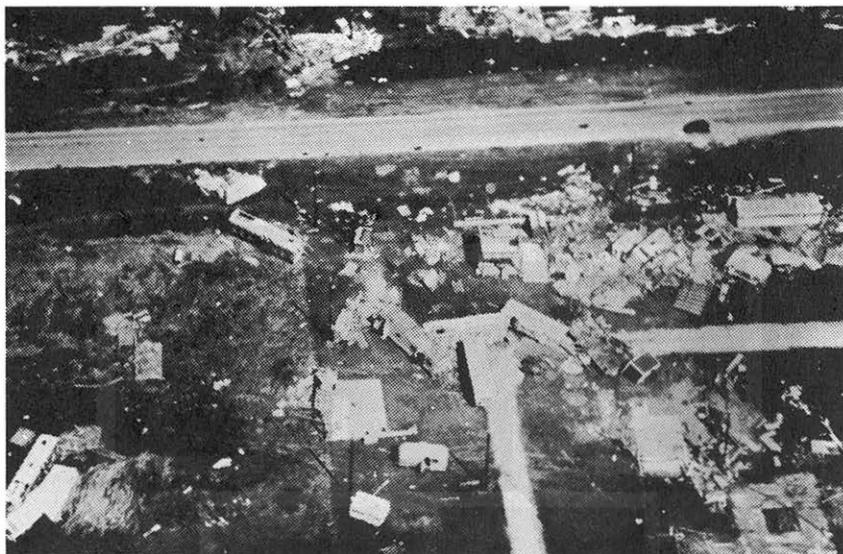
Figure 16. Trailer damage near Jamaica Beach.

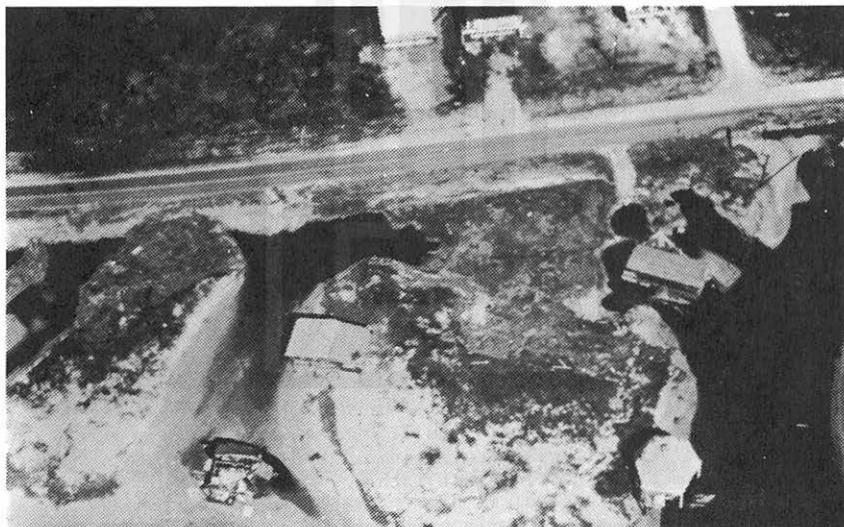
Figure 17. Beach erosion east of Surfside caused by the storm surge. ---Both photos above courtesy of Joseph Golden, NOAA/ERL.

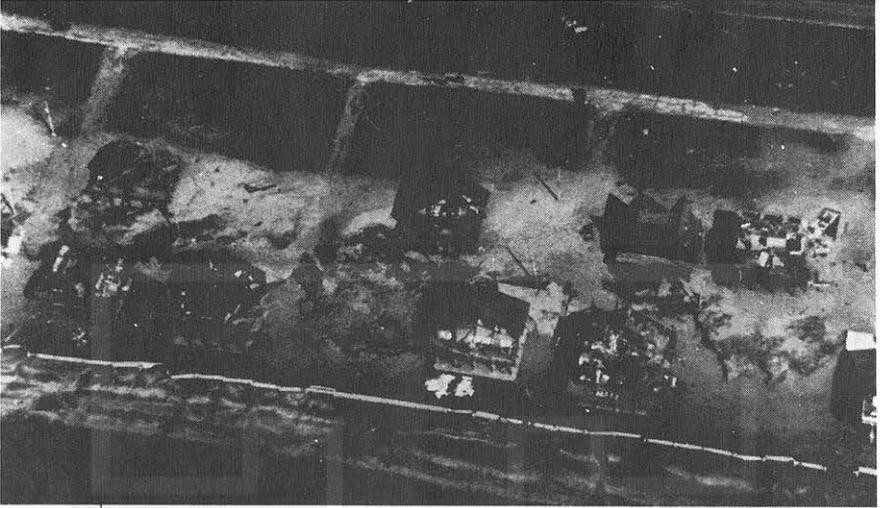
Figure 18. Beachfront homes at Sea Isle, many with roofs blown off and walls collapsed. Although most beach homes on Galveston Island were protected against the storm surge by having been built on stilts, many still succumbed to Alicia's winds.

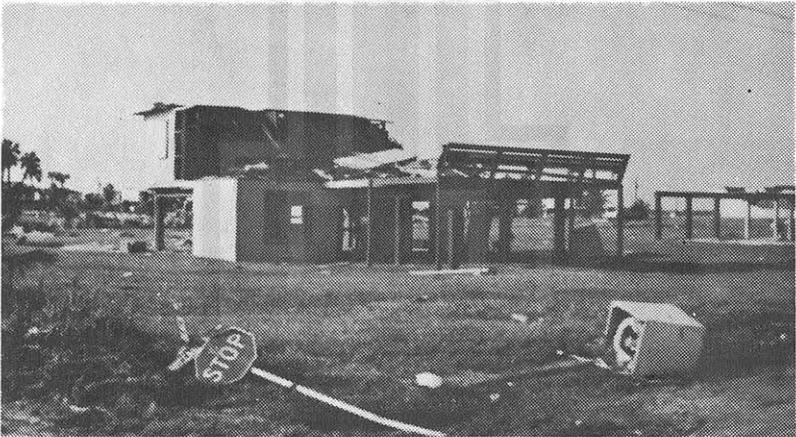
Figure 19. A wind-destroyed home at Jamaica Beach, about 11 miles southwest of Galveston.

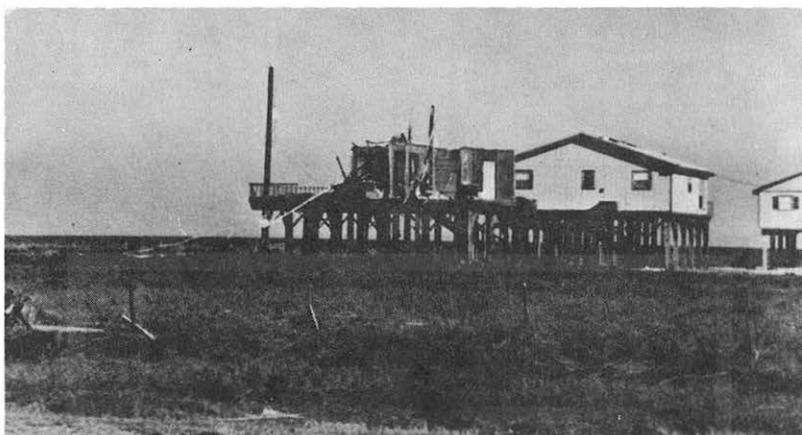
Figure 20. Another home at Jamaica Beach that was blown apart, while an adjacent home of the same design and construction appears untouched.

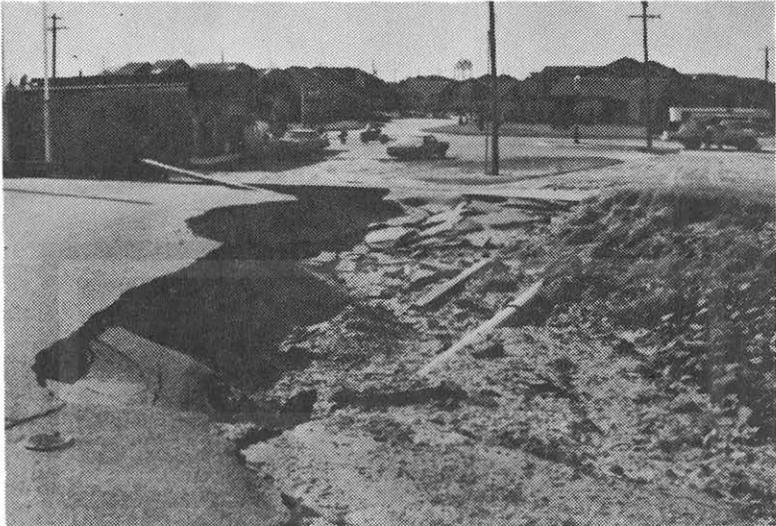
Figure 22. Storm surge erosion of a roadway on the inland side of Seawall Boulevard in Galveston.

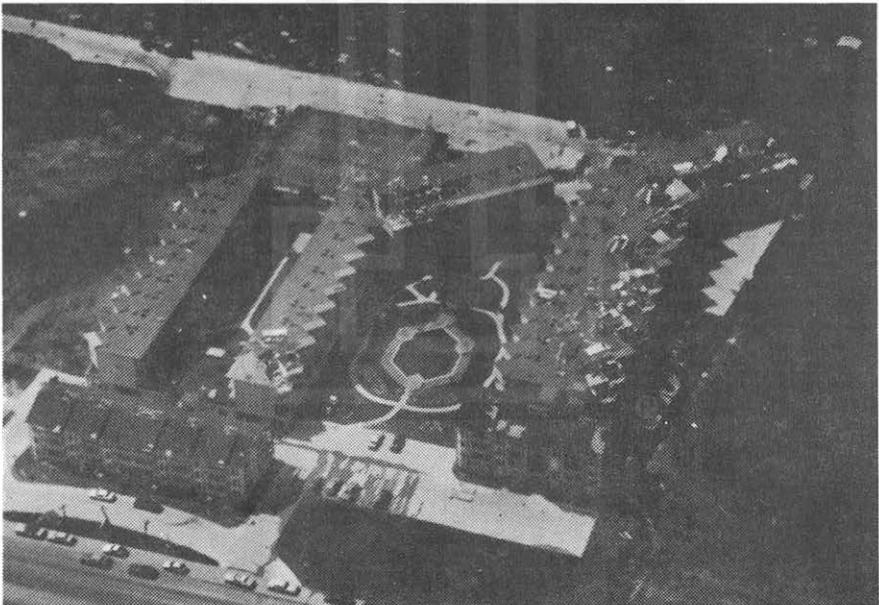
Figure 23. Roofing torn by the wind from a hotel in Galveston.

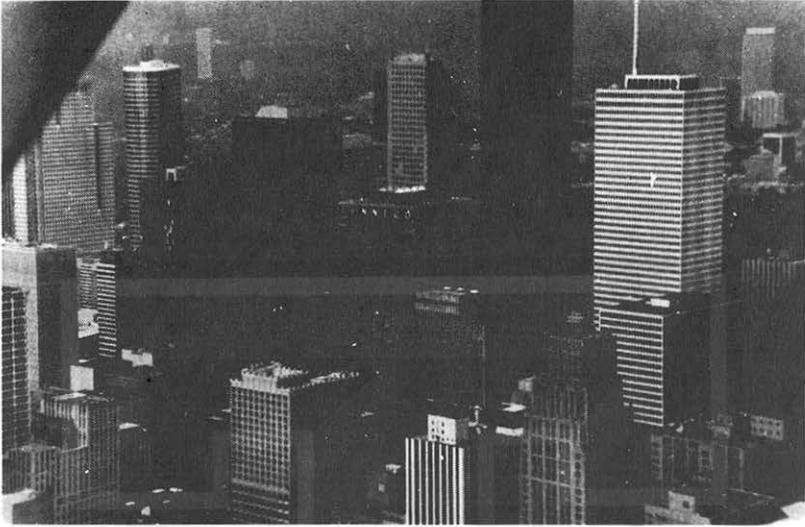
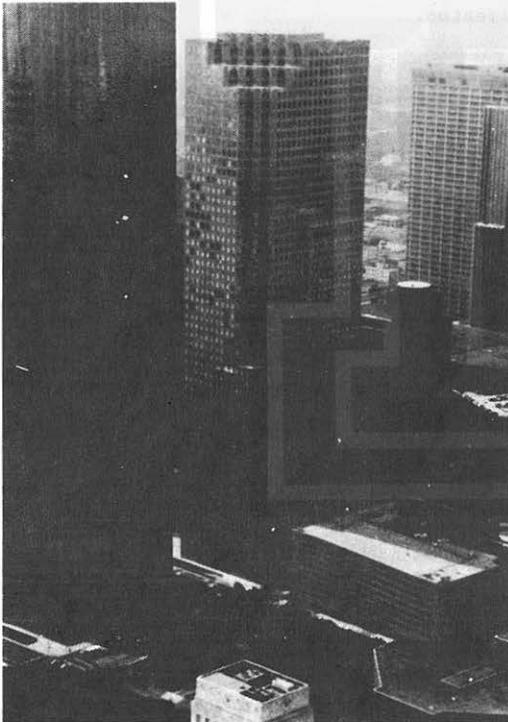
Figures 24 & 25. The skyscrapers of downtown Houston with numerous windows boarded up. It is likely that the majority of the broken panes were caused by the impact of flying debris.

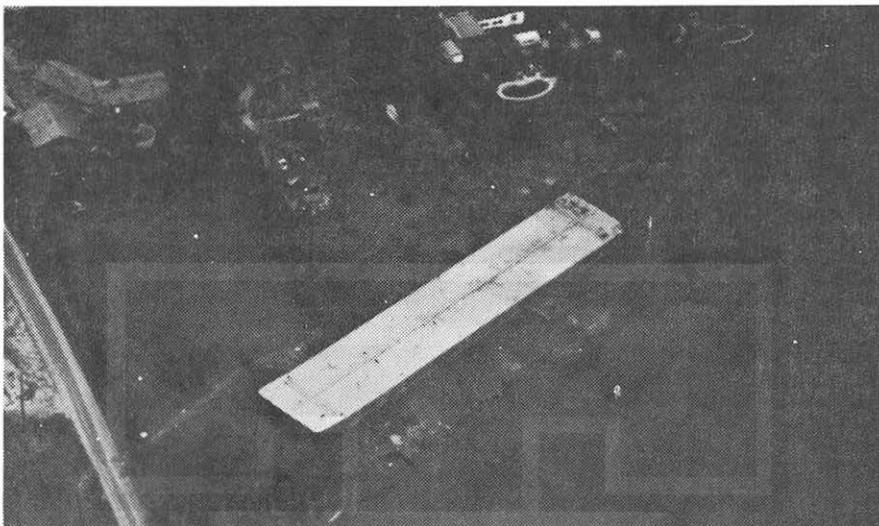
Figure 26. A barge washed ashore by the storm surge near Channelview, 15 miles east of Houston, was found to be occupying someone's back yard.

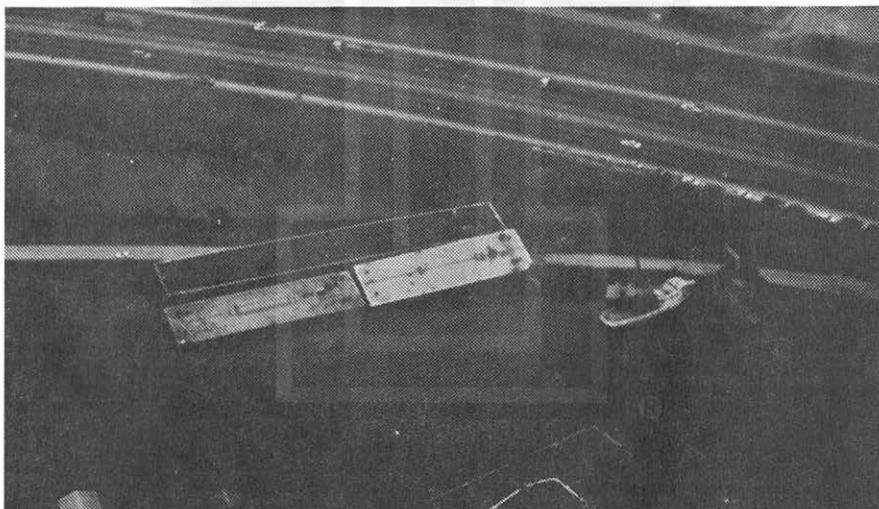
Figure 27. Another barge near Channelview washed up onto a road paralleling Interstate 10.
