Research Paper No.1

Detailed Analysis of Hurricane Andrew of 24 August 1992

ONR Grant N00014-J1136 STORM DATA PROJECT

T. Theodore Fujita, PI

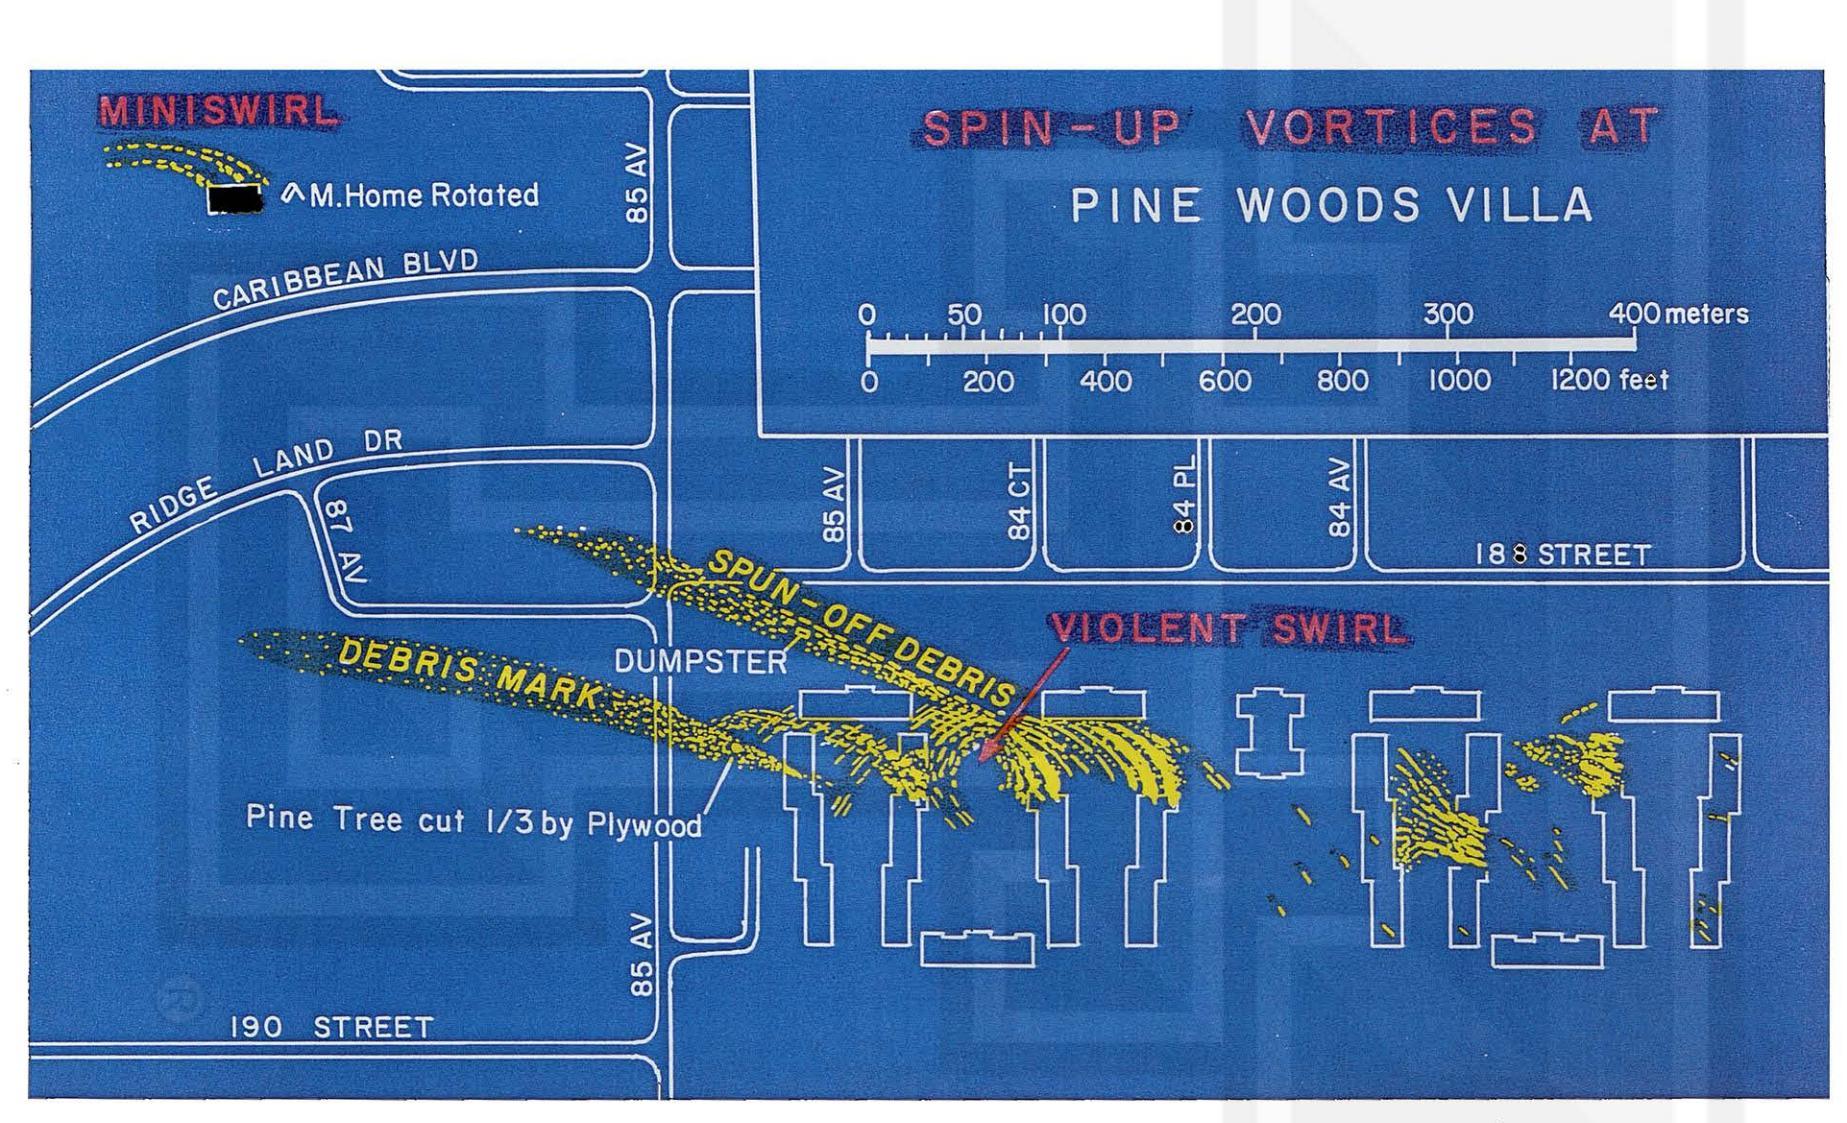
Fig. 1.5 Pine Woods Villa, at 85th Avenue and 188th Street, was broken apart. A dumpster was found inside a streak of debris. The estimated peak wind was 200 mph.

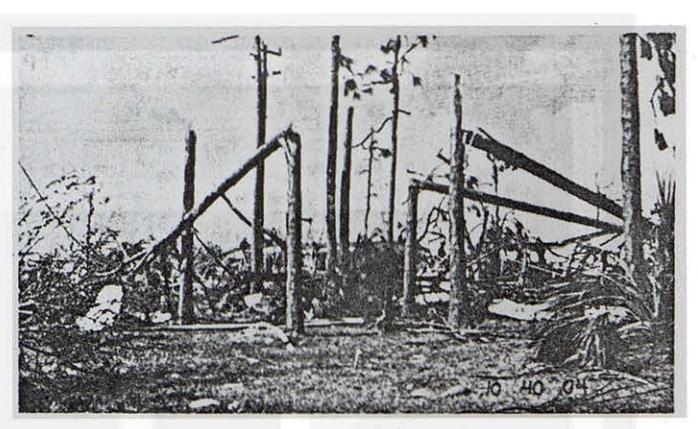
Typical damage of pine trees caused by the first and second winds. Numerous Australian pines were blown down by the first wind. Fujita photo 1040 EDT 9/9/92

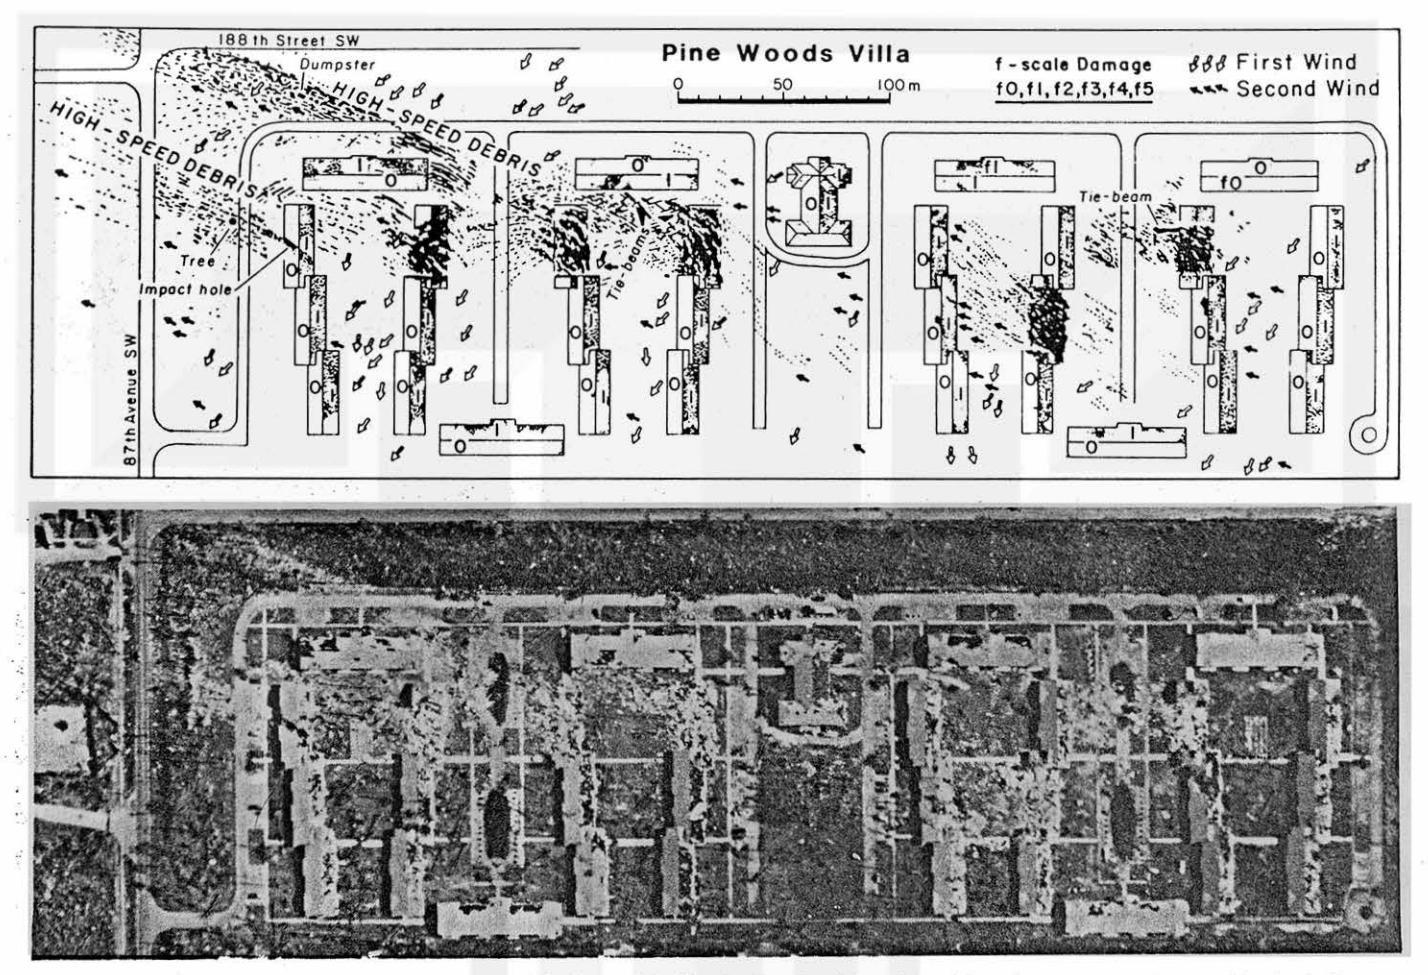
Mini-swirl Damage at Pine Woods Villa Southeast of 188 St and 87 Av SW

Above: Structural and tree damages at the Villa located inside the Tamiami Swath. Although trees were damaged by both first and second winds, the first wind did not cause structural damage, suggesting that the first wind was weaker than the second wind in the Tamiami Swath. The second wind caused the fl damage to the east-side roofs while west-side roofs were not damaged (f0). Below: An enlarged view of a 9"X9" vertical photo taken by Continental Aerial Survey on 8/27/92.

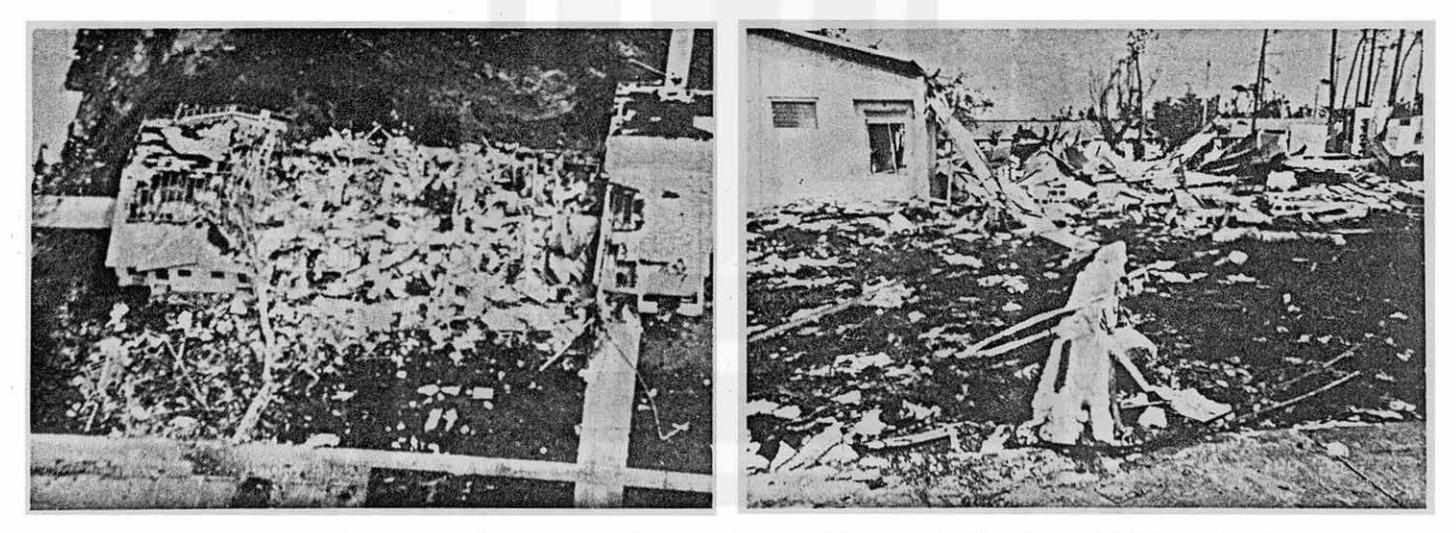
Left: Aerial photo of a tie-beam (see map) blown off toward the west. Fujita photo 1245 EDT 9/14/92. Right: Ground view of the tie-beam reinforced with one-inch steel rods. Fujita photo 1649 EDT 9/15/92.

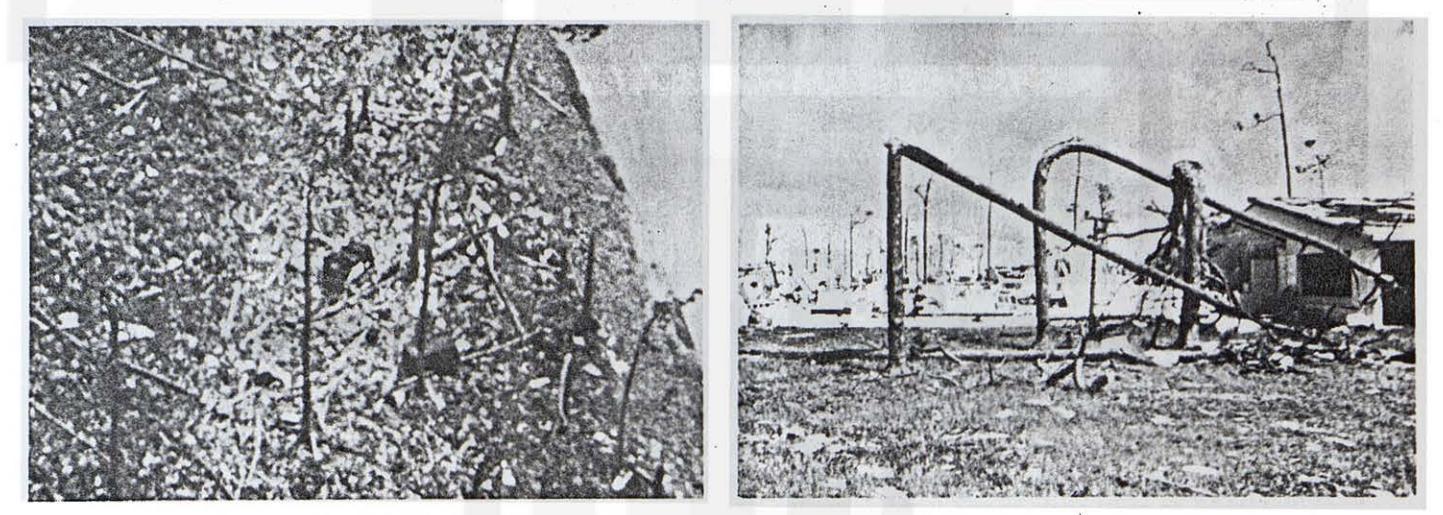
Left: A dumpster found inside the high-speed debris (see map). Some trees in this photo were blown down by both first and second winds. Fujita photo 1234 EDT 9/14/92. Right: Bi-directional tree damage seen near the dumpster site. Fujita photo 1109 EDT 9/9/92.

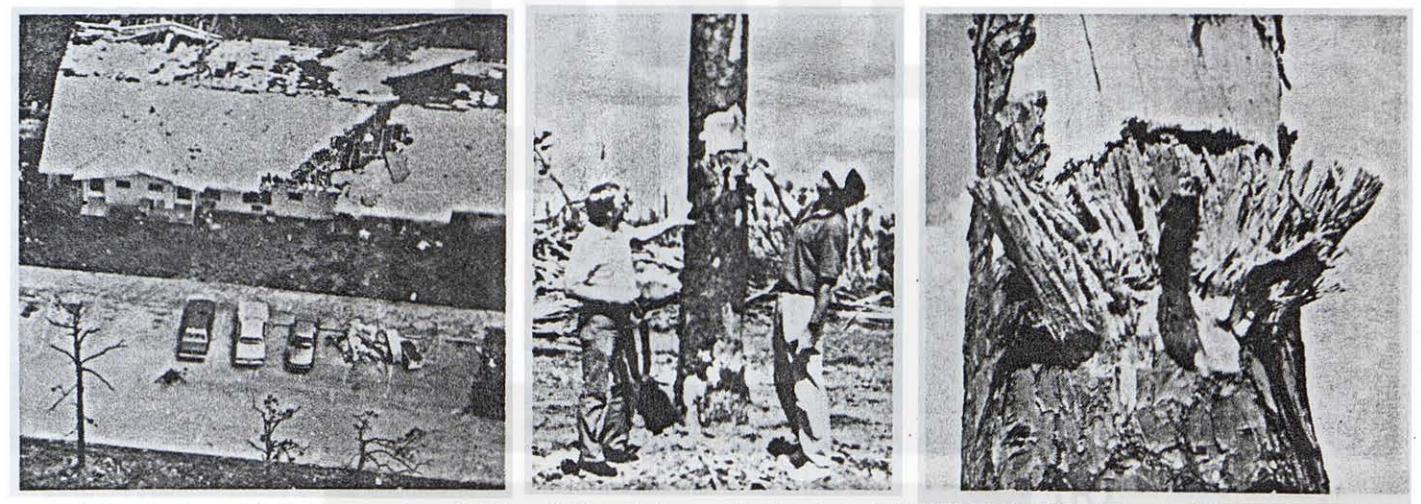
Left: An impact hole (see map) created by a falling tie-beam. Fujita photo 1245 EDT 9/14/92. A piece of flying plywood cut through the trunk of the tall pine tree shown at the lower left of the picture. Center: Drs. Robert Sheets and Peter Black examining the tree trunk. Right: A close-up view of the deep cut. Fujita photos 1057 EDT 9/9/92.

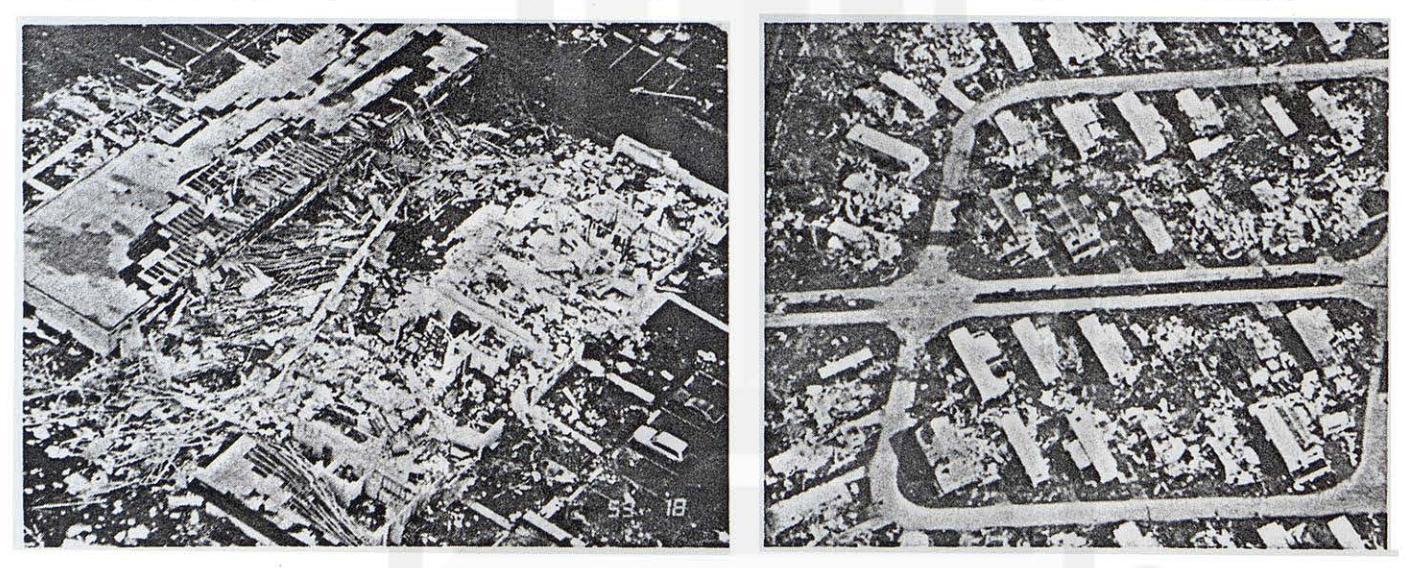
Left: A Naranja Lakes condo oriented in the wind-perpendicular (broadside) direction. The roof was lifted into a vertical position and dropped upside-down after a 180° rotation. Connected and broken tie-beams weighing one ton per 20 ft are visible on the downwind side. Fujita photo 1253 EDT 9/14/92. Right: Mobile homes at Naranja Lake oriented by luck in the wind-parallel (streamline) direction. Fujita photo 0906 EDT 9/8/92.

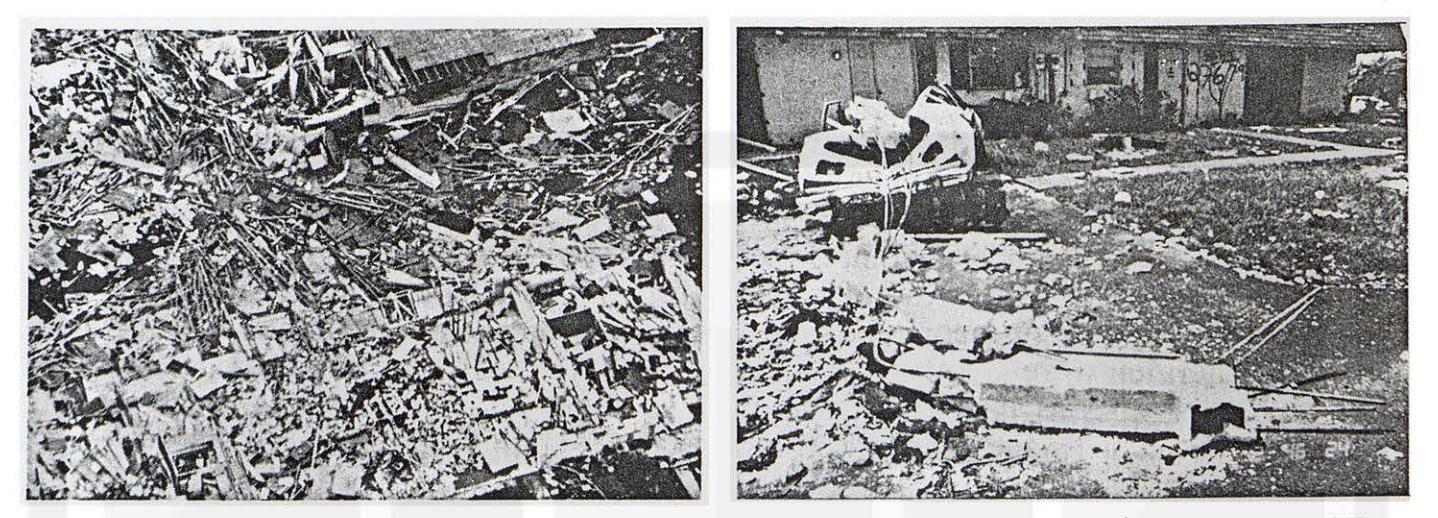
Left: An f3 damage of Naranja Lakes condo caused by a mini-swirl that formed inside the second wind. Fujita photo 1253 EDT 9/14/92. Right: Pieces of a connected tie-beam which flew 150 feet (45m) from a Naranja Lakes condo in the second wind. Fujita photo 1246 EDT 9/10/92.

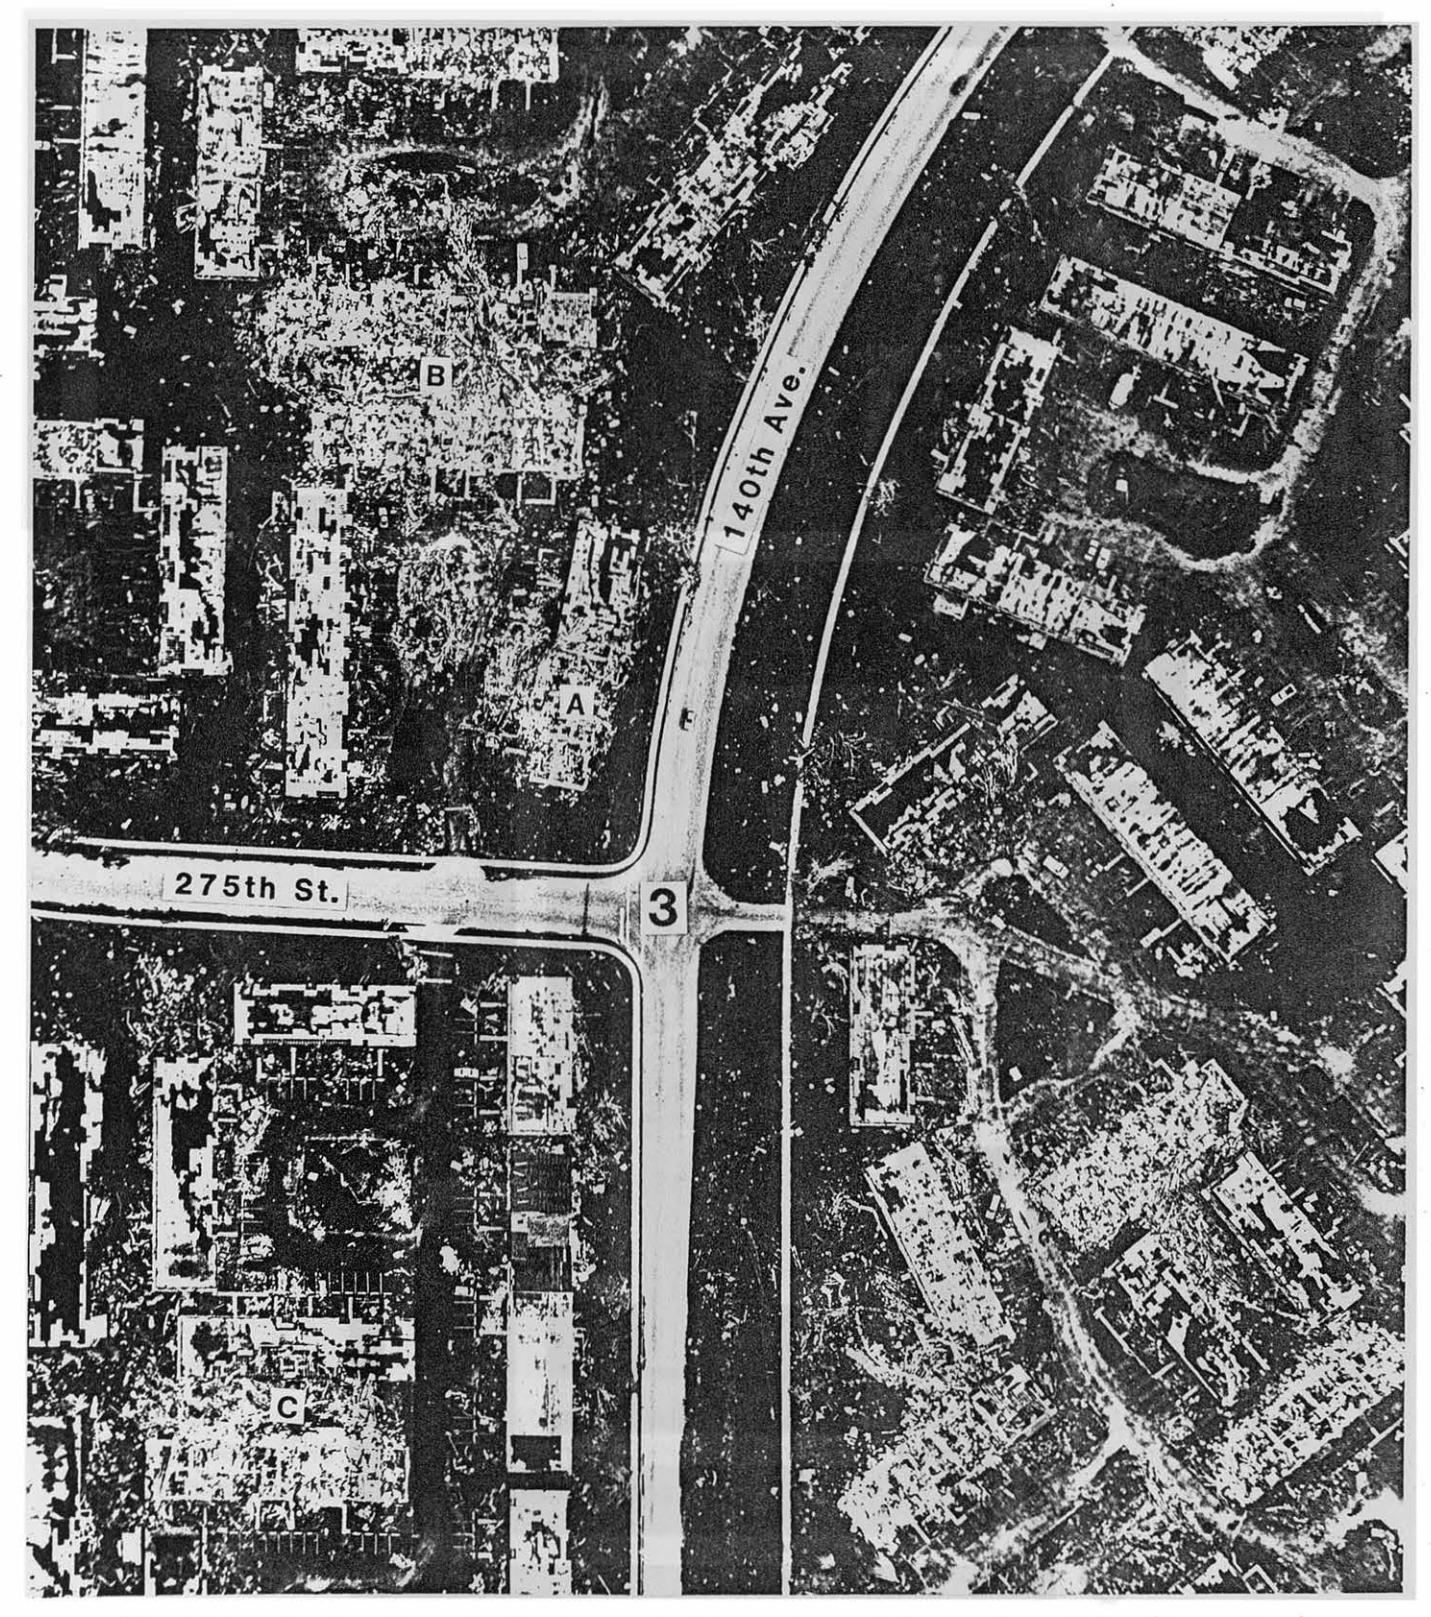
Fig. 5.7 **A.** Southern half of a condo blown toward the northwest by the second wind. **B.** Severe damage of twin condos caused by a cyclonic mini-swirl that moved north-northwest. **C.** Condos damaged by the first swirl.

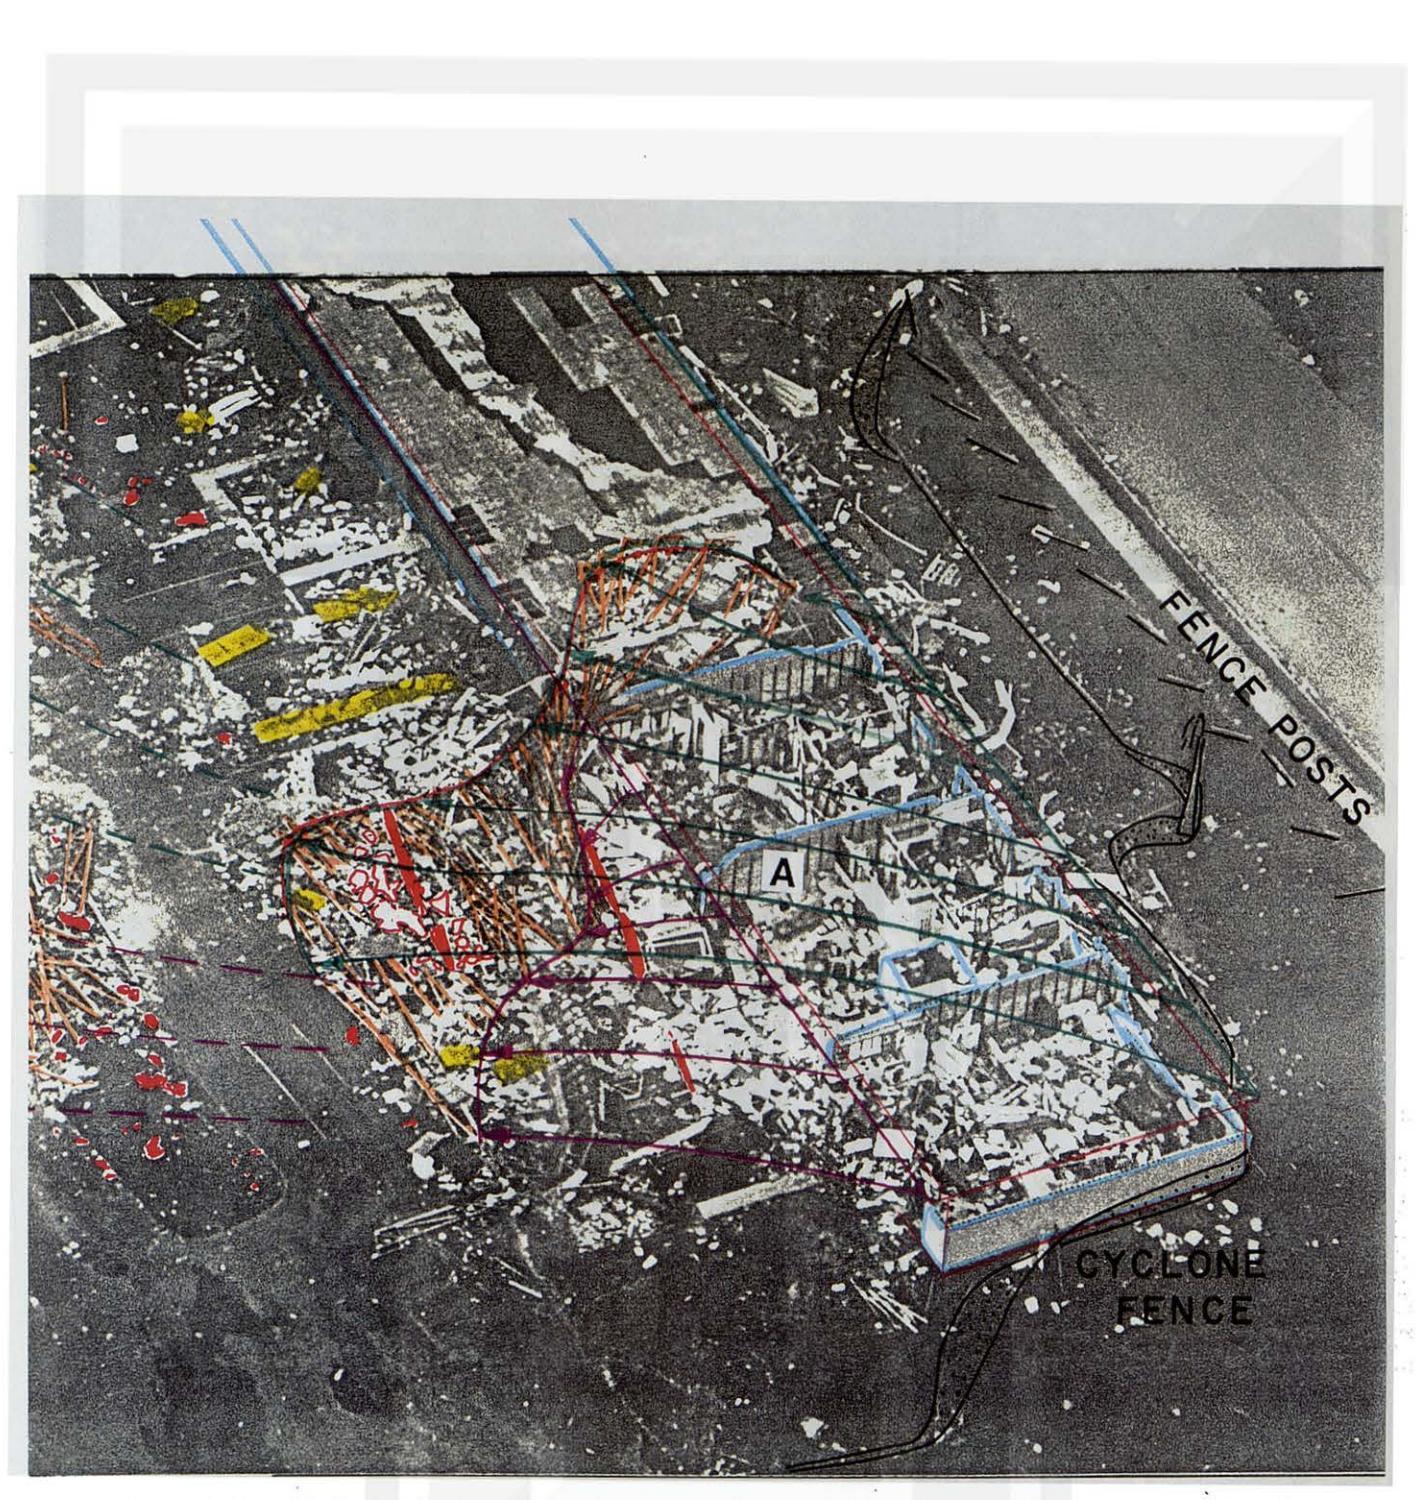
Fig. 5.8 Fujita's photo of condo **A** with its roof lifted toward the northwest and overturned. The fence posts along 140th Avenue were blown down and fence nets were blown against the damaged condos.

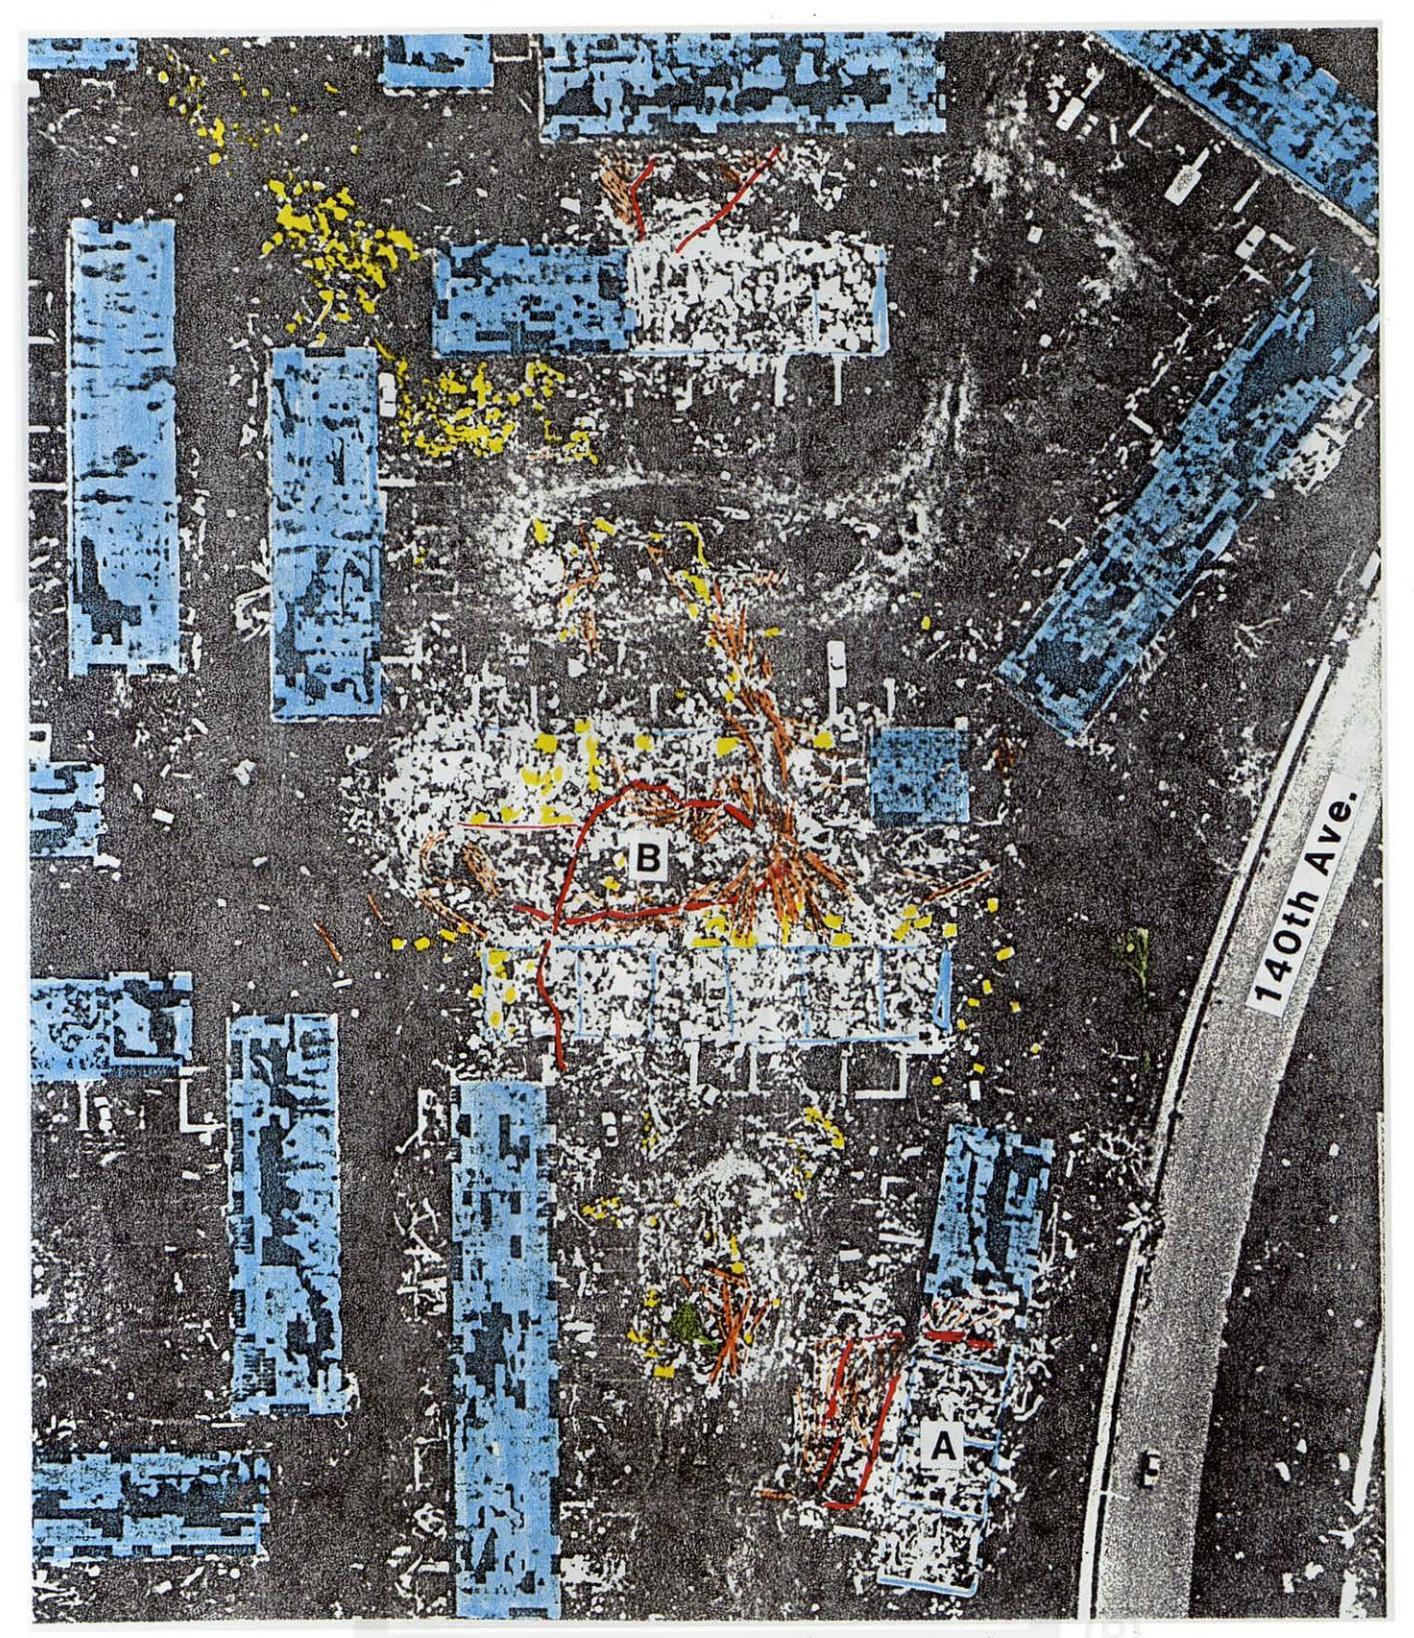
Fig. 5.9 **B.** Twin condos west of 140th Avenue. The northern condo was unroofed first. Then the roof of the southern condo landed on top of it in an upside-down position. The center of a mini-swirl moved over the condos in a north-northwest direction.

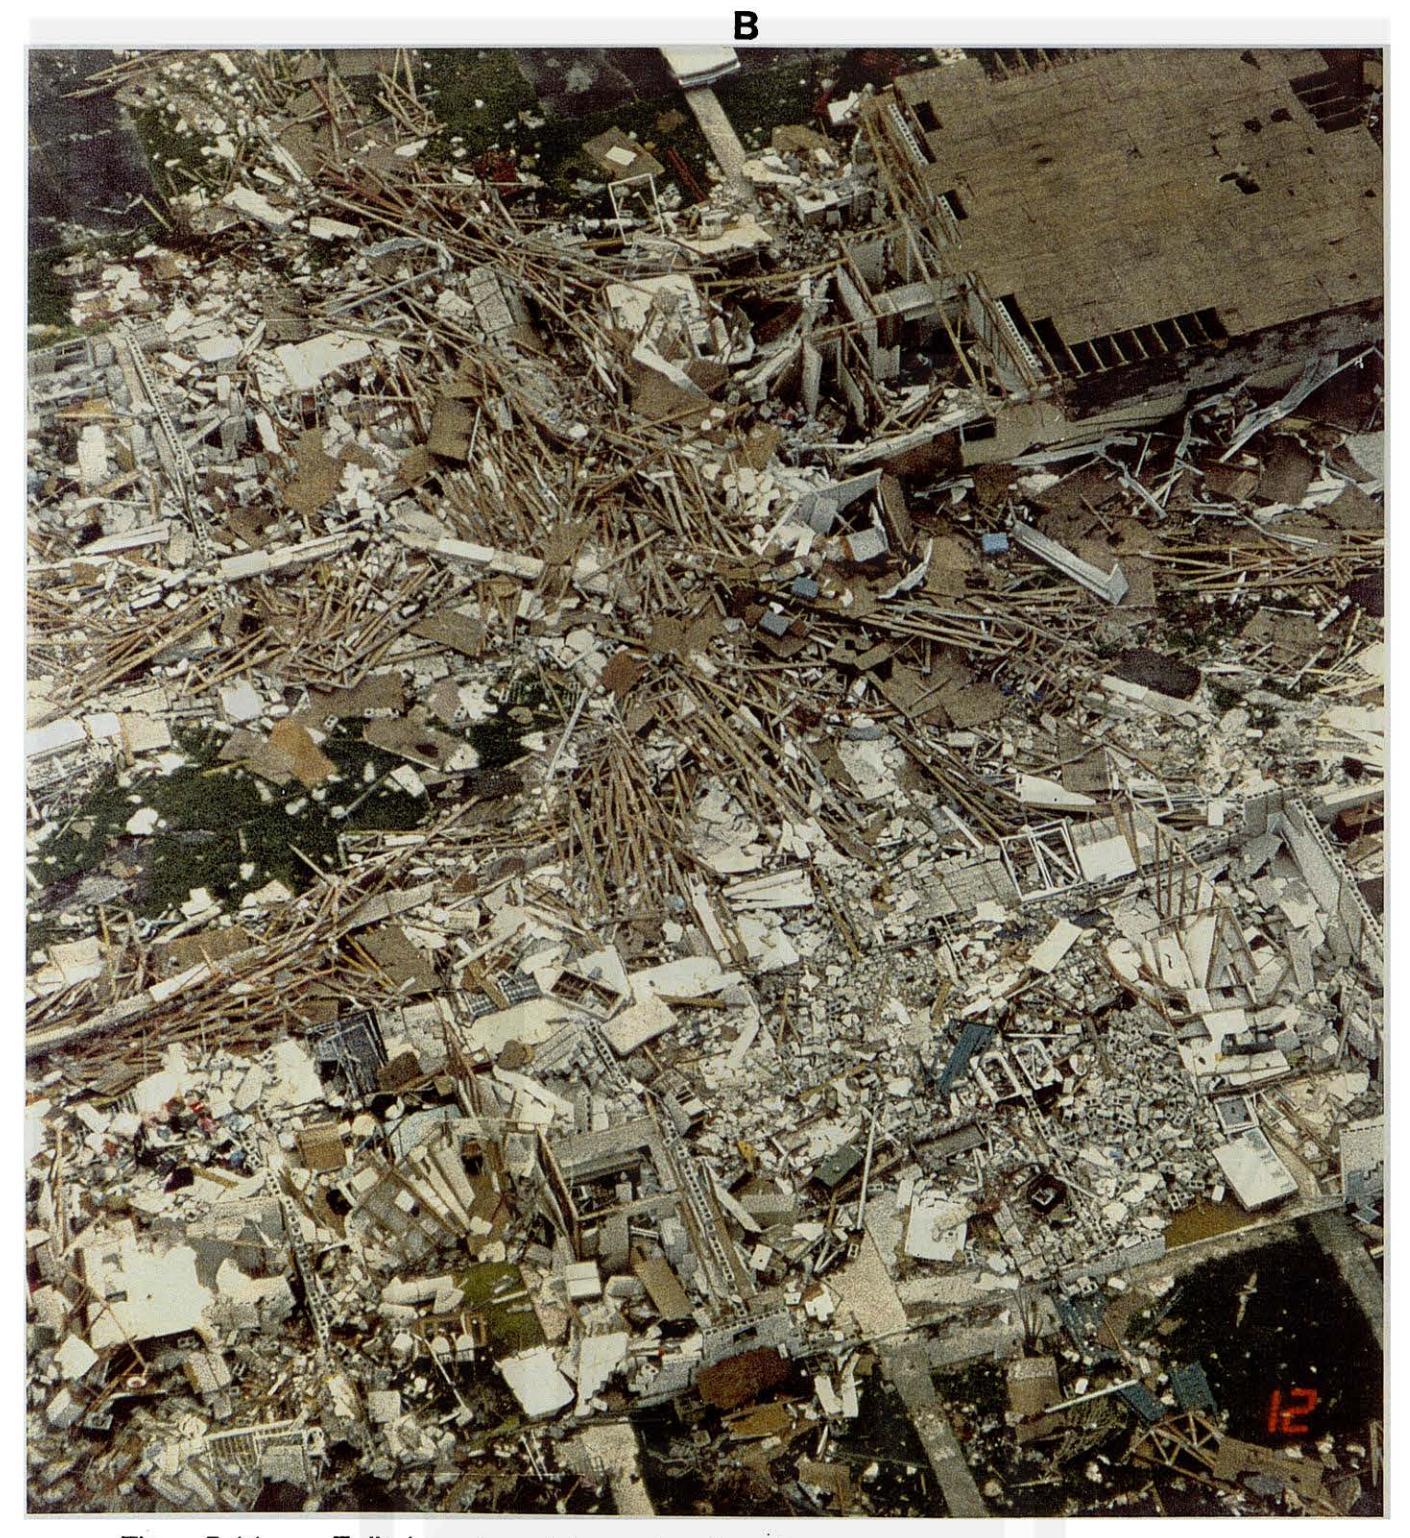
Fig. 5.11 Fujita's color picture showing the severe damage (estimated F4) caused by a cyclonic mini-swirl which moved toward the north-northwest.

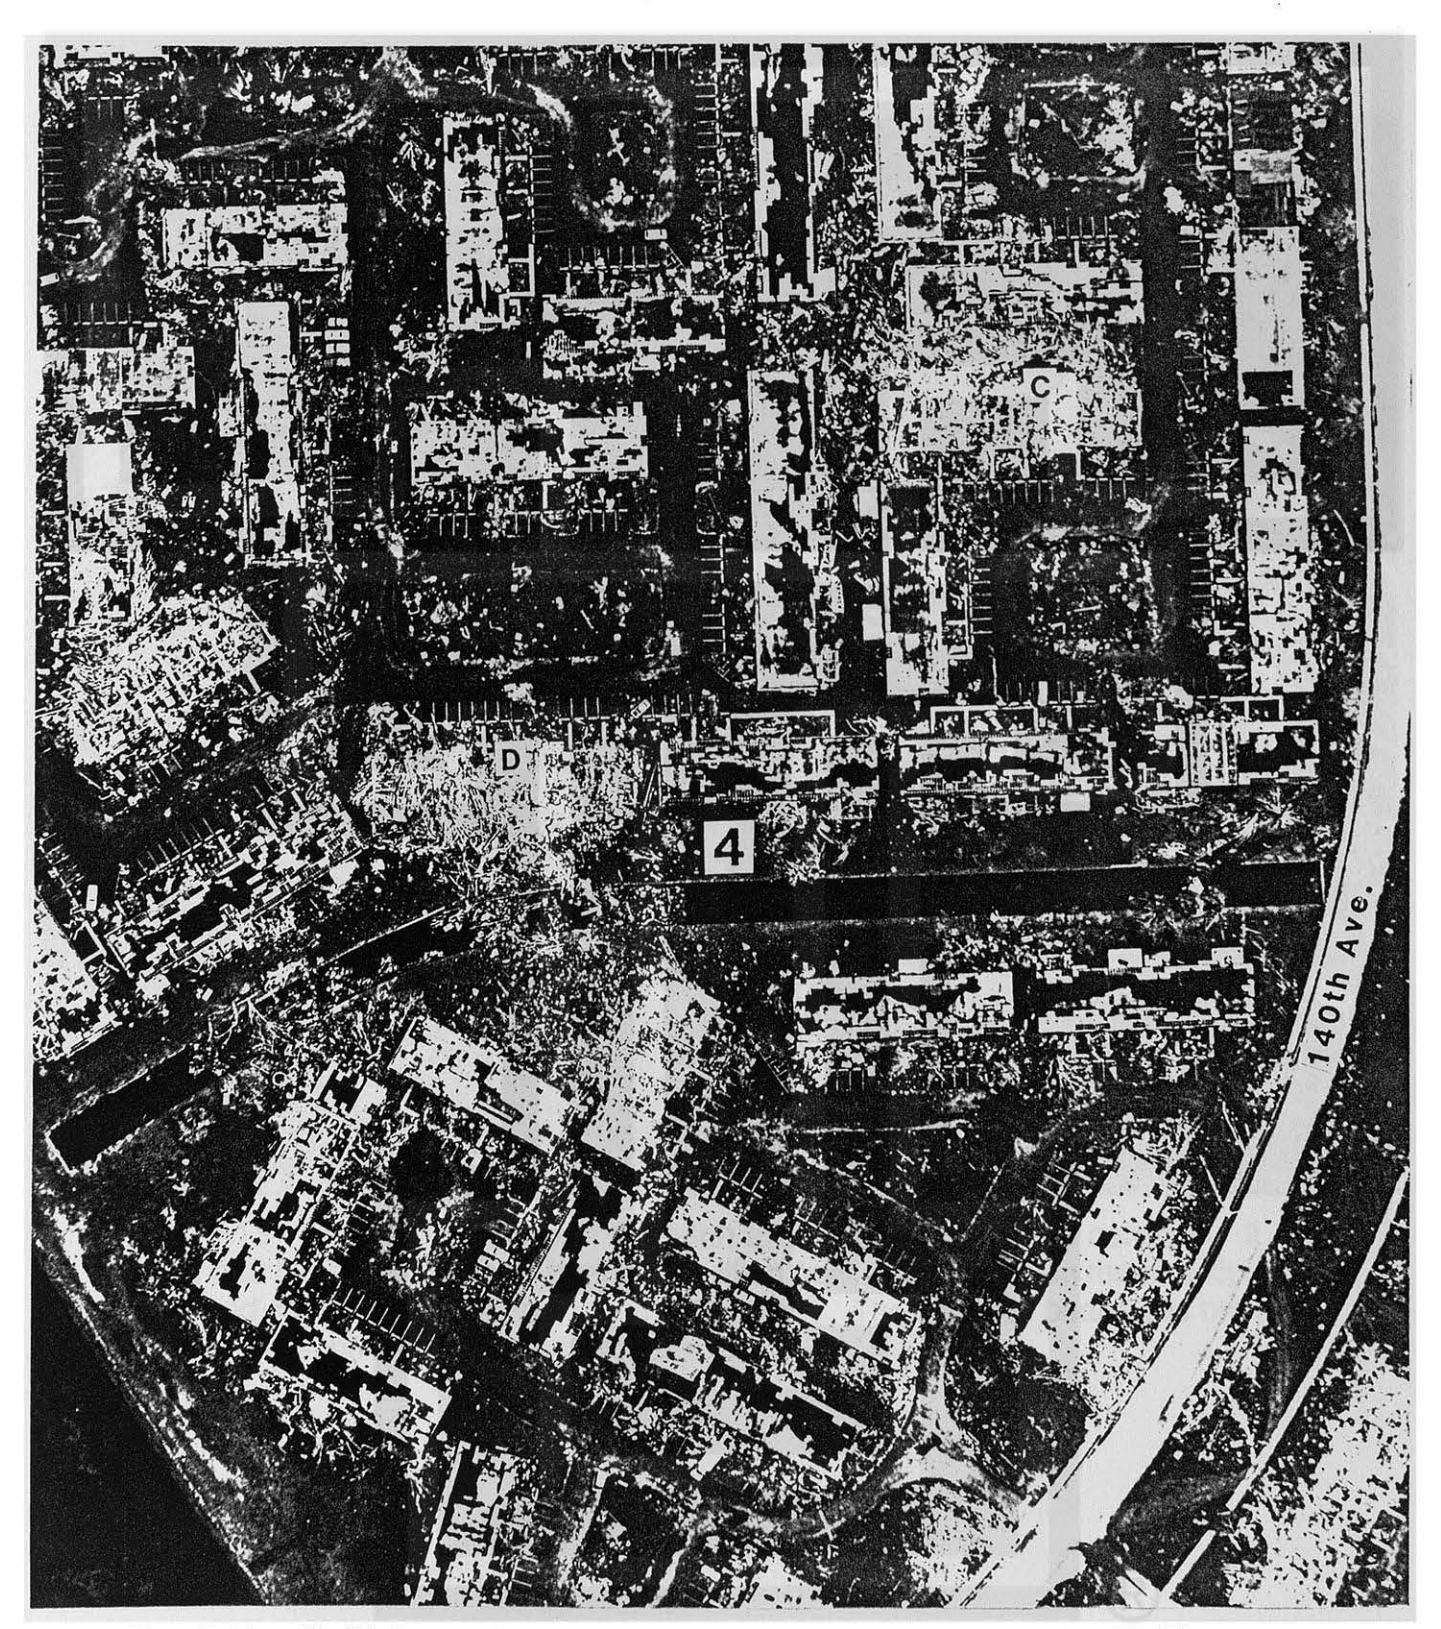
Fig. 5.12 C. Twin condos damaged by the first wind / first swirl. D. The worst damage to a condo, next to a narrow canal. It is seen that a condo to the south was blown off toward D.

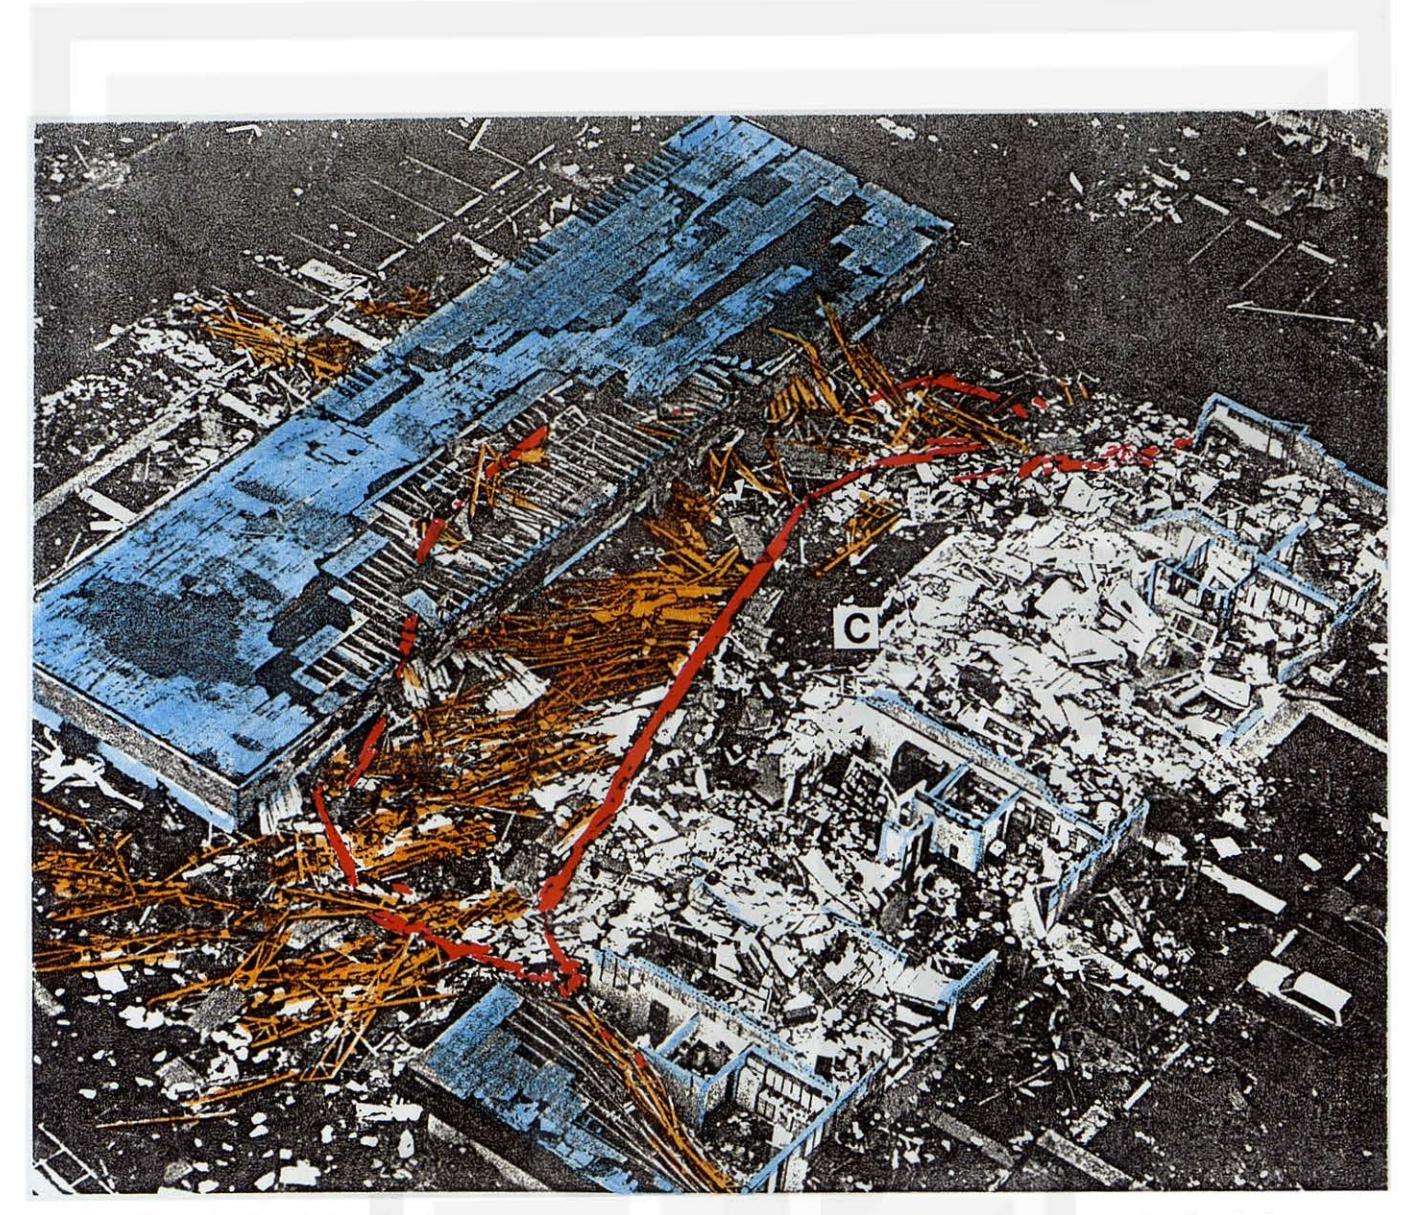
Fig. 5.13 The final position of the north and south tie beams of condo **C**. It is likely that the roof with the tie beams was lifted front side first. Then the roof flipped over and crashed onto the roof of the north condo. The south tie beam was broken into pieces upon hitting the north condo's roof.
