Research Paper No.1

Detailed Analysis of Hurricane Andrew of 24 August 1992

ONR Grant N00014-J1136 STORM DATA PROJECT

T. Theodore Fujita, PI

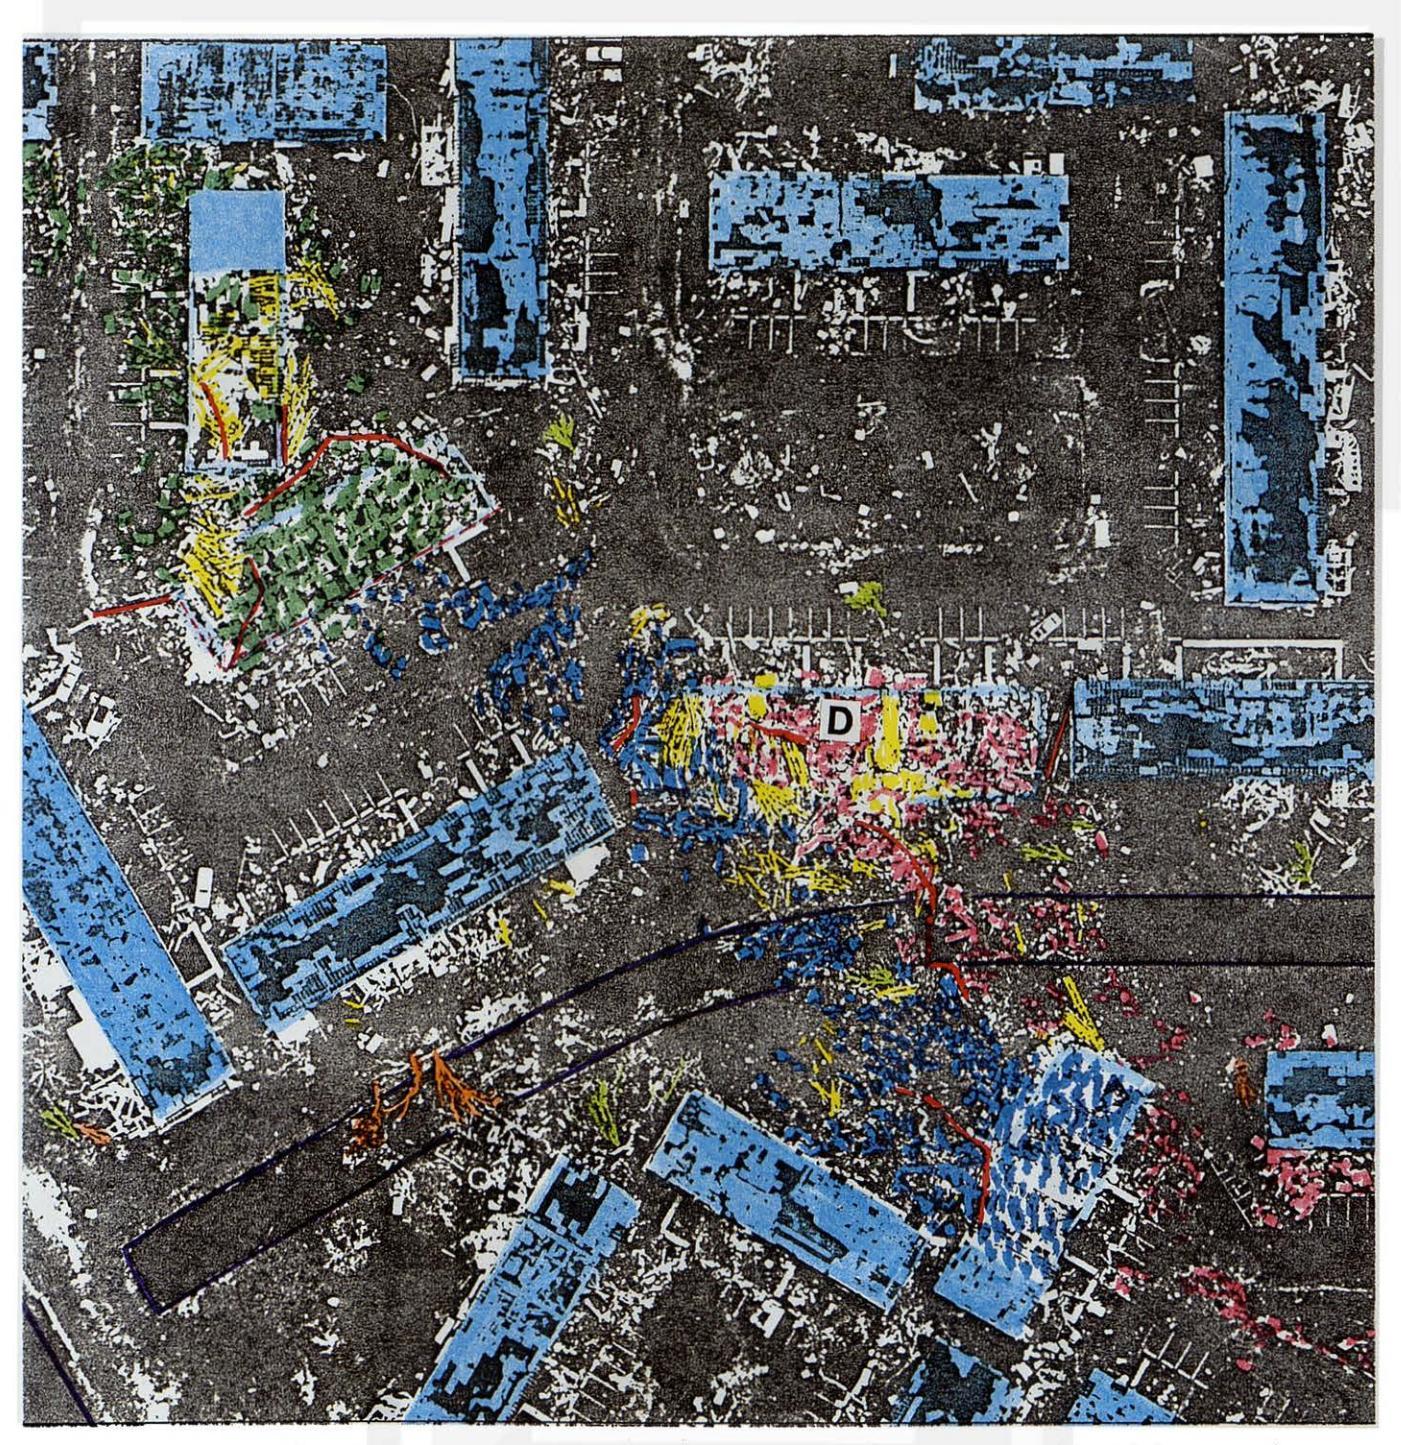
Fig. 5.15 Condo **D** damaged severely by an anticyclonic mini-swirl which moved from north to south crushing the condo and throwing its concrete debris into the canal to the south.

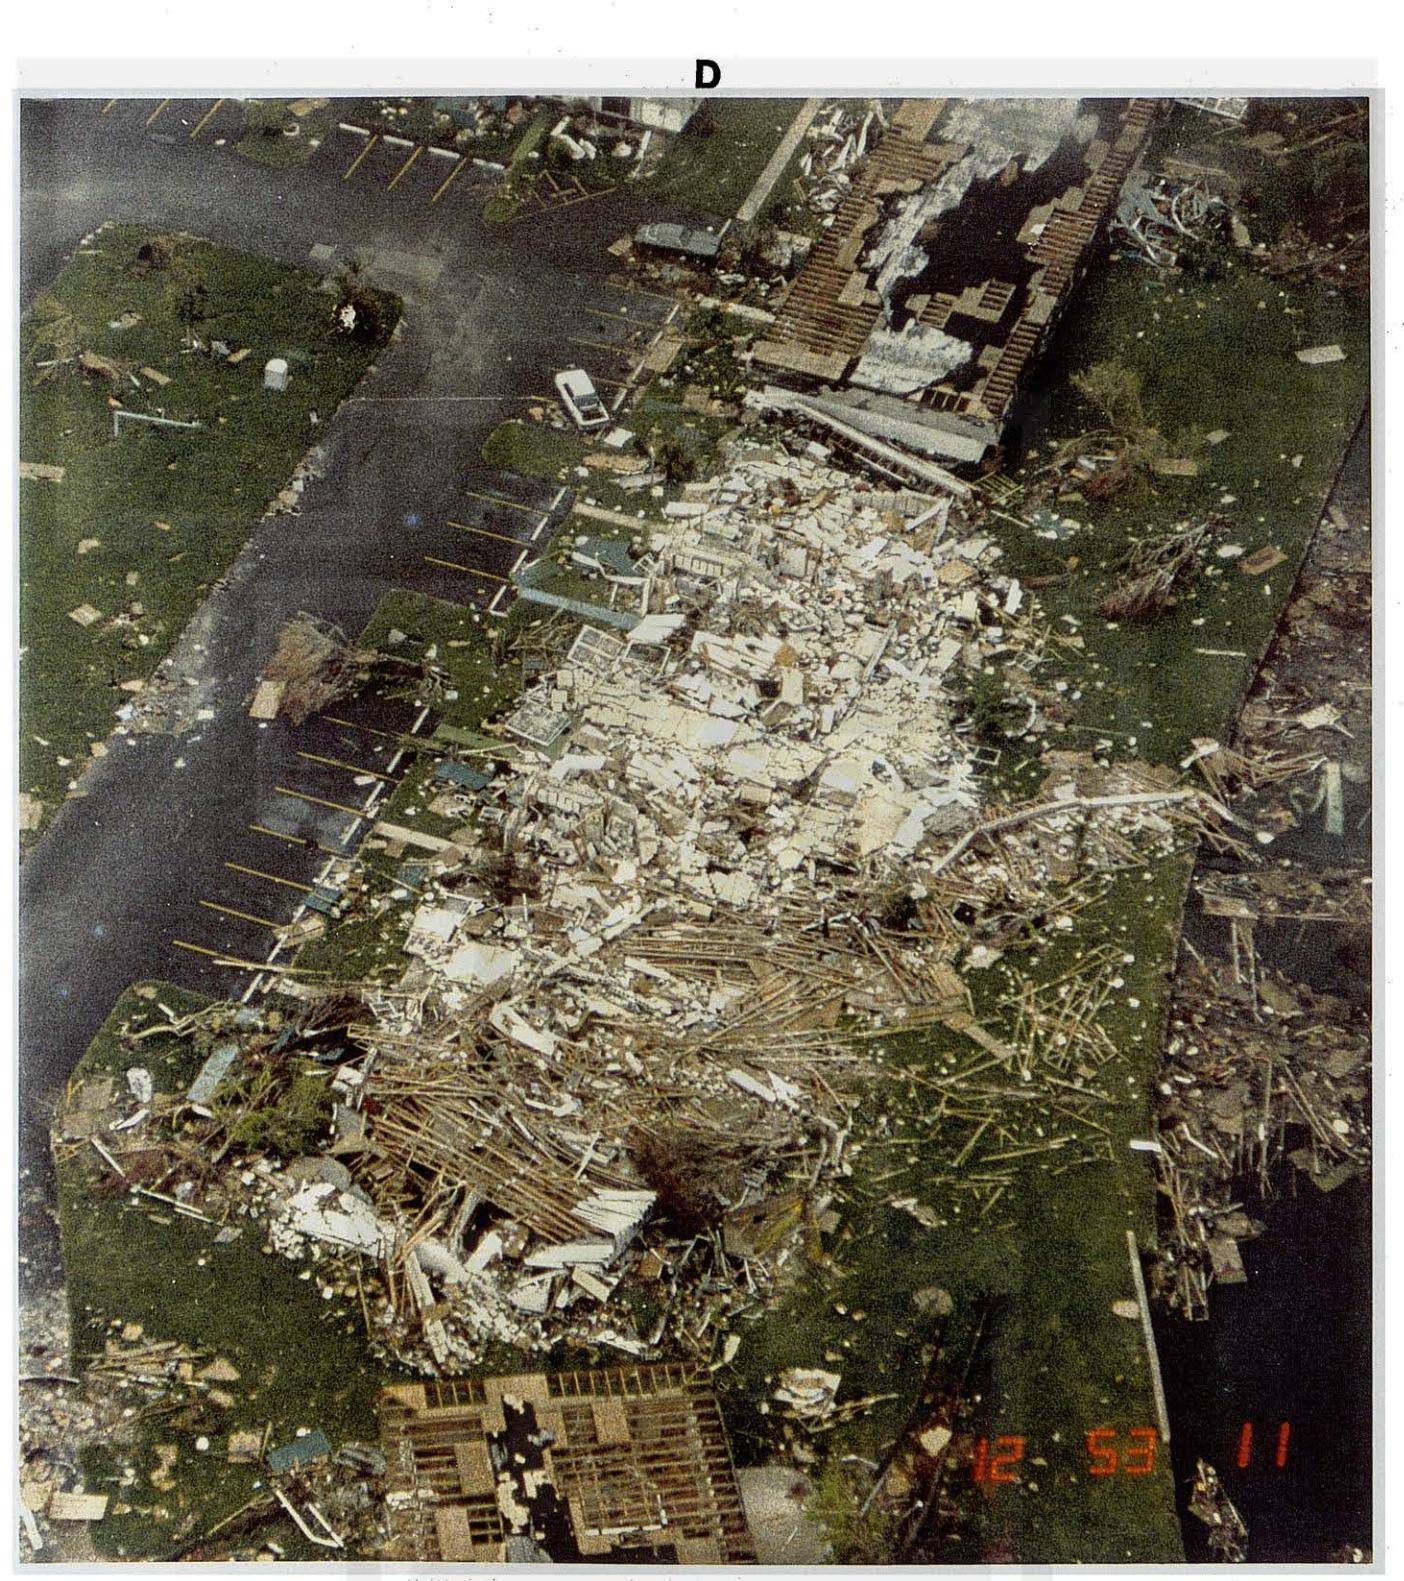
Fig. 5.16 Fujita's color photo showing the detailed damage of condo **D**. A miniswirl in the first wind destroyed the western half of the condo (left to right), pushing off the front (north side) tie beam across the canal to the south of the condo.

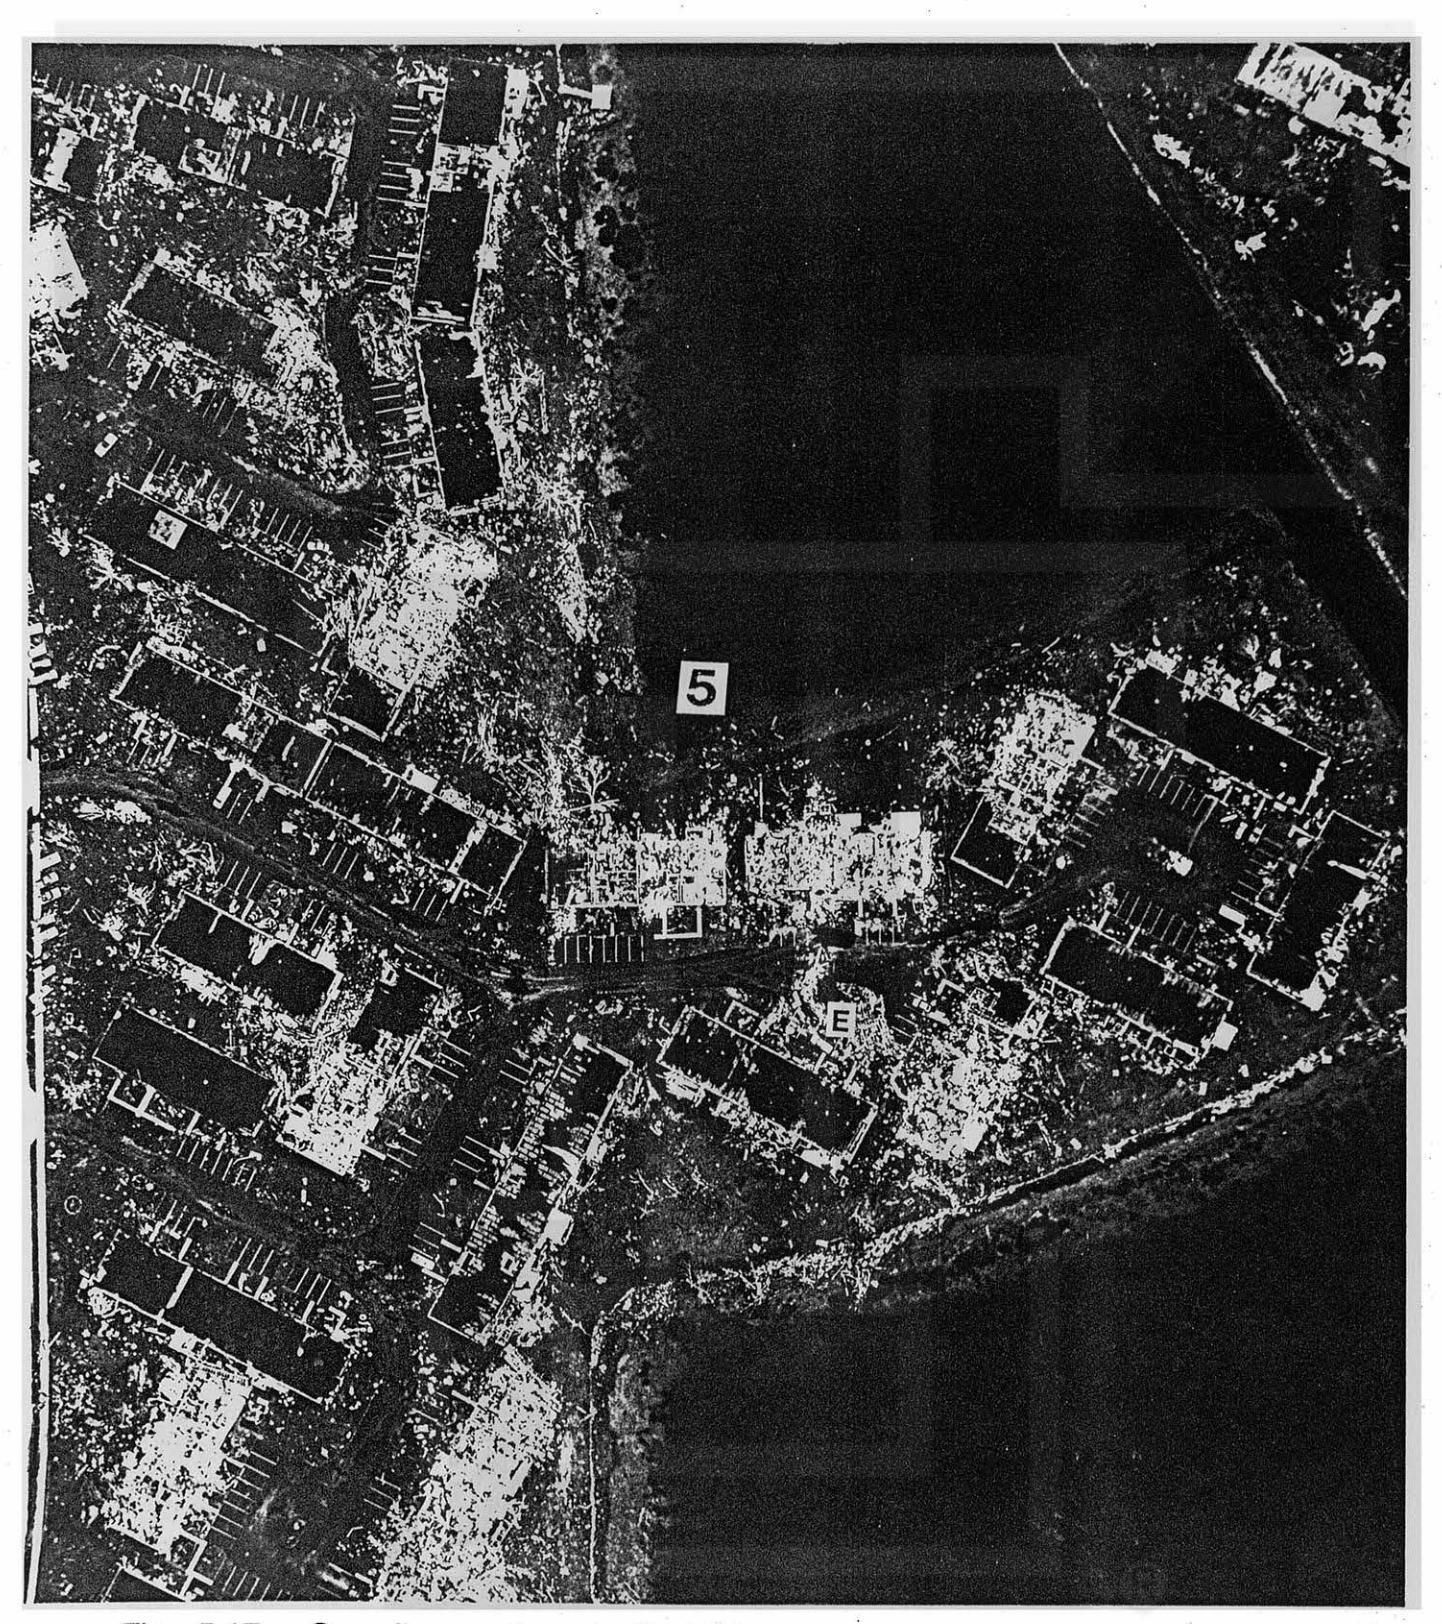
Fig. 5.17 Overall area of condo E which was unroofed and pushed toward the northwest. Its roof with tie beam crash-landed at E.

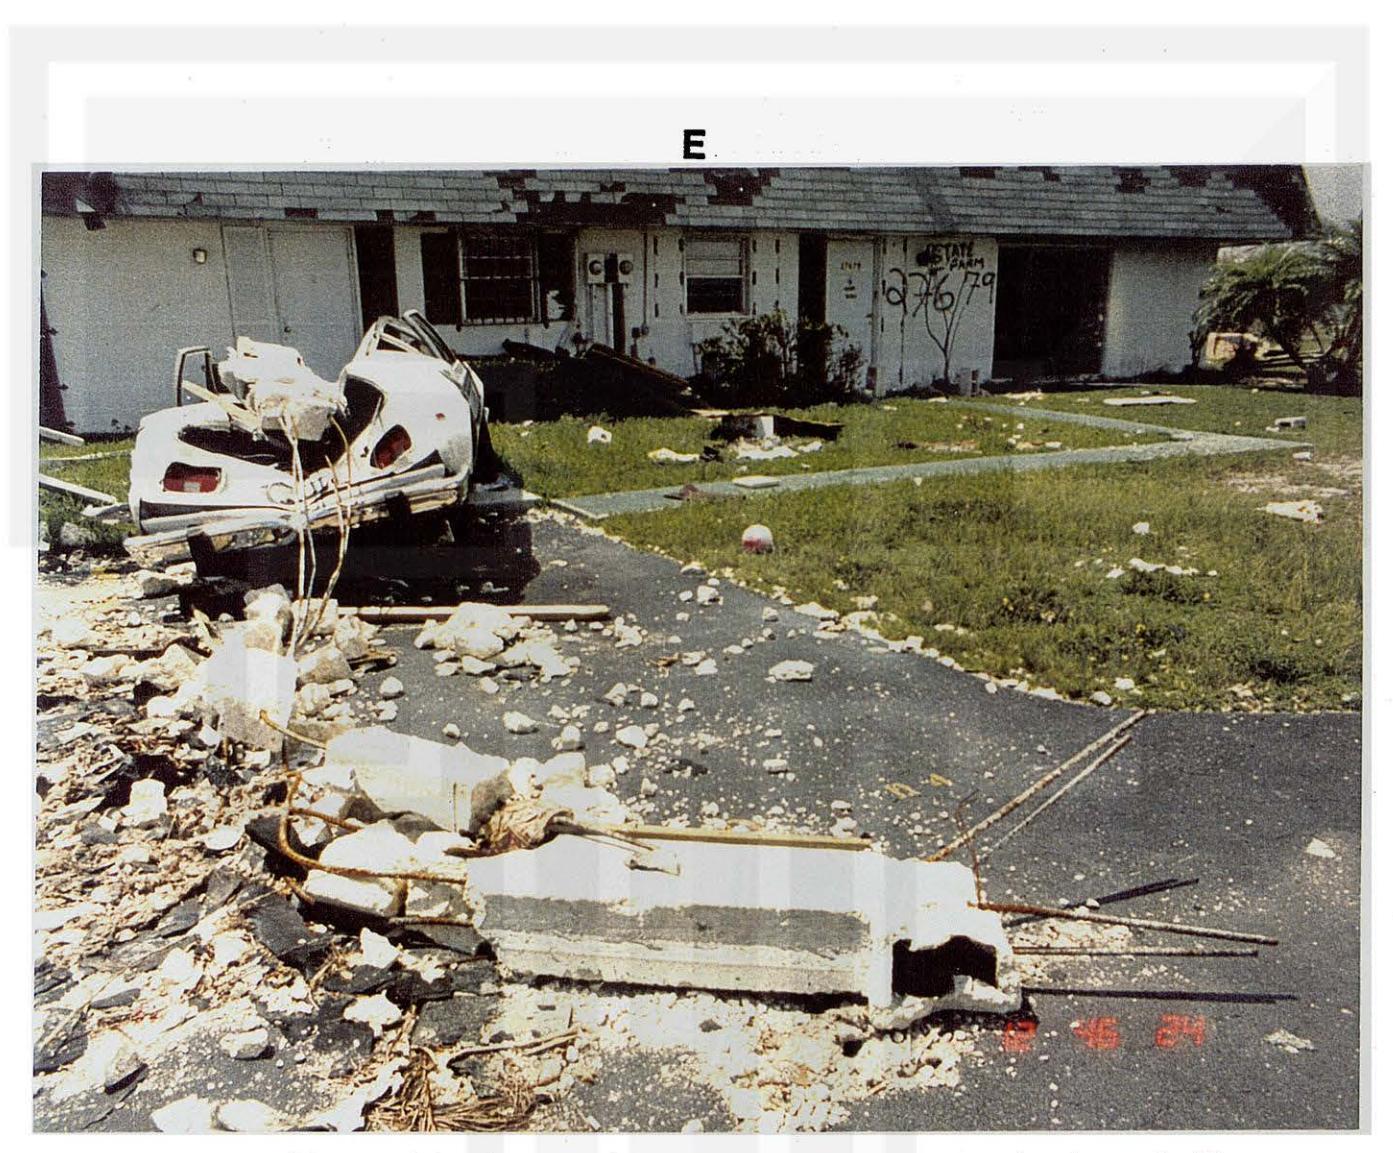
Fig. 5.19 Pieces of the tie beam blown onto a parked car in a lot downwind from condo **E**. A wind-parallel condo seen in the background was particularly undamaged.

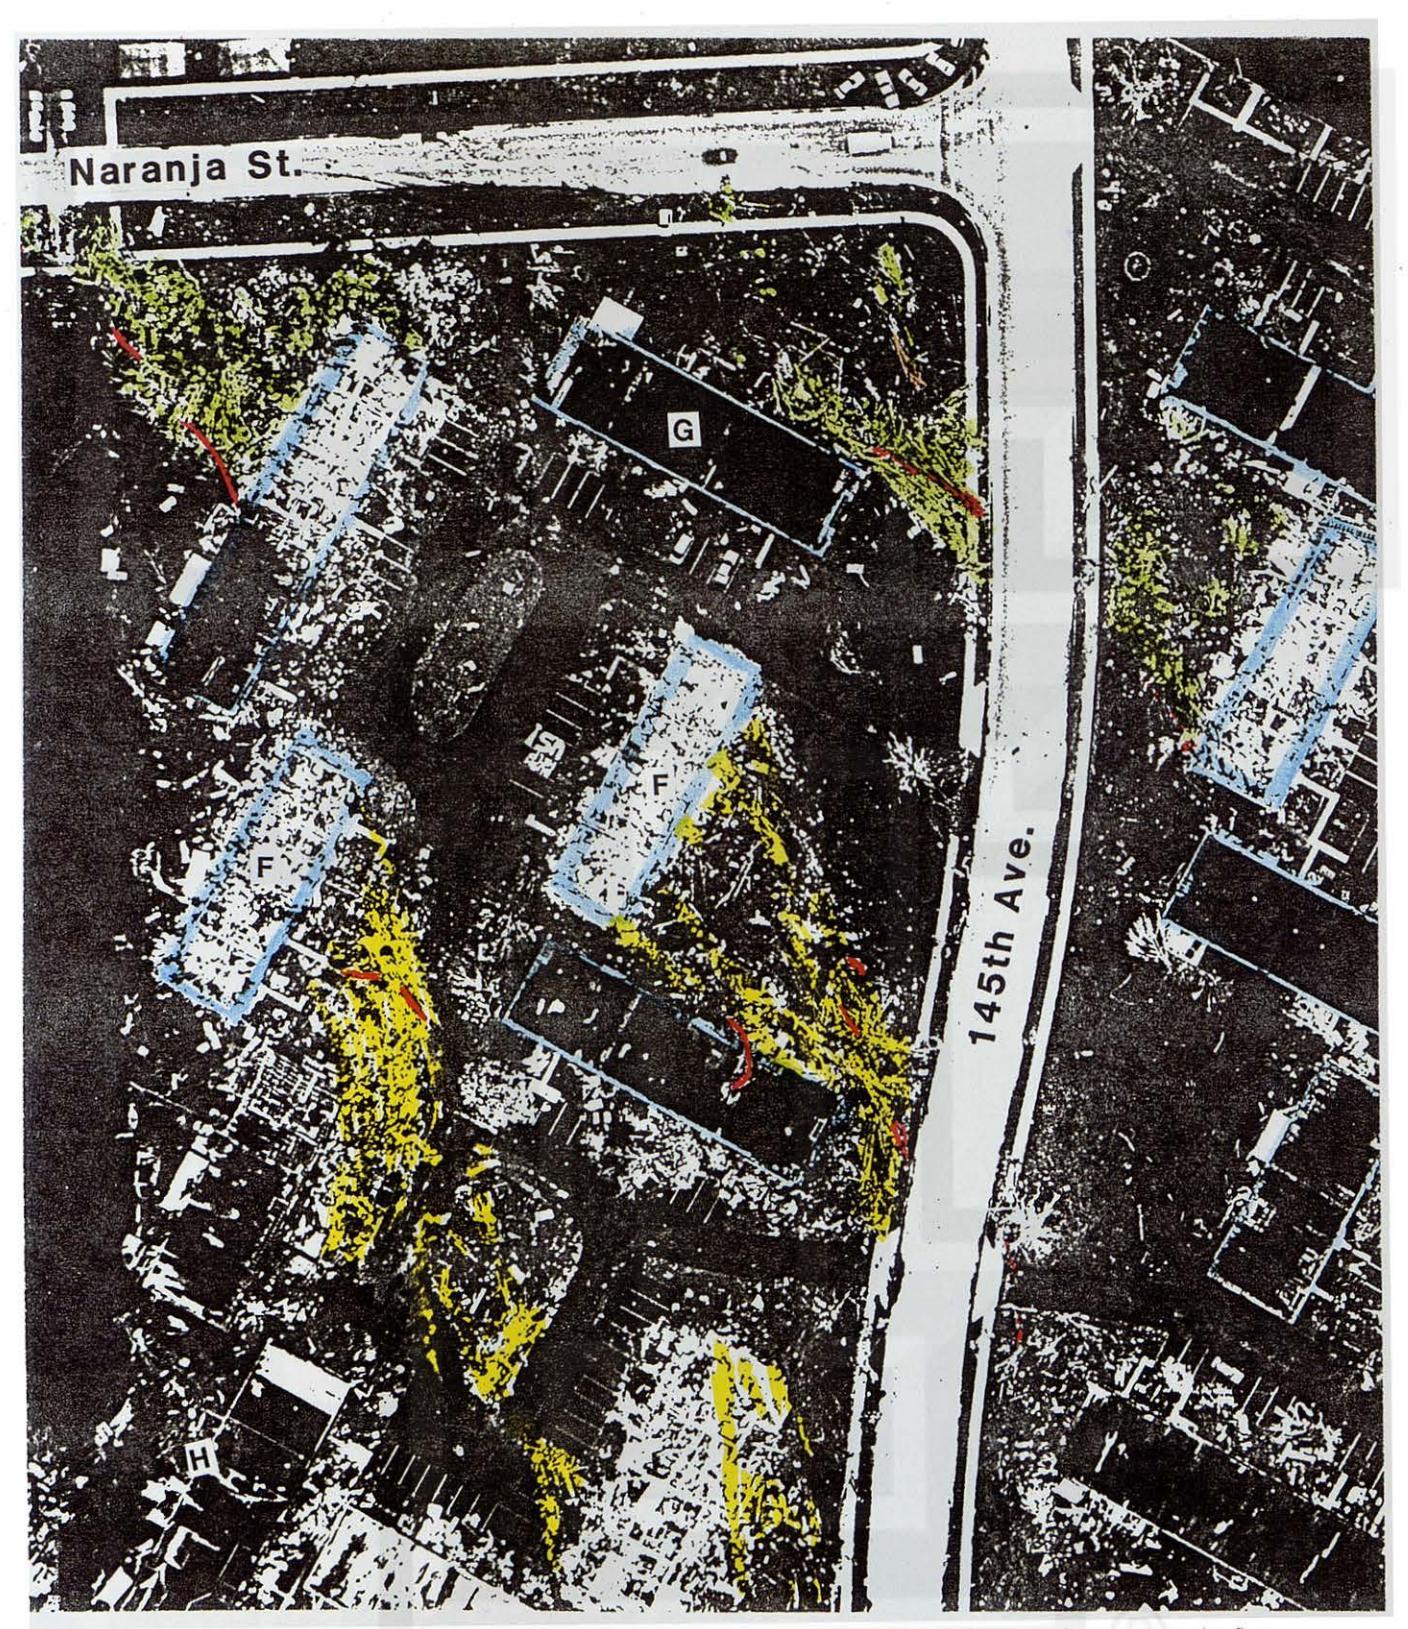
Fig. 5.21 Debris thrown by the first wind (green) and by the second wind (yellow). Condo **G** in the wind-parallel direction was not damaged while condo **F** in the wind-perpendicular direction was damaged severely.

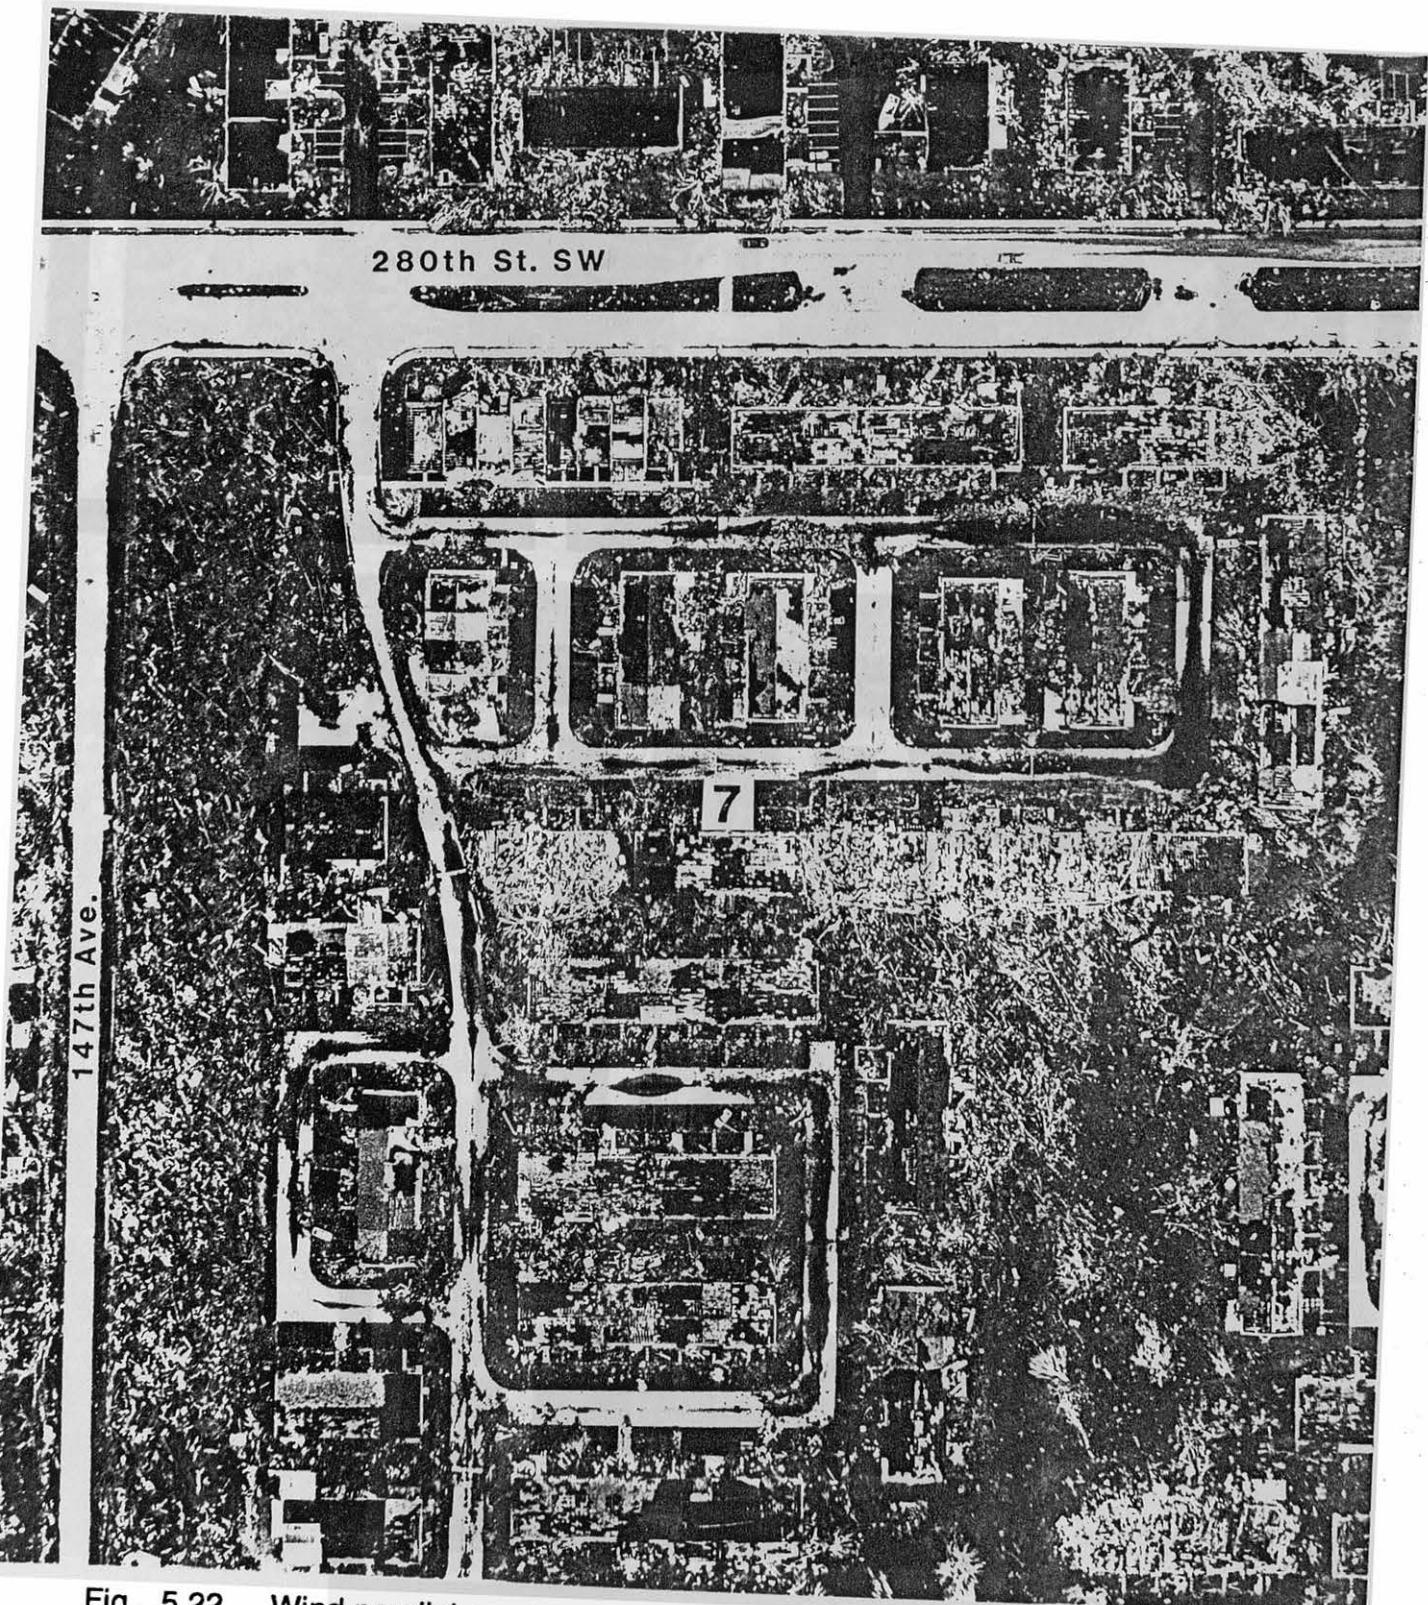
Fig. 5.22 Wind-parallel condos south of 280th Street SW damaged by the first wind from north-northwest.

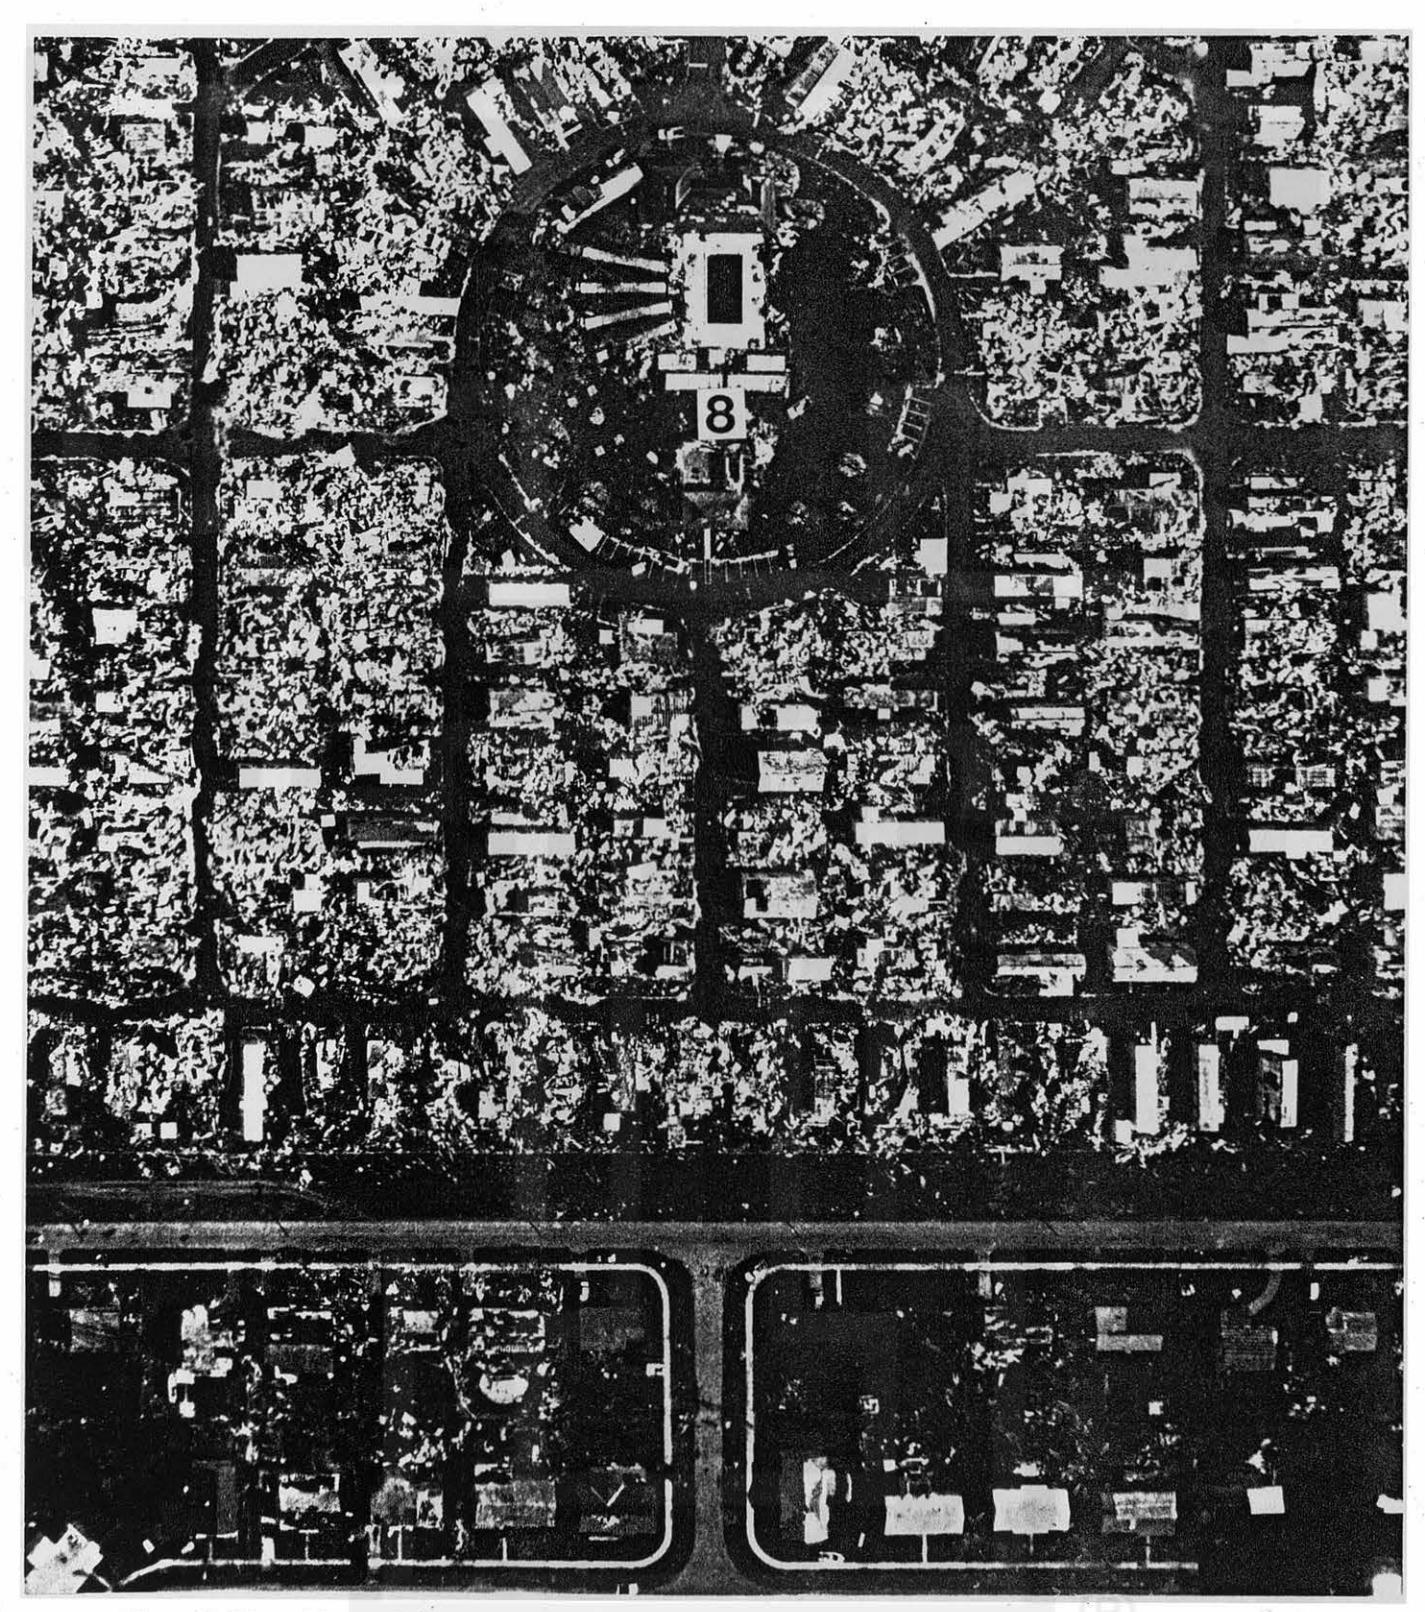
Fig. 5.23 Unexplainable damage of the mobile-home park south of 280th Street SW. Some mobile homes were untouched by the high winds. Why?

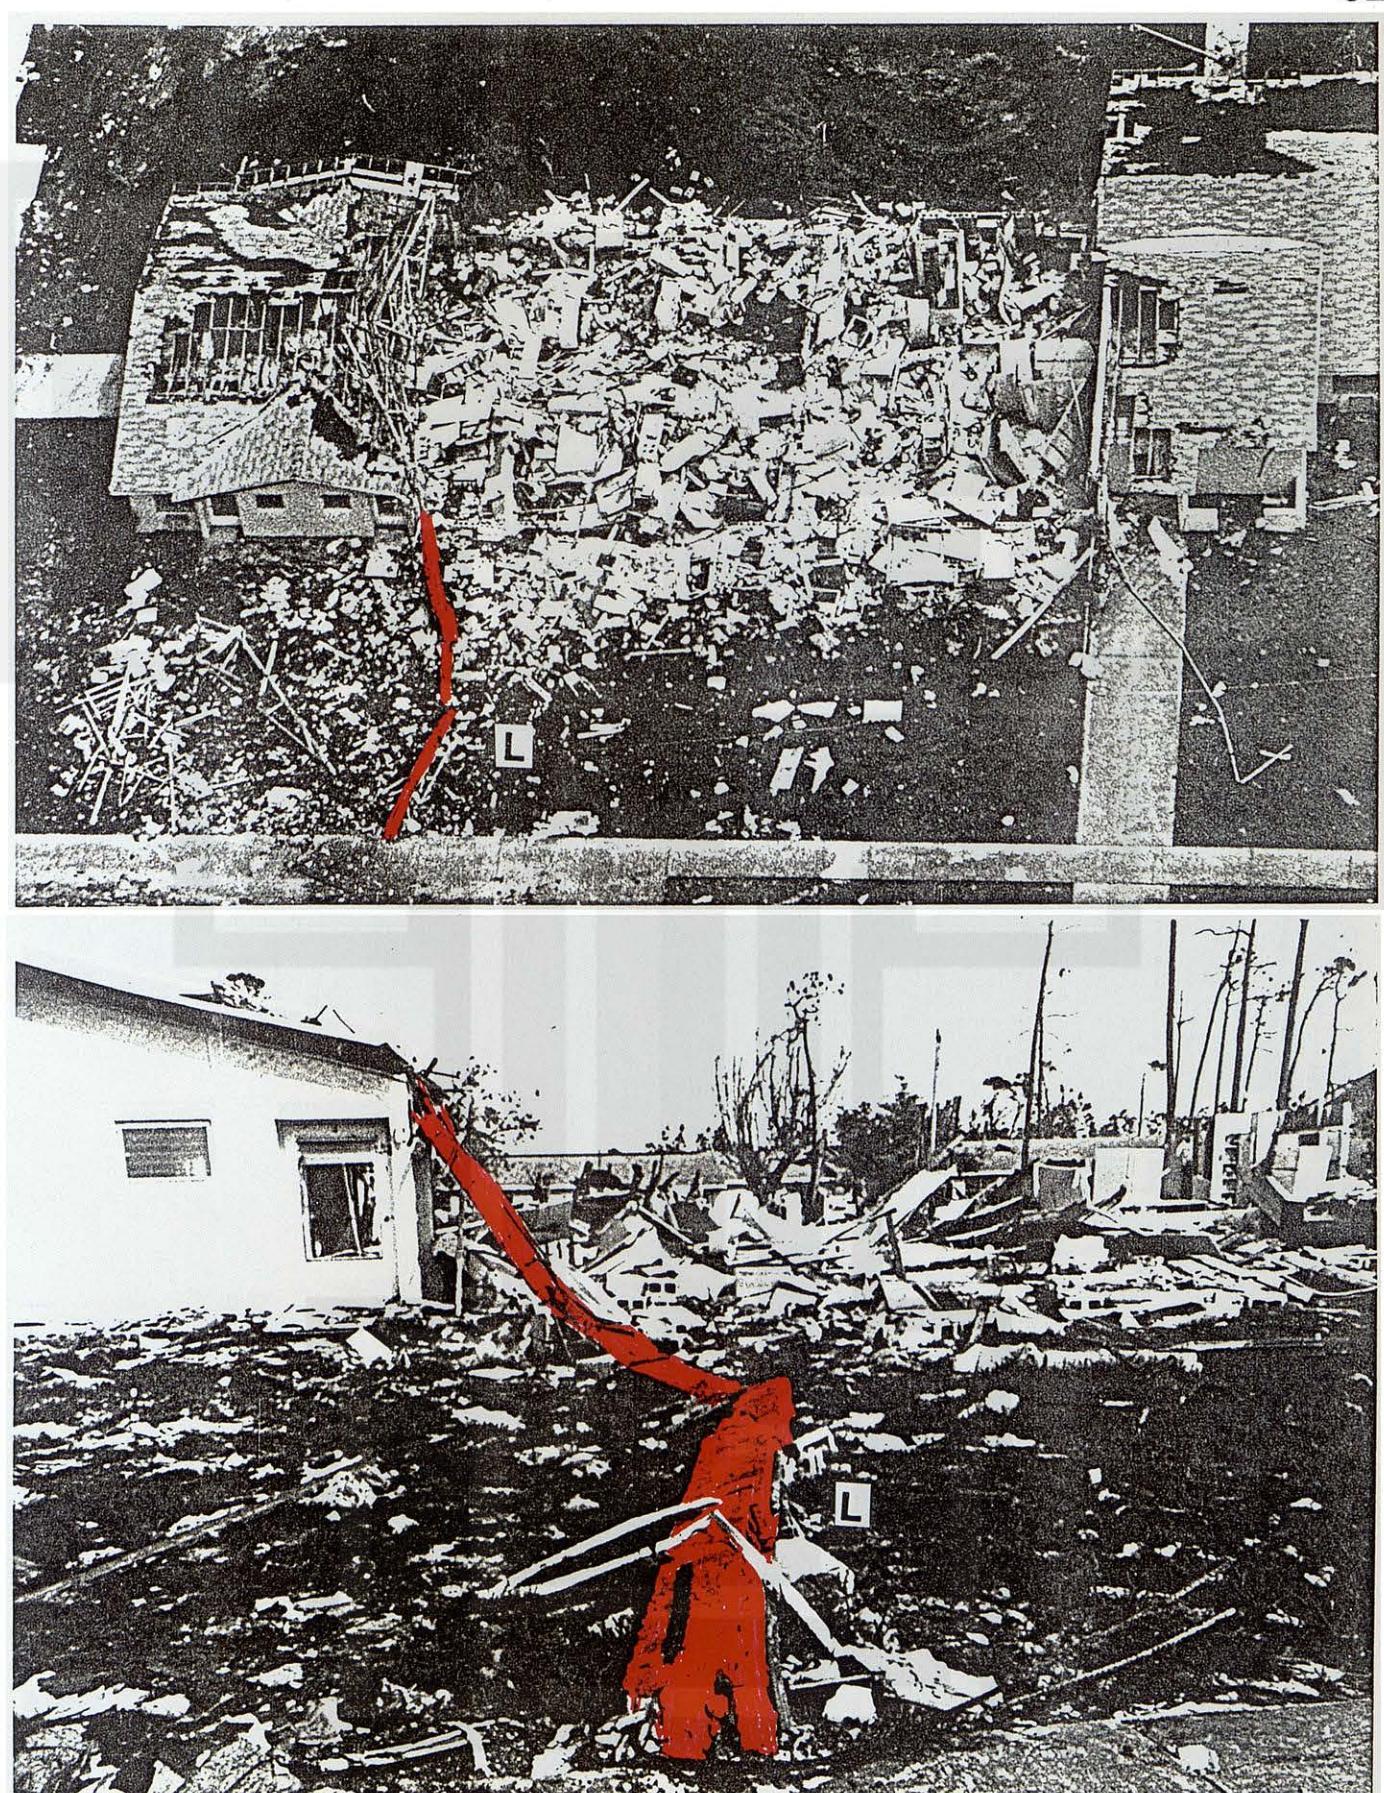
Fig. 6.1 A tie beam from condo L photographed from the air and on the ground by Fujita. A mini-swirl in the first wind caused this damage (see index map, Figure 6.10).

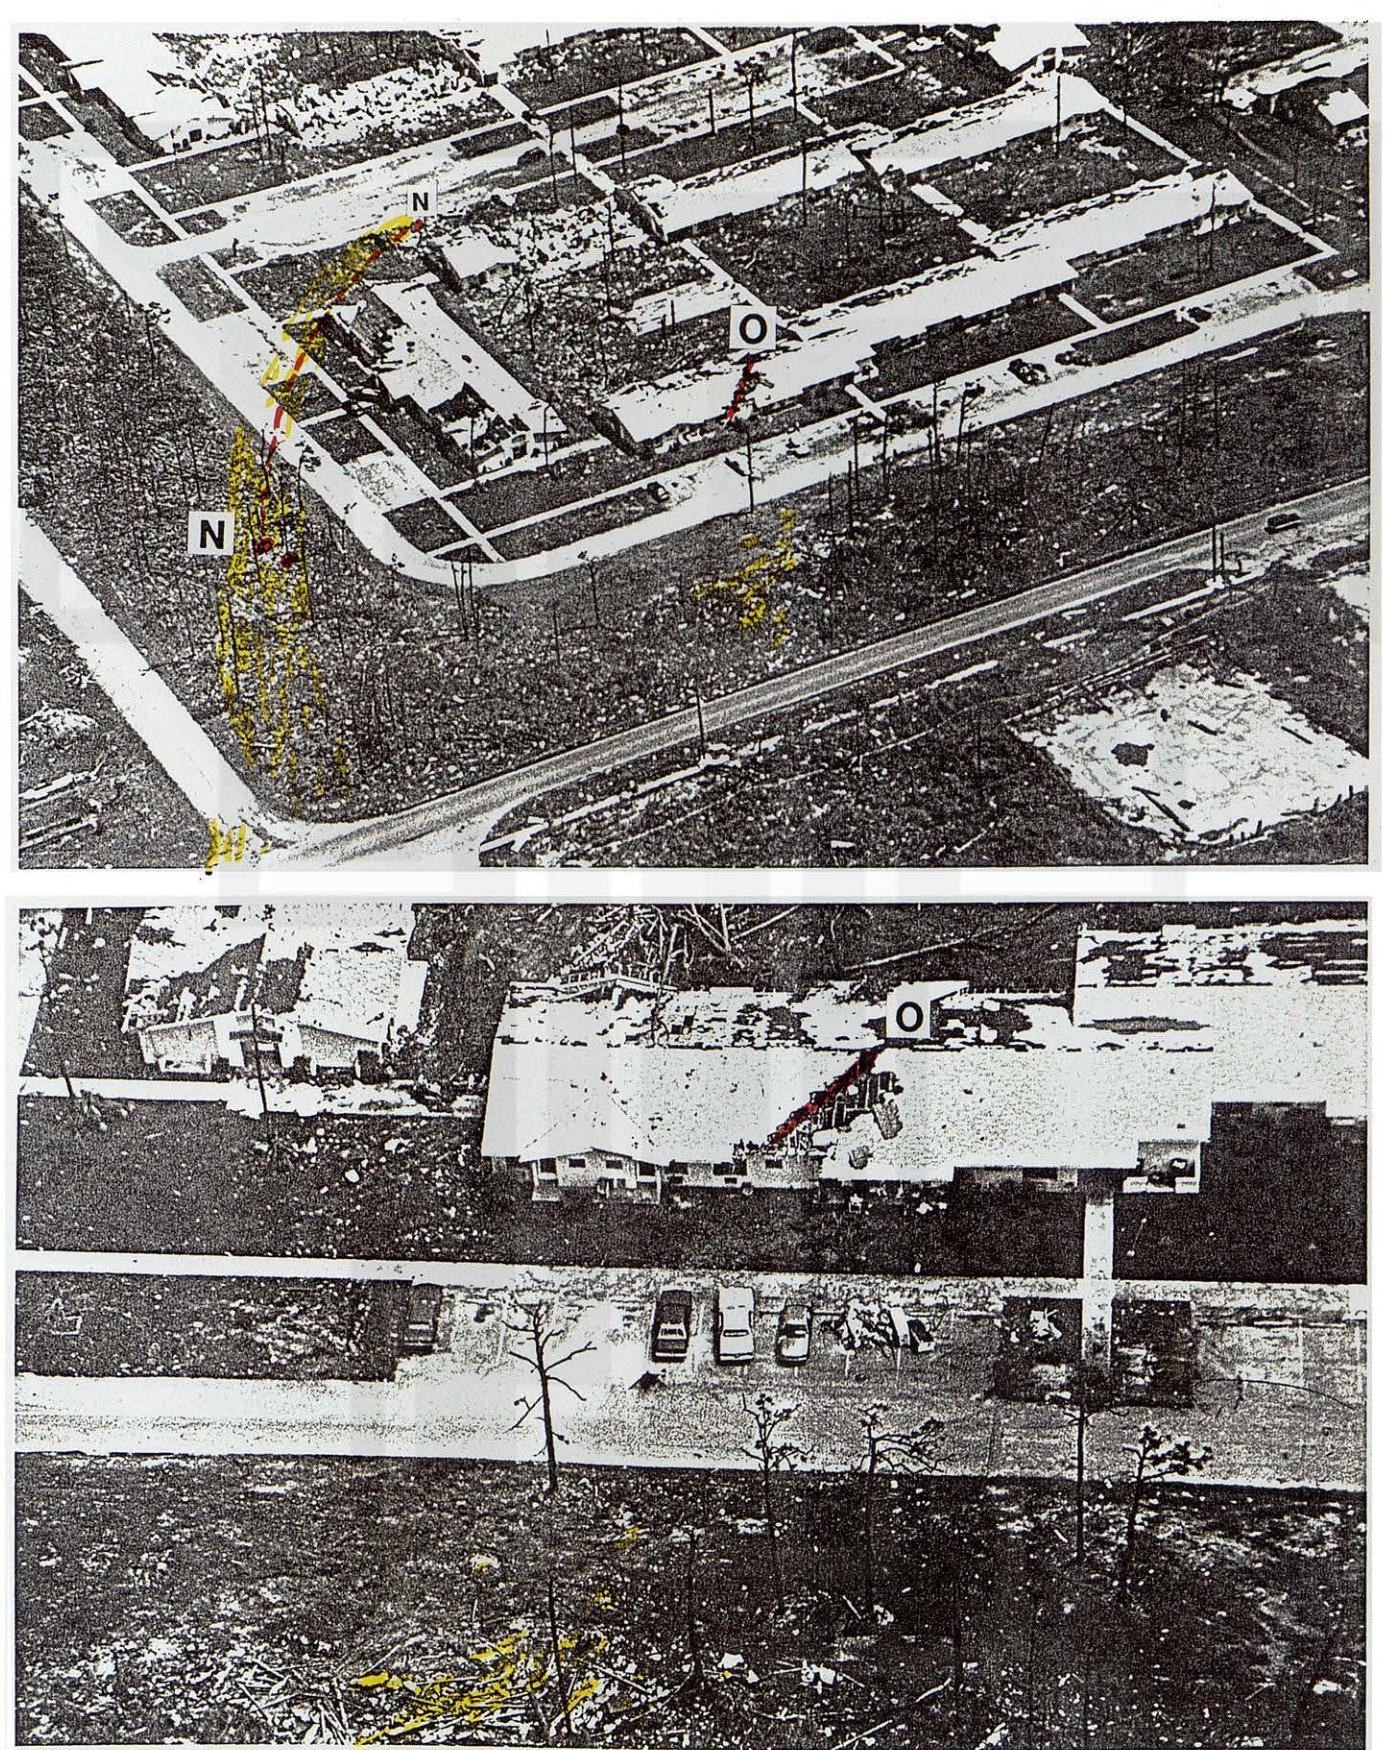
Fig. 6.5 Aerial photo of the debris and a dumpster from N. A sharp cut by a falling tie beam is seen at O.

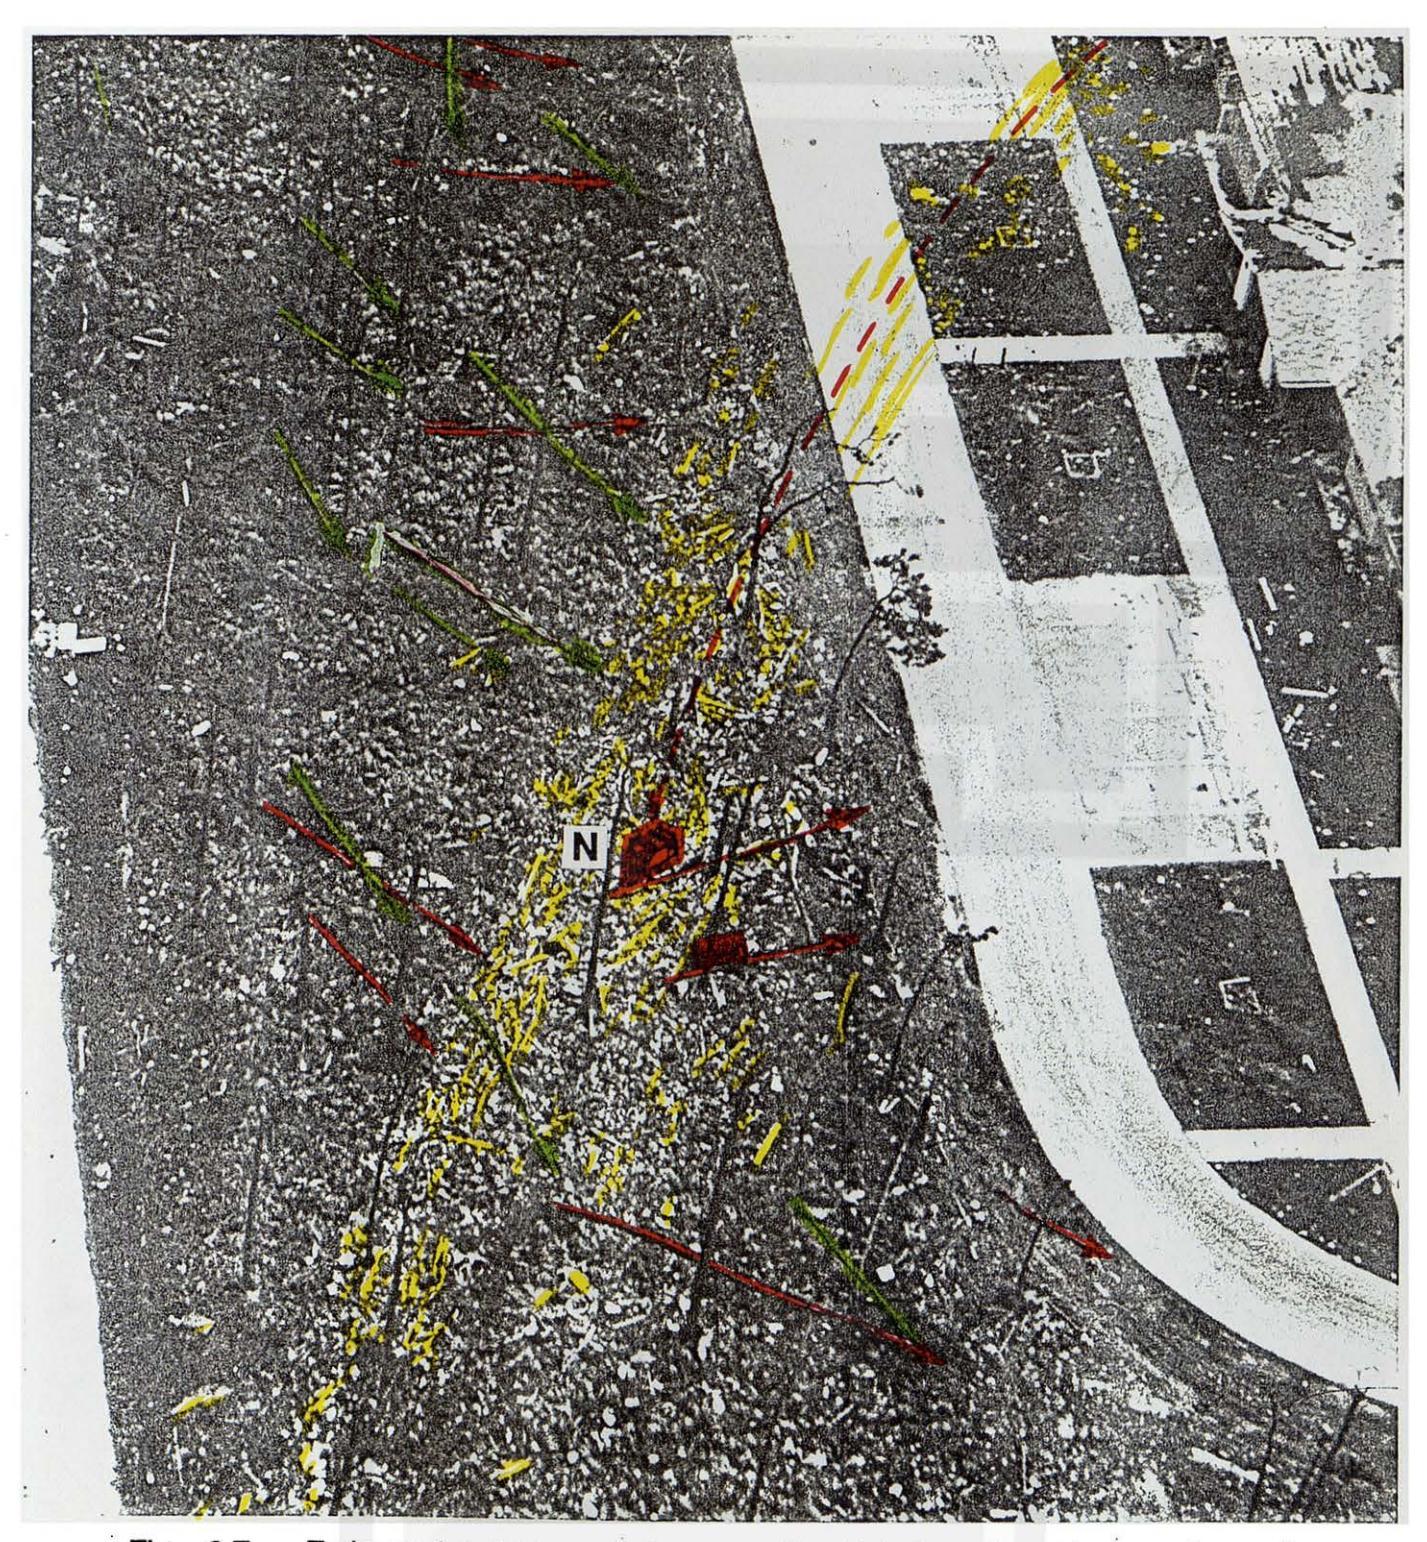
Fig. 6.7 Estimated trajectory of dumpster **N** which flew through an estimated distance of 110 meters (360 feet). The winds were induced by an anticyclonic mini-swirl inside the first winds.
