Post City, Texas, Oct. 22nd, 1908.

I herewith hand you drawing No.08015, Sheets 1 and 2, from Engineering Department, Double U Company, Post City, Texas. These sheets show error in location of fences and buildings along the south row of farms upon the plains from 19 to 43 inclusive.

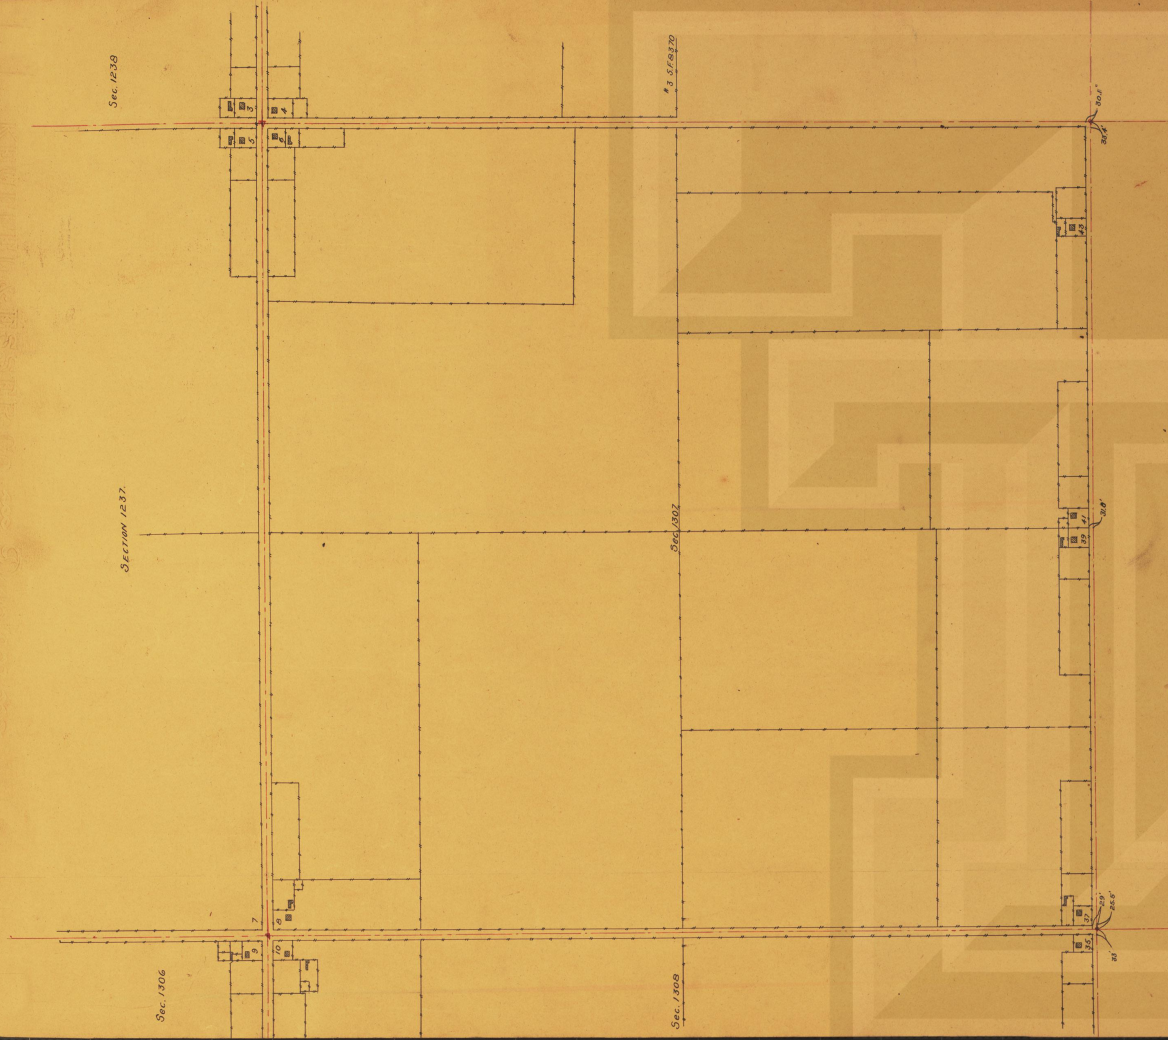
Red lines indicate corner section lines

The error was discovered about the middle of April when we were laying out fences for farms north of the Tahoka road. We discovered that the fence lines did not line with the fence already built south of said road, and began an investigation to find out the reason, as the field notes showed that the north and south section lines south of the Tahoka road were in line with those north of the Tahoka road. Mr.Twichell set a stone at each section corner along the Tahoka road, but set none one mile south of said road, but did set the section corners two miles south. As the notes showed that from the N.E.corner of section 1310 to the S.E.corner section 1320 was a straight line, we ran this line straight on the ground and found it to be 45 ft. west of a stone that some one had set for the S.E. corner of section 1310, and from which all of the farms in this locality had been laid out from. We did the same thing one mile east and found the S.E.corner of section 1309 45.5 ft. west of a stone which had been previously set by some one and used for the lay-out of the farms. We proceeded in the same manner from the N.E.corner of 1308 to the S.E. of 1316; also from the N.E.corner 1307 to the S.E. corner of section 1. In each case we found stones previously set by some one, which had been used for the laying out of the farms, but in each of the last two cases the stones were about seven ft. out of line.

I brought this matter to Mr. Post's attention at the time of the discovery, and he instructed me to use the correct corners for all future fences, which I have done, and at that time he said we would correct the old ones, and I ~~will~~ lay these maps before you at this time in hopes that a final decision in writing (after having looked the matter over with the whole of the information before you) might be received so as to have the matter of record, and for future guidance.
