COMMON DENOMINATOR OF THREE WEATHER-RELATED
AIRCRAFT ACCIDENTS

T. Theodore Fujita

Fernando Caracena

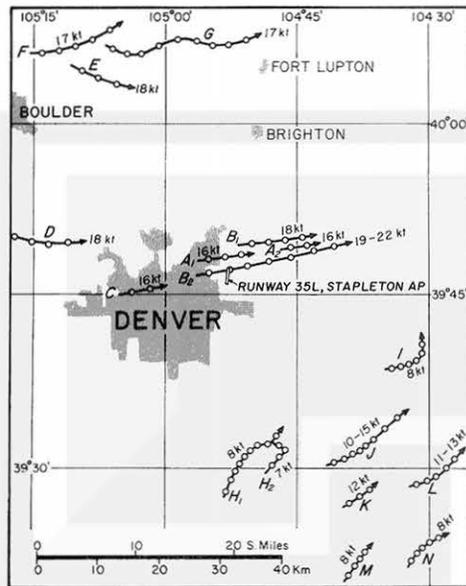
Fig. 4. Movement of scattered storm echoes near Denver on August 7, 1975 between 1518 and 1622 MDT. NWS at Limon, about 70 n. miles SE of Denver, took radar pictures at 5.3-min intervals during this period. Open circles show the echo centroids in each picture.

Not all thunderstorms in the Denver area were alike, however. The echoes to the southeast of the city acted like slow-moving bubbles. Most of them travelled toward the northeast at 7 to 15 kt. In contrast the echoes over the Boulder area were moving at 17 to 18 kt (see Fig. 4)

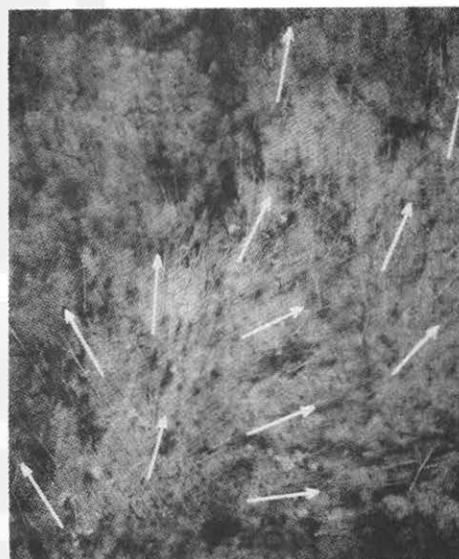
Fig. 15. A diverging pattern of tree damage near Beckley, North Carolina. Damage was probably caused by an intense downburst descending on the forest on April 3, 1974. Photo by Fujita, taken from Cessna 172.

During the damage survey of the 148 tornadoes on April 3, 1974, Fujita found diverging patterns of blown-down trees located a considerable distance away from tornado paths (see Fig. 15).
