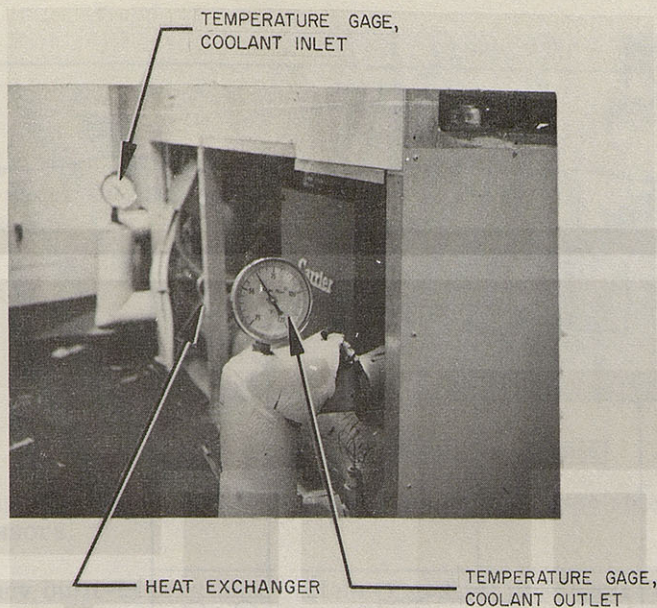
Fig. B14 - Liquid chiller which cooled the coolant fluid in the thermal control system

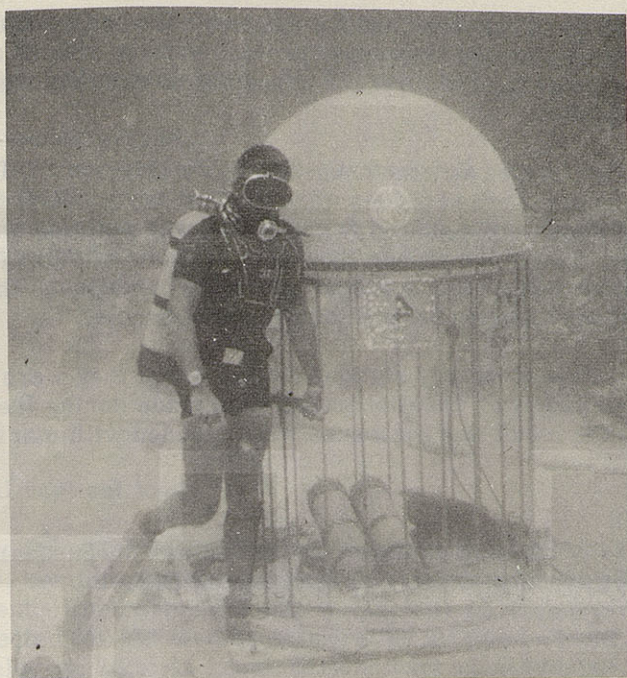
Fig. B28 - One of the five way stations, which served as shark cages and as rest and communication stations. The spare scuba tanks were maintained by surface support divers.

The base structure consisted of a square steel plate, 1-1/4 inch thick, providing sufficient ballast to maintain negative buoyancy of the way station when the dome was filled with air. The cage structure was fabricated from 1/2-inch-diameter steel rods, welded to 4-foot-diameter rings and bolted to the base structure. A section of the cage structure was hinged to swing outward as a door. A stainless-steel-bar latch on the door was located so that it would be easily operated from either side of the door. The hinges for the door consisted of simple stainless steel pins. On the door was mounted a plate with a number, from 1 to 5, identifying the particular way station.

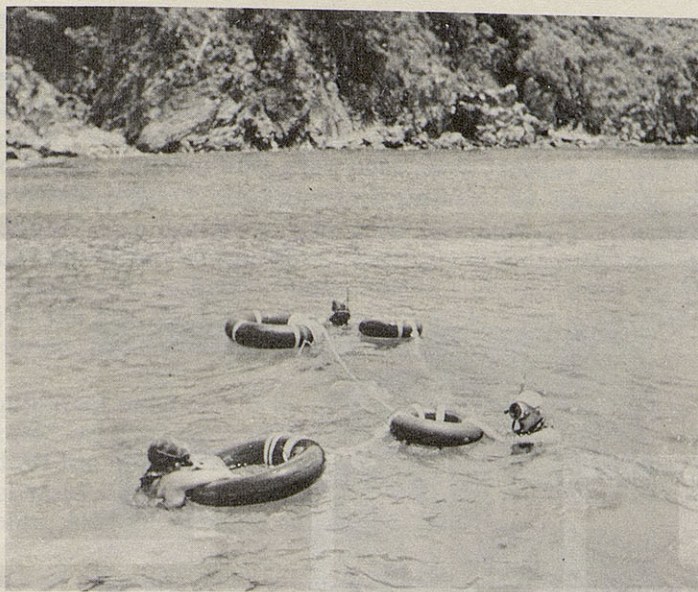
Fig. B31 - Template for locating the positions of the support barge legs

The final position of the support barge was determined in the following manner: The Ammi pontoon has six 24-inch-I.D. spudwells in it. These are holes through the pontoon, top to bottom, through which pile legs can be placed. The four corner spudwells would be used on the support barge. A template was made using four inflated inner tubes with connecting lines. The inner tubes were spaced the same distances apart (length, beam, and diagonal) as the four corner spudwells of the Ammi pontoon. The template was floated over the site and manipulated by swimmers until a position was found at which all four pile legs would be sitting on a relatively flat surface amid the rocks and coral outcroppings on the bottom (Fig. B31). Markers (plastic-bottle floats) were then placed at the pile leg spots for future reference in positioning the support barge.

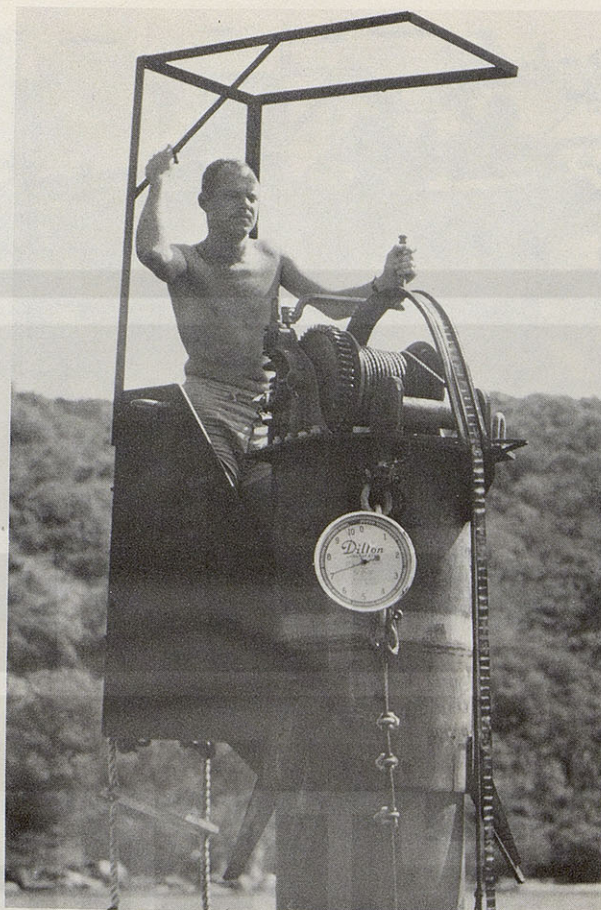
Fig. B51 - Tensionometer in use to control the descent of the launch barge
