**SEMI-FINAL REPORT No. 4**

**DETAILED ANALYSIS OF THE STORM SURGE  
CAUSED BY TYPHOON NANCY OF 1961  
IN WEST CENTRAL JAPAN**

**T. Theodore Fujita**

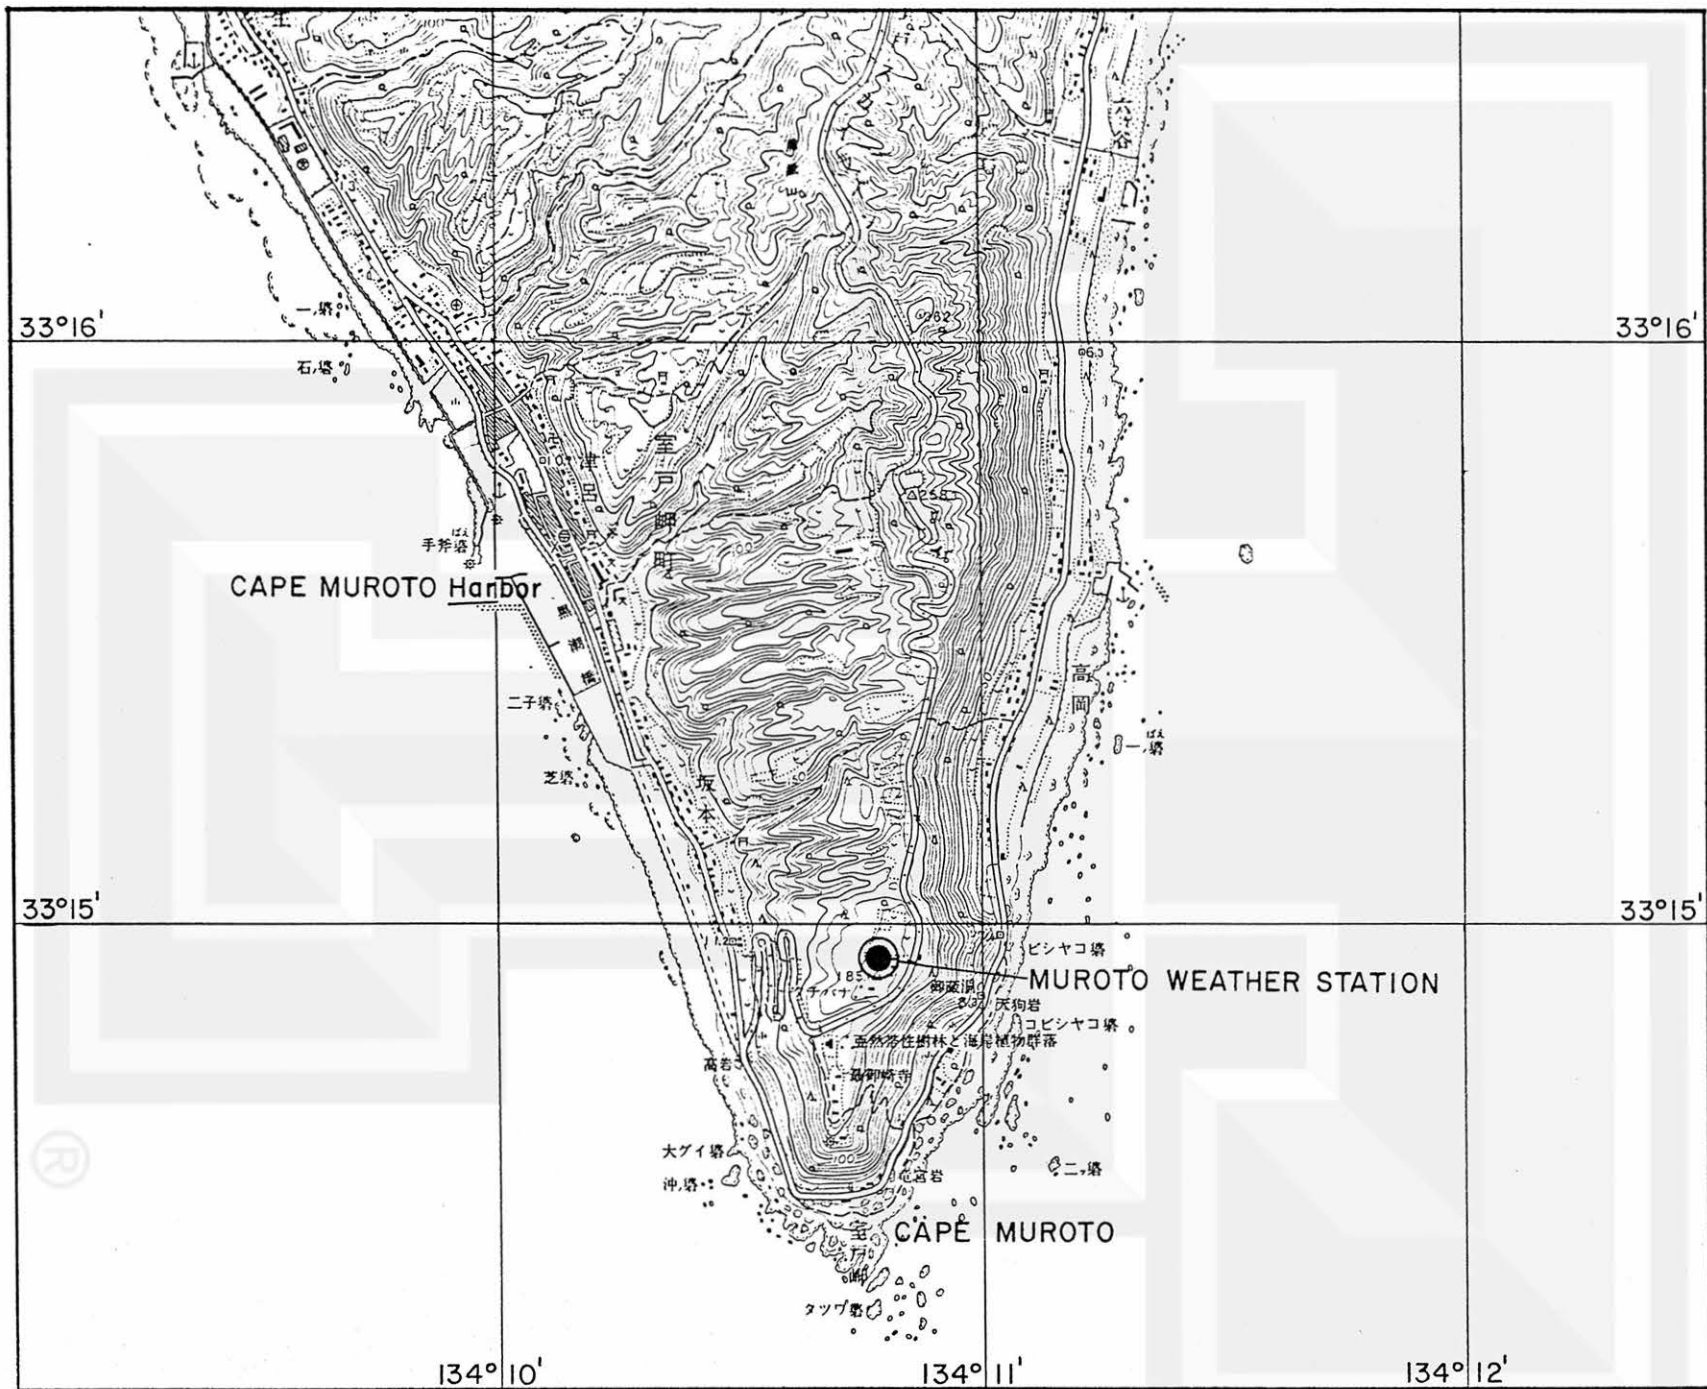
Fig. 2.1 Muroto Weather Station located atop a 185 m (810 ft) cliff. The anemometer recorded a 66.7 m/s (149 mph) 15-minute maximum wind and 84.5+ m/s (189+ mph) peak gust.

The JMA Muroto radar (5cm) is located 1 km (0.6 mile) north of the southern tip of Cape Muroto (Fig. 2.1). The height of the foundation is 185 m (810 ft.) with practically no obstructions in most directions, except between 330° and 010° azimuths where the mountains extend toward the 1995 m (6500 ft.) Tsurugi-yama far to the north.

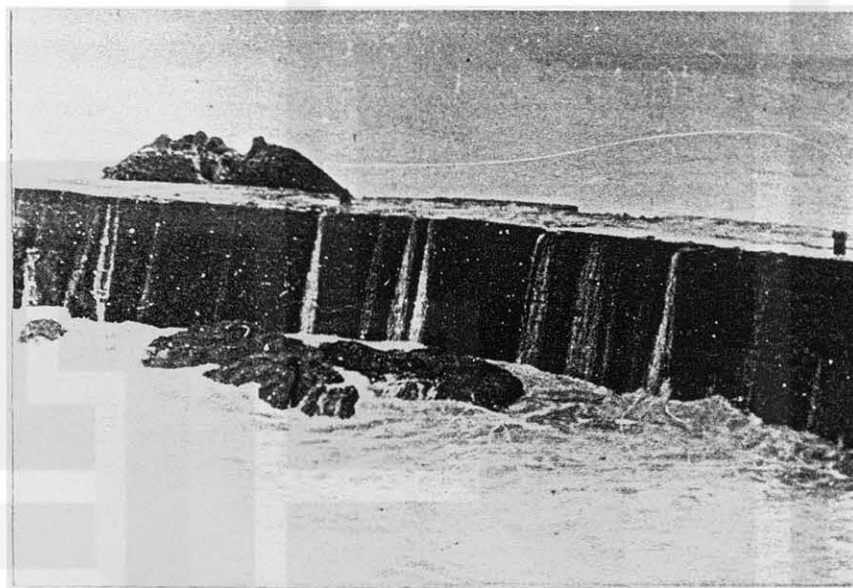
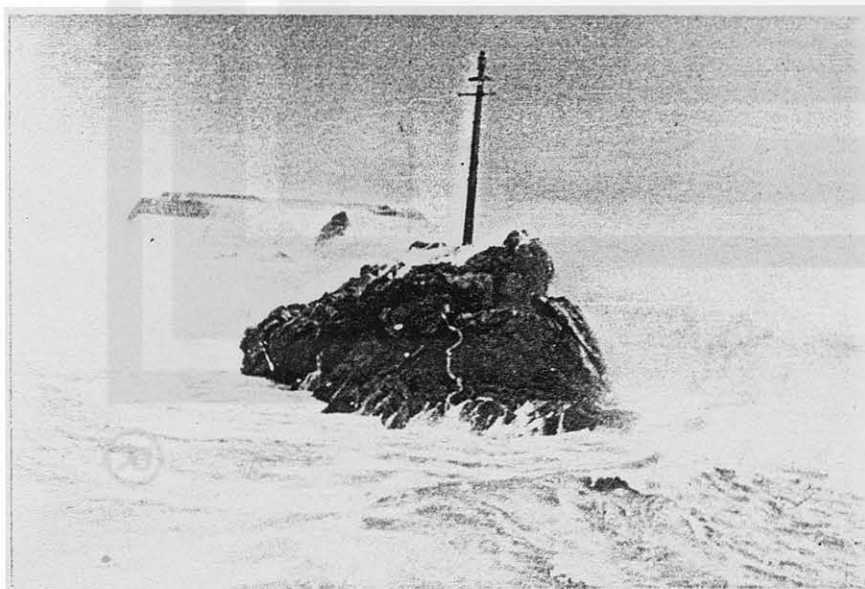
Fig. 6.1 Storm surge and wave action of Typhoon Nancy at seawall locations estimated to be in Cape Muroto Harbor and vicinity on the east side of Cape Muroto.

Furthermore, I was not able to determine where the 16 pictures in Figures 6.1 through 6.4 were taken. It is extremely likely that the photographic sites are located along the coastline between Cape Muroto (see Fig. 2.1) and Cape Muroto Harbor. Any one of these pictures implies that the peak gust of the typhoon was as strong as 189+ mph, as was estimated at the Muroto Weather Station overlooking the Pacific Ocean.

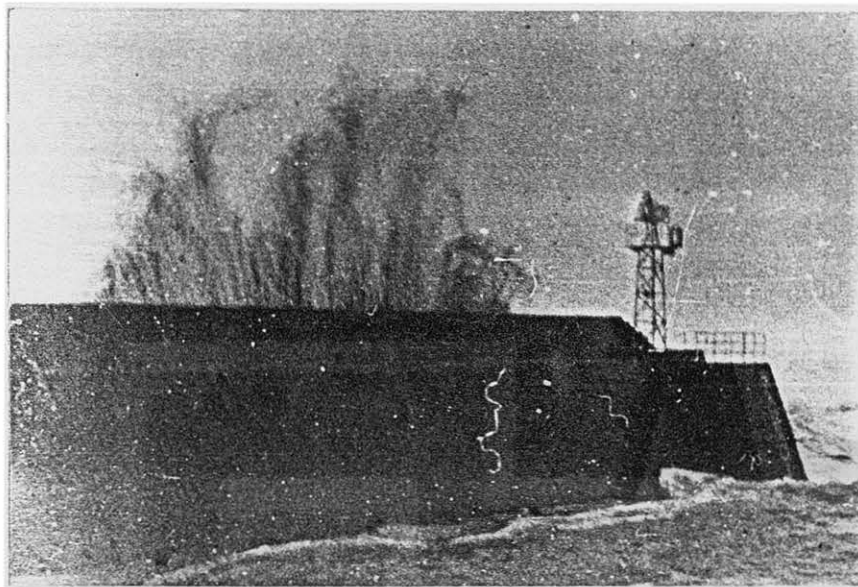
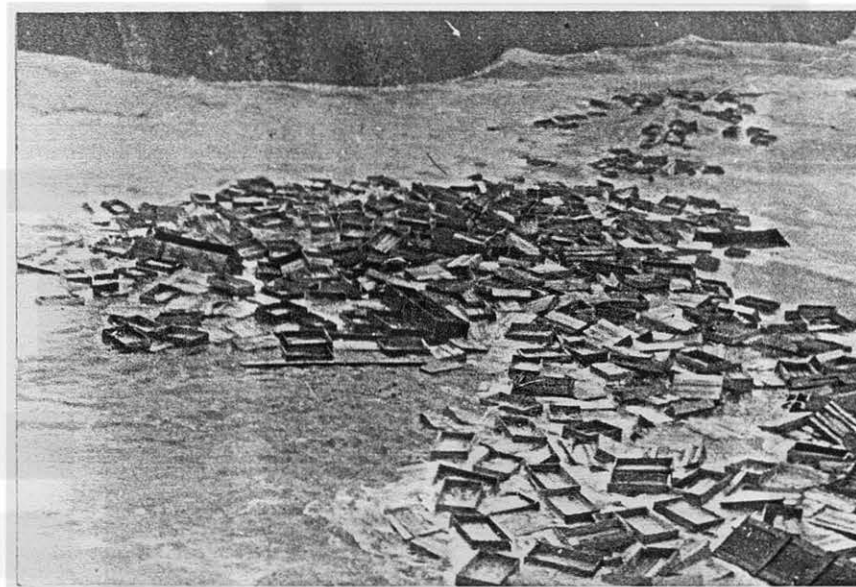
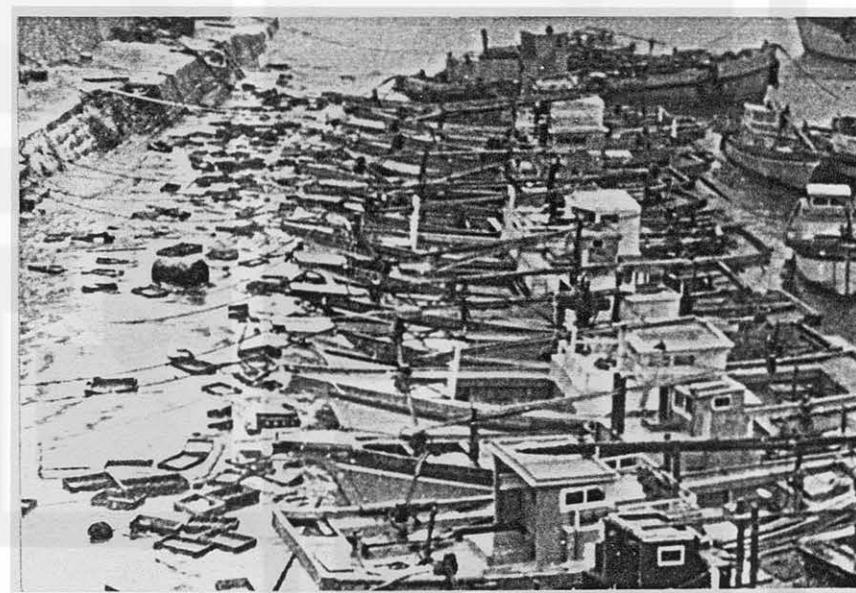
Fig. 6.2 Splash of typhoon waves crashing against the waterbreaks of the harbor (left). Drifting boxes and fishing boats fill the inside of the harbor (right).

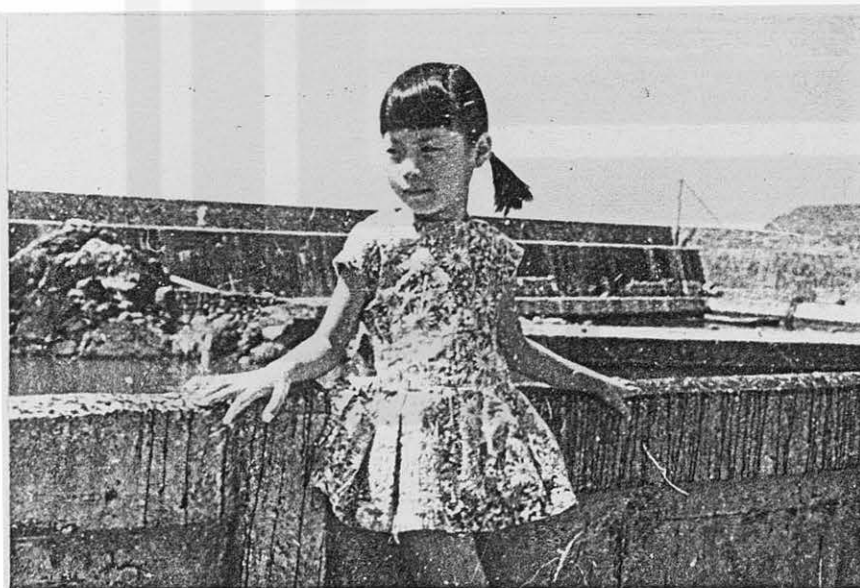
Fig. 6.3 Coastal dikes and houses left destroyed or heavily damaged in the wake of Typhoon Nancy. An unidentified youngster observes the damage which most likely left a lasting impression.

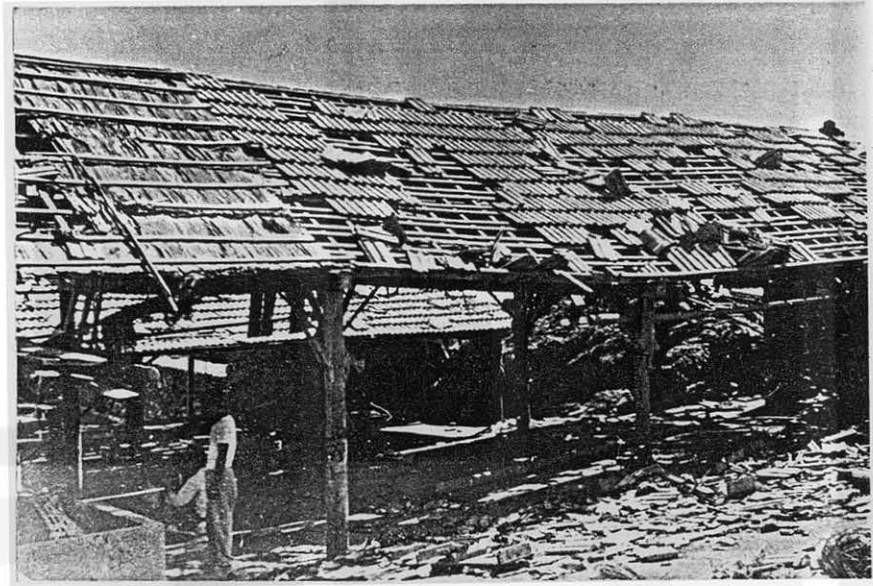
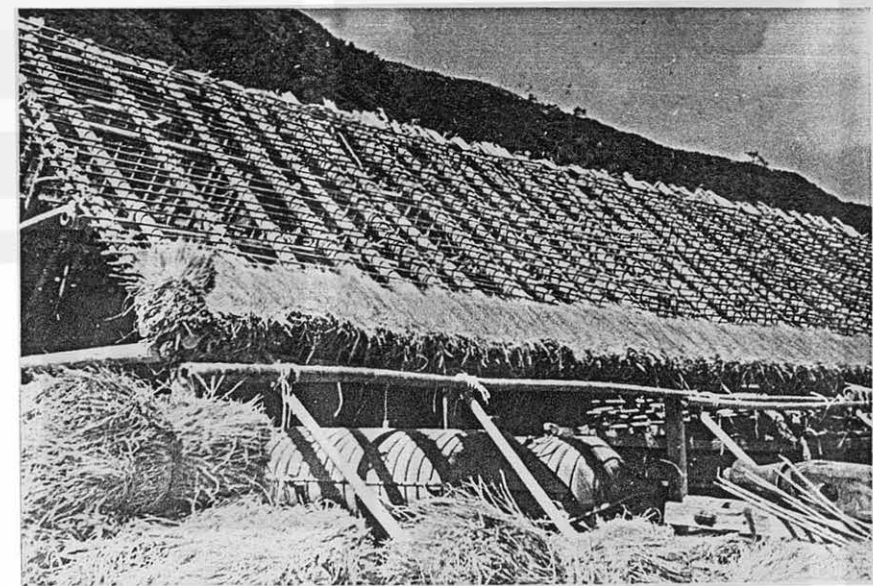
Fig. 6.4 Subtropical trees that were pushed over by Nancy's fury; and pole barns with straw roofs in the process of being repaired.
