DOWNBURSTS AND MICROBURSTS -- AN AVIATION HAZARD --

T. Theodore Fujita

The University of Chicago
Chicago, Illinois

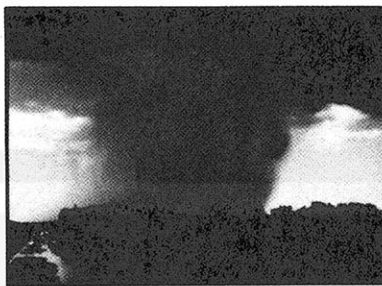
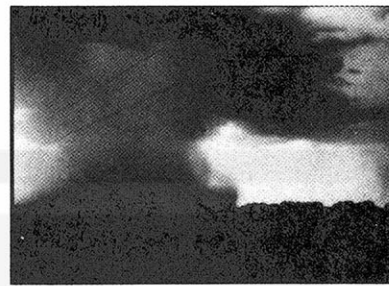
The sequence of pictures in Figure 1 reveals the formation and development of a microburst which descended from the cloud base at about 1.5 km (5,000 ft). The diameter of the downburst core was 1.0 to 1.2 kms (3 to 4,000 ft).

Figure 1. Microburst in action, July 1, 1978. Copyrighted pictures by Mike Smith.

Four stages of the evolution of a microburst, as implied by Smith's pictures and wind effects of other microbursts are :

A. DESCENDING STAGE

An air current descends with precipitation that evaporates inside the downflow. The precipitation looks

innocent enough and a flight beneath the descending virga is expected to be smooth.

B. CONTACT STAGE

The downflow hits the ground. Precipitation may or may not reach the ground, depending upon the drop-size distribution, height of the cloud base, environmental relative humidity, etc..

C. OUTBURST STAGE

The outflow spreads out violently within the 100- to 200-m (300 to 500 ft) layer above the ground. An arc of the outburst front pushes outward from the downburst center.

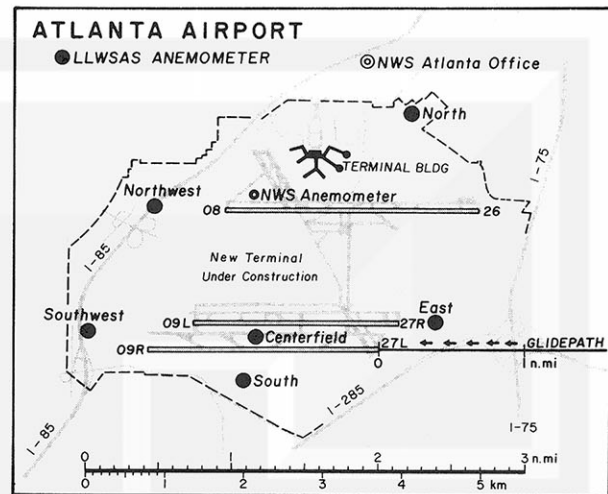
Figure 4 shows the distribution of six anemometers in relation to three runways at Atlanta Airport. If a classical gust front approaches from the north or northwest, the LLWSAS will pick up the preset thresholds to activate an alarm.

Figure 4. Location of six LLWSAS anemometers at Atlanta Airport.

The storm's first echo appeared on the radar scope at 1802 (see Figure 5). The echo was one of those air-mass showers scattered all around the airport. At 1845, 43 min. after the first echo, NWS anemometer at the airport (see Figure 4 for the location) recorded a 32 kt peak gust from the northwest.

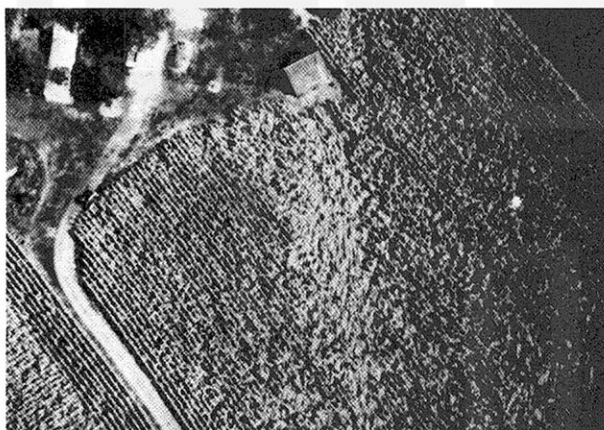
Vertical wind near the ground should not be underestimated. A high-wind streak in the corn field in Figure 18 was caused by a wind of 70 mph (60 kt). If the descending angle is between 20 and 30 degrees, the vertical current at the roof top will be 20 to 35 kt (35 to 60 fps).

Figure 18. Downburst winds deflected by a slanted roof. September 30, 1977 storm in Indiana. Estimated downward current on the roof, 35 to 60 fps. Photo by Fujita.
