REPORT ON THE CHICAGO TORNADO
OF MARCH 4, 1961

Rodger A. Brown and Tetsuya Fujita

Research Paper #1

Technical Report to the U. S. Weather Bureau
(Contract No. 9931)

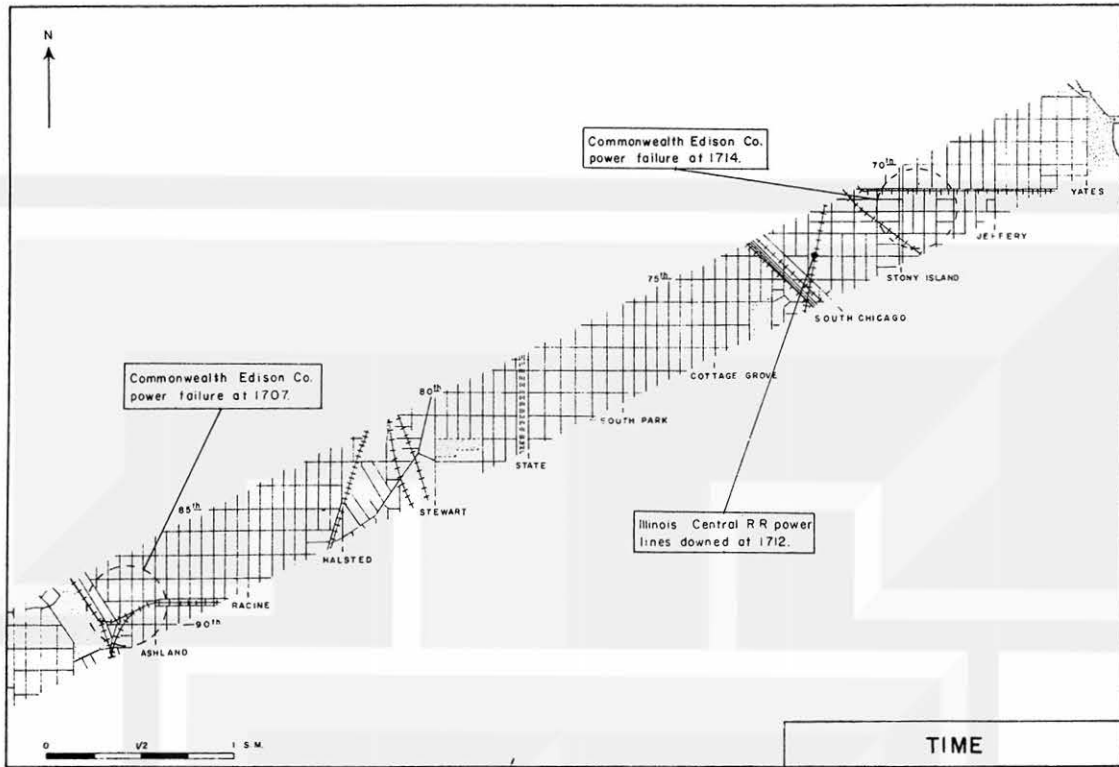
Fig. 10 The times of tornado passage.

Using the times shown in Fig. 10, an average forward speed of the tornado was calculated to be about 45 mph. This means that the tornado started about 1706 CST and reached Lake Michigan about 1715.
