An Analysis of Three Weather-Related Aircraft Accidents

T. THEODORE FUJITA AND FERNANDO CARACENA

Reprinted from BULLETIN OF THE AMERICAN METEOROLOGICAL SOCIETY,
Vol. 58, No. 11, November 1977

Two aircraft accidents in 1975, one at John F. Kennedy International Airport in New York City on 24 June and the other at Stapleton International Airport in Denver on 7 August, were examined in detail. A third accident on 23 June 1976 at Philadelphia International Airport is being investigated. Amazingly, there was a spearhead echo just to the north of each accident site. The echoes formed from 5 to 50 min in advance of the accident and moved faster than other echoes in the vicinity. These echoes were photographed by National Weather Service radars, 130–205 km away. At closer ranges, however, one or more circular echoes were depicted by airborne and ground radars. These cells were only 3–5 km in diameter, but they were accompanied by downdrafts of extreme intensity, called downbursts. All accidents occurred as aircraft, either descending or climbing, lost altitude while experiencing strong wind shear inside downburst cells.

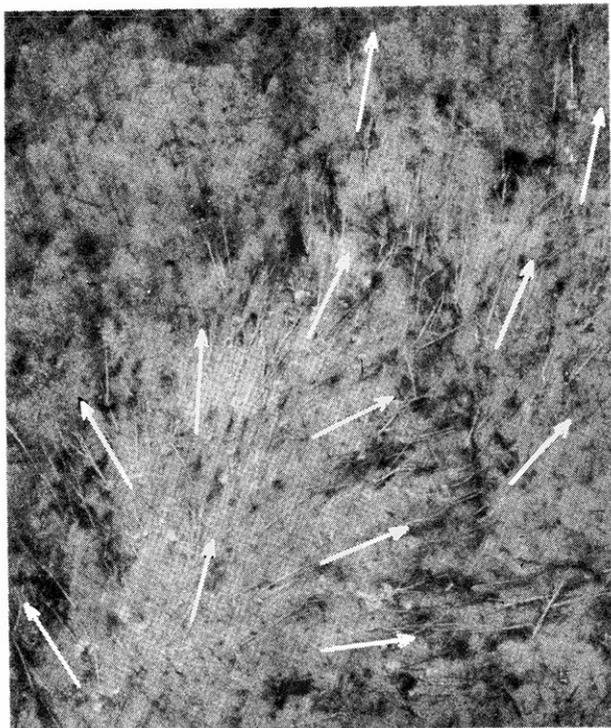
Fujita (1976a) and Piaget (1976) have sighted and photographed numerous patches of trees blown down in diverging patterns; these observations suggest effects of downdraft of extreme intensity (see Fig. 6). Very recently Fujita confirmed, through an extensive aerial mapping, that 25 downbursts caused \$50 million damage to trees in northern Wisconsin on 4 July 1977. The damage swath was 267 km long and 27 km wide and did not show any sign of a tornado in it.

FIG. 6. A diverging pattern of tree damage near Beckley, N.C. Damage was probably caused by an intense downburst descending on the forest on 3 April 1974. (Photo by Fujita; taken from Cessna 172.)

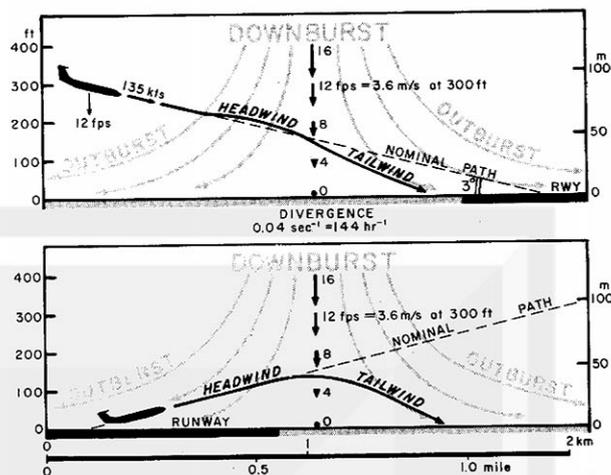
Since the vertical current of the downburst spreads out in the form of an outburst, a landing aircraft will first encounter a headwind, then a downburst, and finally a tailwind (see Fig. 7). A similar sequence of headwind, downburst, and tailwind will be experienced by a climbing aircraft immediately after the liftoff. In either case, the aircraft could most likely fly out of the danger, provided that the intensity of the draft cell is that of a downdraft. When a downburst is encountered, especially at a crucial moment, the chance of fly-out depends upon various factors, such as the extent and intensity of downburst, the altitude and airspeed, the pilot response, etc.

FIG. 7. Schematic diagrams of flight paths under the influence of a downburst cell.

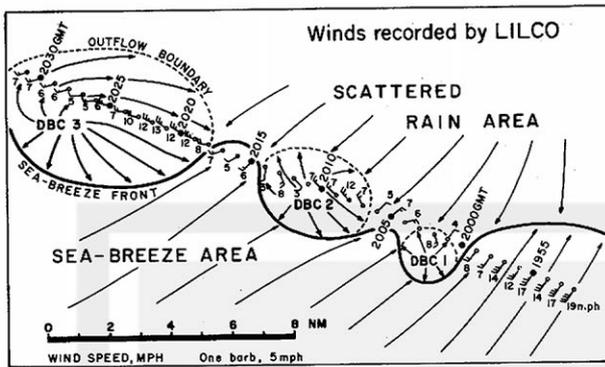
Apparently the downburst cells passed across a meteorological tower with an anemometer at 62.5 m (205 ft), instrumented and operated by the Long Island Lighting Co. The tower is located about ~11 km (7 mi) ESE of the accident site. The time-space conversion of winds reveals the passage of three downburst cells, which had weakened considerably (see Figs. 12 and 13).

FIG. 13. Winds at 62.5 m (205 ft) recorded by the Long Island Light Co. (LILCO) on 24 June 1975. Time-space conversion of the winds reveals the passage of downburst cells (DBC) in weakening stages across the wind tower.

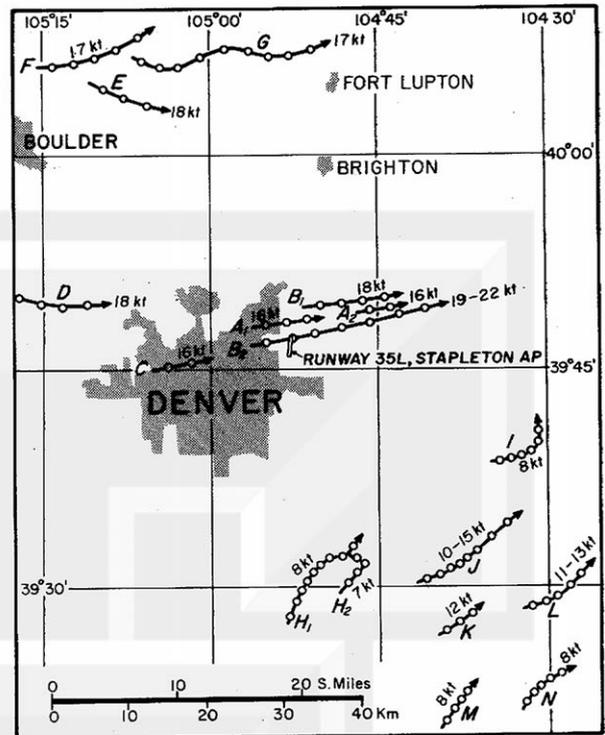
During the afternoon the National Weather Service (NWS) 10 cm radar located at Limon, Colo., observed a number of echoes moving eastward off the Front Range. These echoes did not move uniformly. The echoes to the southeast of the city acted like slow-moving bubbles. Most of them traveled toward the northeast at $3.5\text{--}7.5$ m s^{-1} (7–15 kt). In contrast, the echoes over the Boulder–Ft. Lupton area were moving at $8.5\text{--}9$ m s^{-1} (17–18 kt) along wavy paths (see Fig. 14).

Echoes over the Denver area moved straight, at faster rates than those expected from the motion of neighboring echoes. Echo B, between 1518 and 1544 MDT, sped toward the ENE at $9.5\text{--}11$ m s^{-1} (19–22 kt). Echo A, between 1606 and 1622 MDT, which moved over the accident area, traveled at 8 m s^{-1} (16 kt) along a straight path. Furthermore, the shape of echo A at its mature stage was somewhat like a spearhead, 8 km (5 mi) wide and 16 km (10 mi) long. Later, it changed into two circular cells, one located behind its tip and the other near the rear end.

FIG. 14. Movement of scattered storm echoes near Denver on 7 August 1975 between 1518 and 1622 MDT. NWS radar at Limon, Colo., ~ 130 km (70 n mi) southeast of Denver, took pictures at 5.3 min intervals during this period. Open circles show the echo centroids in each picture.

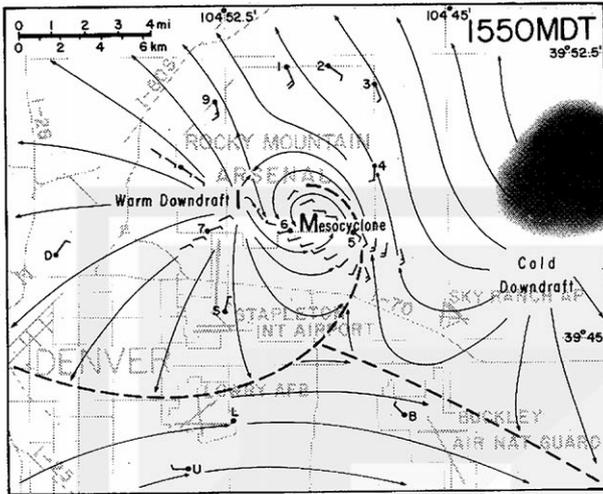
by this network and on echoes recorded by Limon radar. At 1550 MDT, echo B was leaving the mesoanalysis area. There was a center of warm downdraft near the southwest corner of the arsenal. A mesocyclone was swirling slowly where the flow from two downdrafts met (see Fig. 18).

FIG. 18. Mesoanalysis map for 1550 MDT, 7 August 1975. A small mesocyclone is seen on the south boundary of Rocky Mountain Arsenal.

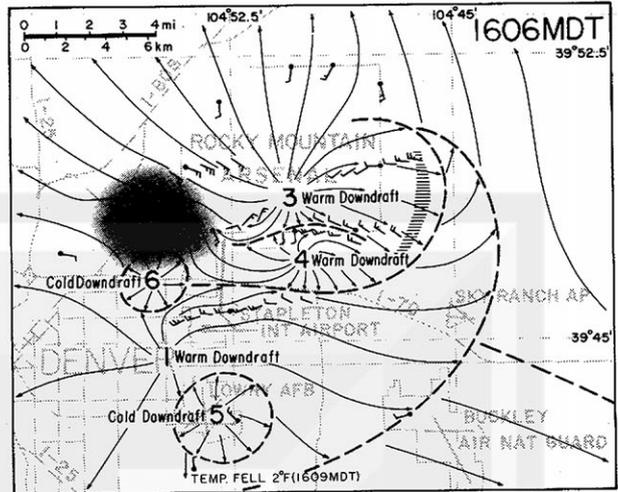
By 1606 MDT, a new downdraft, No. 4, descended to the south of No. 3, resulting in a distinct convergence line along the outflow boundary. The echo to the south of Station U disappeared, leaving a cold downdraft, No. 5, centered over Lowry Air Force Base. A circular echo, ~5 km (3 mi) in diameter, formed where the downdraft air was converging. We may suspect that the echo was producing a cold downdraft, No. 6, near its southern edge. Braniff 67 took off 1 min before this map time, whereas Frontier 509 lifted off 2 min later. Both aircraft were probably unaware of the development of cell No. 6 into a downburst (see Fig. 21).

FIG. 21. Mesoanalysis map for 1606 MDT, 7 August 1975. A circular echo formed over the area of surface convergence. The area of 10 m s^{-1} (20 kt) or stronger wind is hatched.

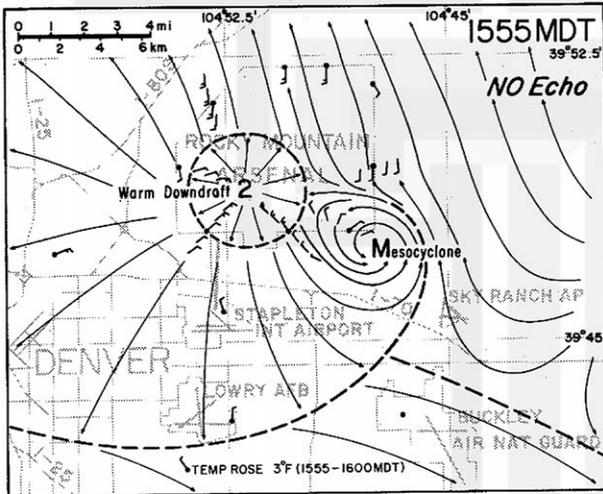
Between 1555 and 1600 MDT, air temperature at Station U rose 1.7°C, indicating that the flow from downdraft 1 was warm. Meanwhile, a warm downdraft, No. 2, began spreading out in all directions (see Fig. 19).

FIG. 19. Mesoanalysis map for 1555 MDT, 7 August 1975. A warm downdraft formed while the mesocyclone weakened.

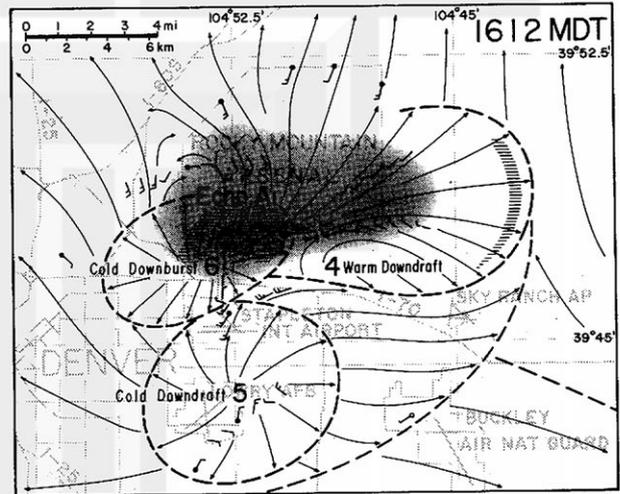
FIG. 22. Mesoanalysis map for 1612 MDT, 7 August 1975. The circular echo changed into a spearhead echo that extended rapidly toward the east. Areas of 10 m s^{-1} (20 kt) or stronger winds are hatched.

now took the shape of a spearhead, extending rapidly toward the east. A few minutes later, the echo changed into two circular echoes interconnected by a weak echo (see Fig. 22).

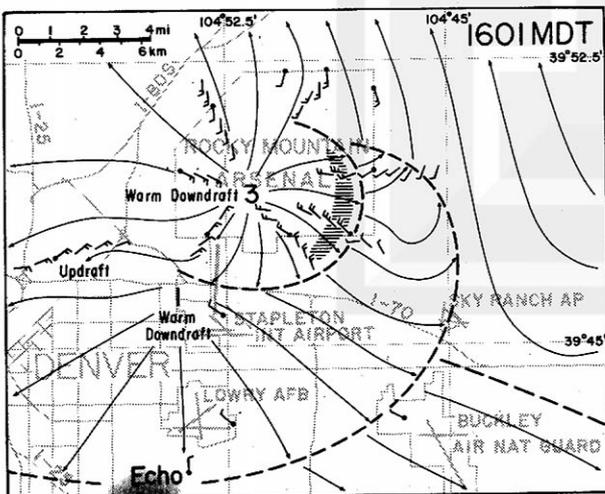
Then a much stronger downdraft, No. 3, overtook the old one. At 1601 MDT, it was characterized by a first gust line located only along the eastern boundary. There was no radar echo associated with downdrafts 1, 2, and 3, which apparently had descended at the same spot, one after another. A small echo was approaching Dr. Jordan's stations, U and L (see Fig. 20).

FIG. 20. Mesoanalysis map for 1601 MDT, 7 August 1975. The warm downdraft spread out, especially toward the east. The area of 10 m s^{-1} (20 kt) or stronger wind is hatched.

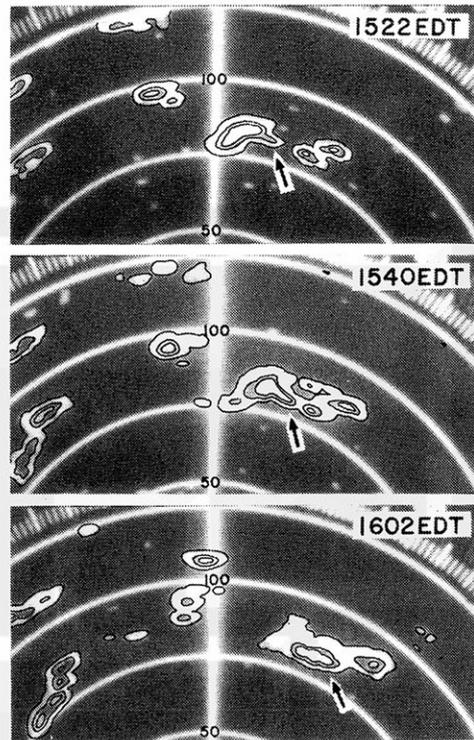
A spearhead echo, in its mature stage, is not a pendant to a larger parent echo. Instead, the whole echo takes the shape of a spearhead when observed by radar from a long distance, such as 148 km (80 n mi) (JFK thunderstorm), 130 km (70 n mi) (Stapleton thunderstorm), and 204 km (110 n mi) (Philadelphia thunderstorm). They are relatively small echoes with an appearance of harmless air-mass showers (see Fig. 25).

FIG. 25. Contour representation of the spearhead echo near JFK on 24 June 1975. The formative stage is seen in the picture at 1522 EDT. At 1540 EDT, the parent echo is being drawn into the spearhead section. Finally, at 1602 EDT, 3 min before the accident, the parent echo was absorbed entirely into the spearhead echo.

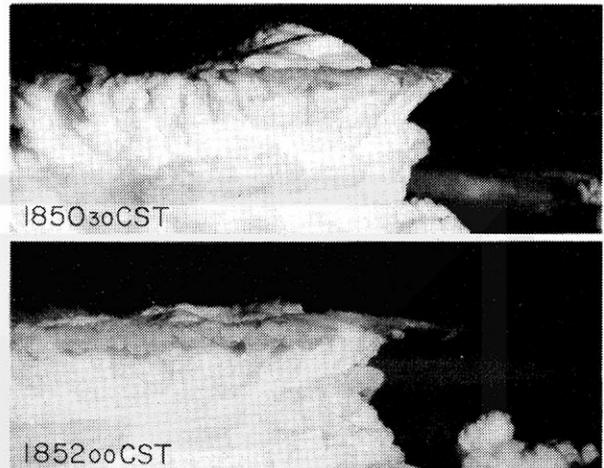
Although a number of fast-collapsing tops, such as those in Fig. 29, have been documented during the past few years, some meteorologists are skeptical as to the mechanism of an air current descending from anvil-top level all the way to the ground because it has been postulated that most downdrafts originate inside storm clouds.

FIG. 29. Collapse of an overshooting dome within 1.5 min. Sometimes a large, tall dome collapses so fast, as in this case, that the skin of the anvil is pushed outward. The collapsed dome descends into the anvil and the hole is filled gradually. (Pictures taken near San Antonio, Tex., on 6 May 1973; from Fujita (1974).)

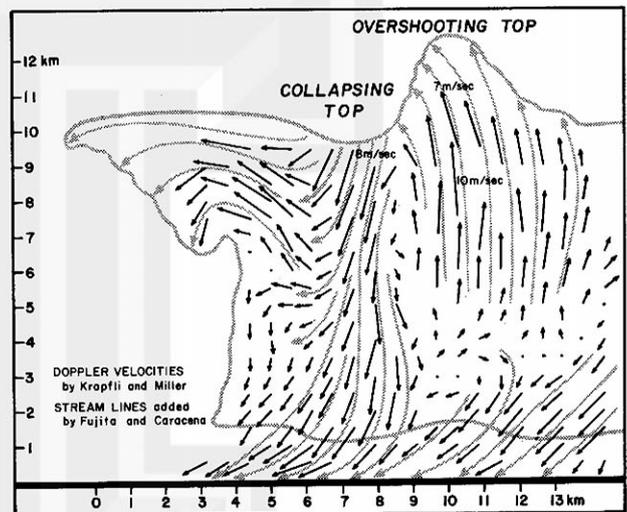
in Fig. 30). This cross section strongly suggests a possibility of experiencing a downburst beneath a fast-collapsing cloud top. In other words, the occurrence of downbursts might not be as rare as had been thought. Their short lives, coupled with small areas, would have escaped detection and subsequent reporting for awareness and preparedness.

FIG. 30. A vertical cross section of Doppler velocities inside a 28 July 1973 thunderstorm in Colorado. Dual-Doppler velocities were obtained by Kropfli and Miller (1976). (Original data obtained through personal communication.) Both cloud boundary and streamlines were added by the authors.

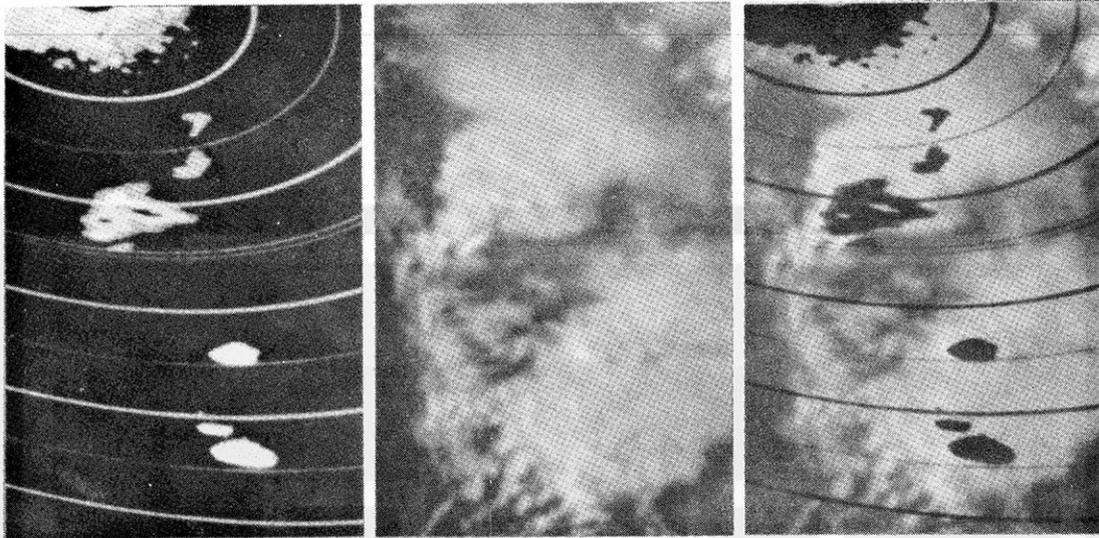
On 6 May 1975, NWS Kansas City radar depicted a spearhead echo located ~185 km (100 n mi) away. Meanwhile, the SMS/GOES satellite took pictures, looking down from a geostationary altitude 40 700 km (25 300 mi) above the equator (see Fig. 31). One of the Learjets on the University of Chicago-NASA research mission took cloud-top pictures of this spearhead echo while flying at 13.7 km (45 000 ft). The picture sequence revealed that the overshooting in the echo area was very significant.

FIG. 31. A spearhead echo of 6 May 1975. Radar echo at 1722 CDT (left), SMS/GOES picture at 1722 CDT (center), and their combination (right).
