Streamwood Microburst

Final Report to NCAR
NSF/UCAR Grant S9129

WRL Report 236

Streamwood Microburst of

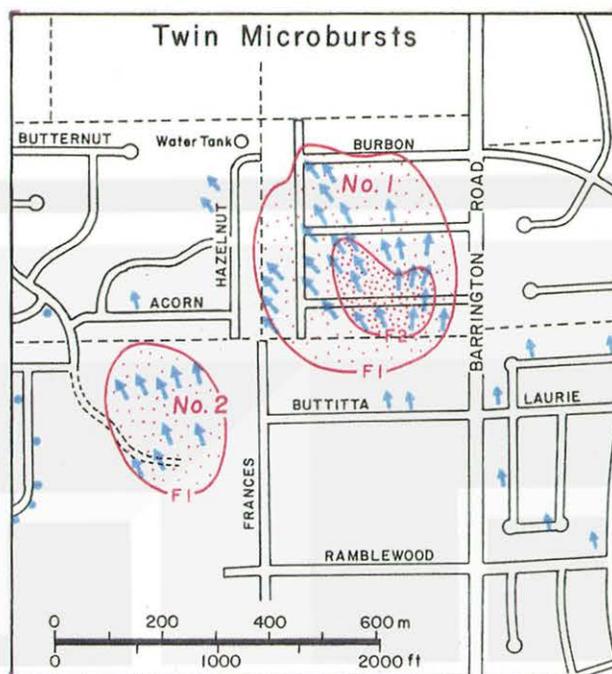
Fig. 1 Twin Microbursts No.1 and No.2 which descended in Streamwood over the industrial park and over a small forest, respectively.

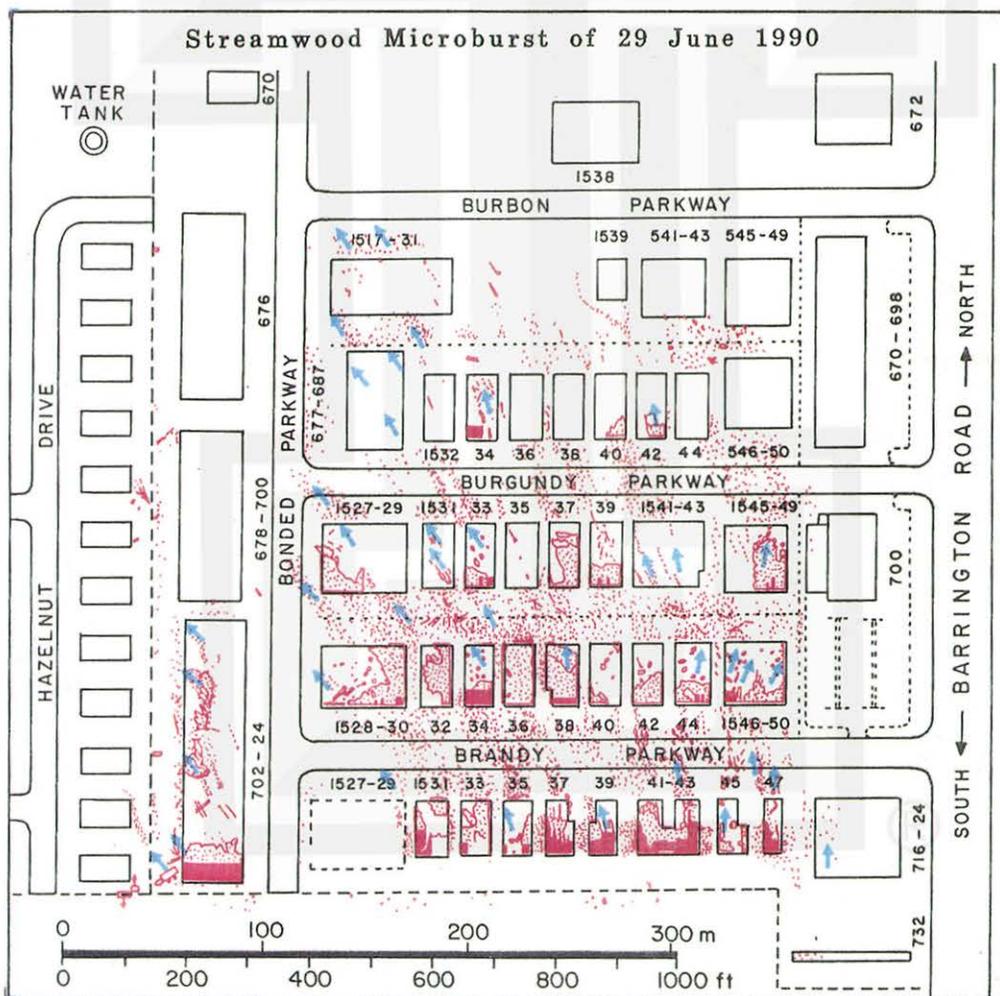
In order to substantiate the nature of the microburst winds, both direction and speed, five aerial photographs, A through F, used in producing the damage map (Fig. 2) were located on the detailed map of the industrial park. The overall photo A (Fig. 3) reveals the abrupt increase in the southerly winds at the south edge of the industrial park. Photos B and C show the southwest section of the industrial park damaged by the 100 to 120 mph winds from the south-southeast (Figs. 4 and 5).

Fig. 2 Detailed damage map of the industrial park.

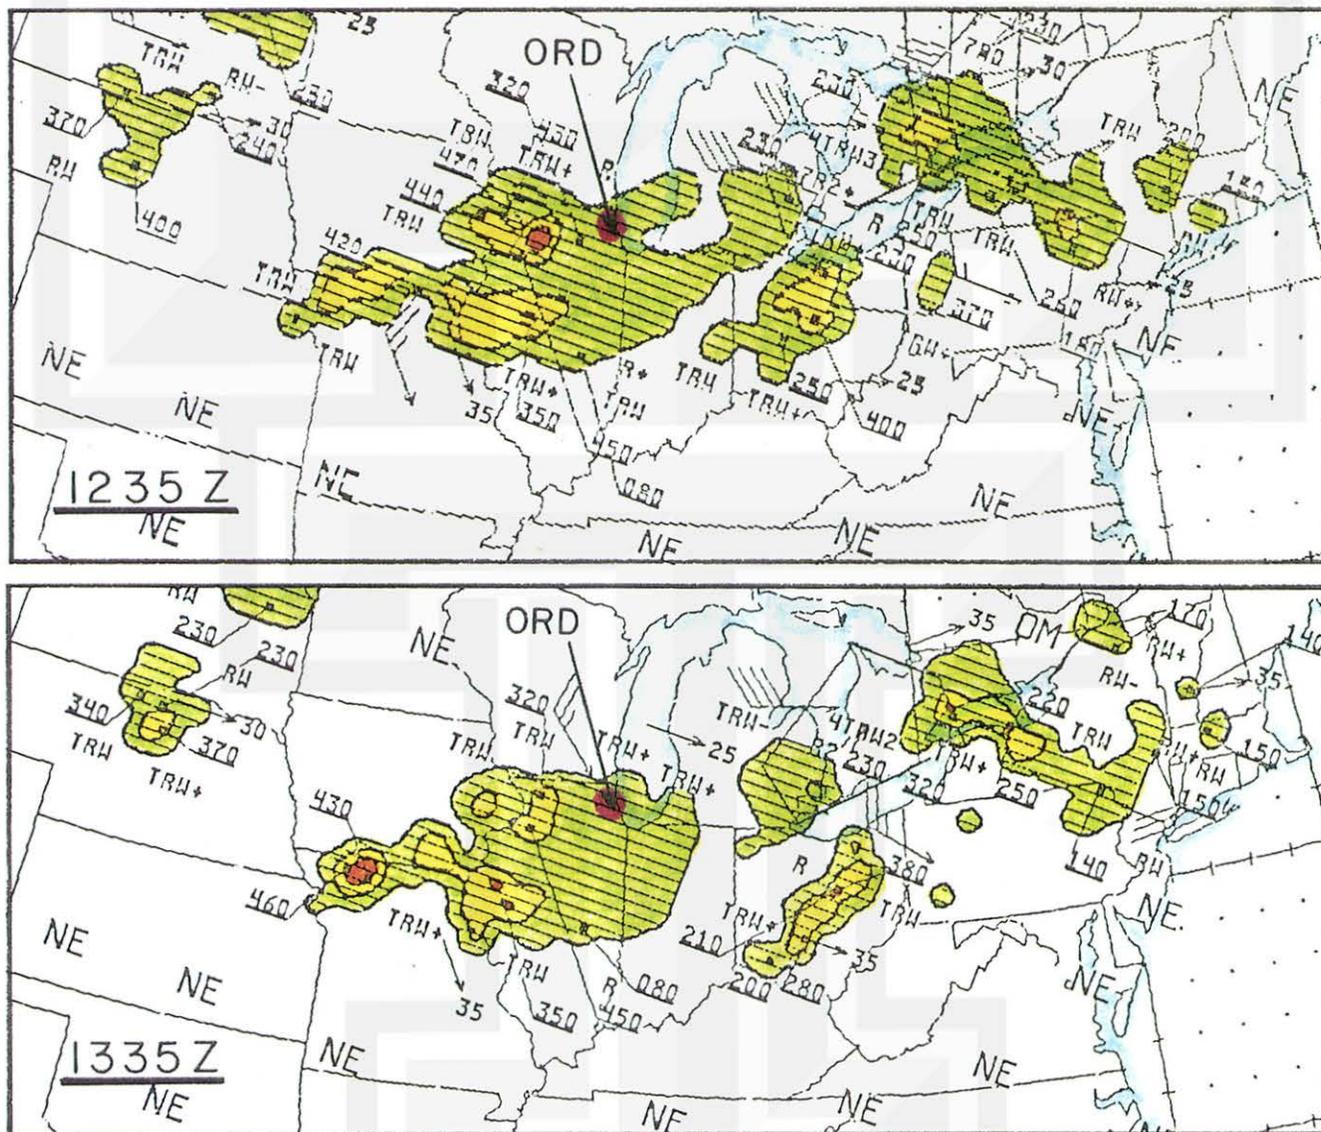
The national radar summary (Fig. 19) also confirms the weather condition. In spite of the radar summary, pilot reports on localized severe winds began at about 1300 GMT (8 a.m. CDT). These reports consisted of severe downdrafts, waterspouts over Lake Michigan, severe turbulence, etc. Selected reports are listed below:

Fig. 19 National radar summary maps at 1235 and 1335 GMT, approximately 30 minutes before and after the microburst time at 1309 GMT.

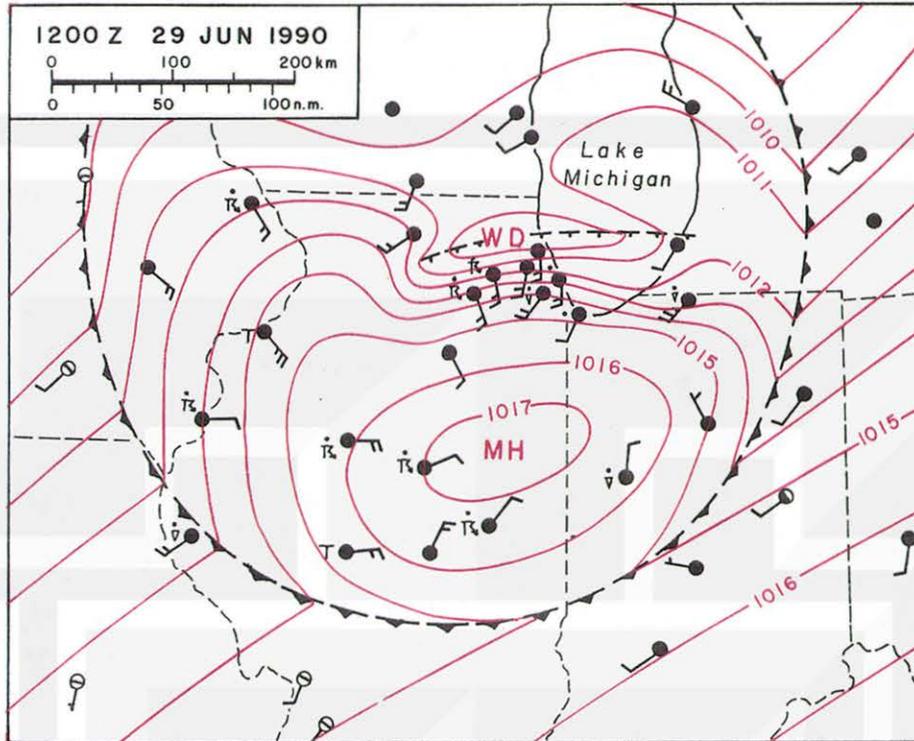
Fig. 20 The parent mesohigh (MH) of the Streamwood microbursts located over east-central Illinois at 1200 GMT. The wake depression (WD) was moving toward the O'Hare area.

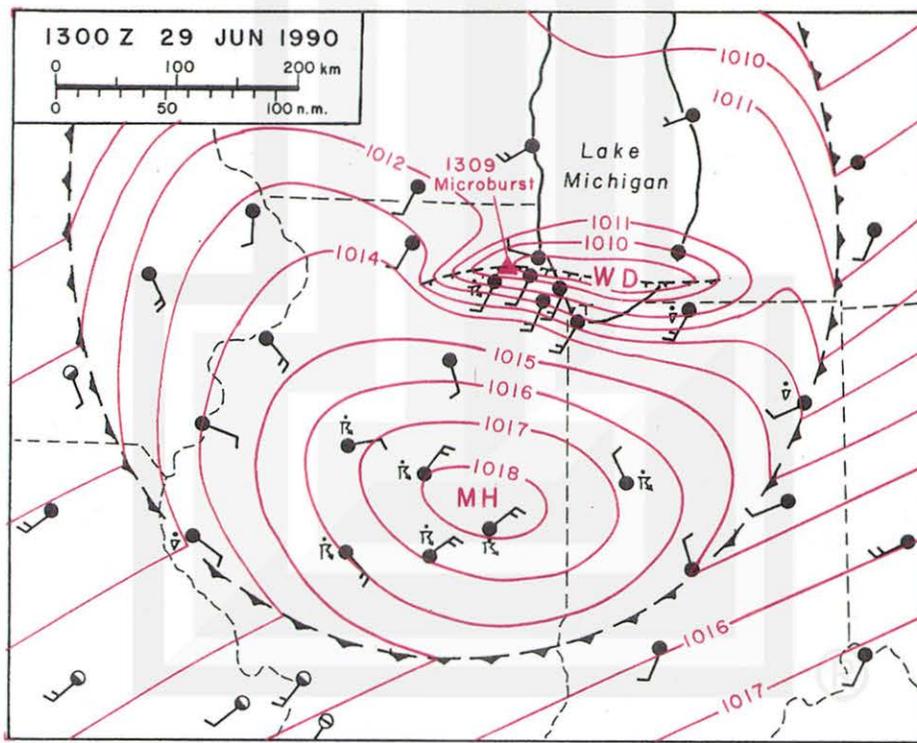
Fig. 21 The wake depression at 1300 GMT several minutes before the onset of the microbursts.

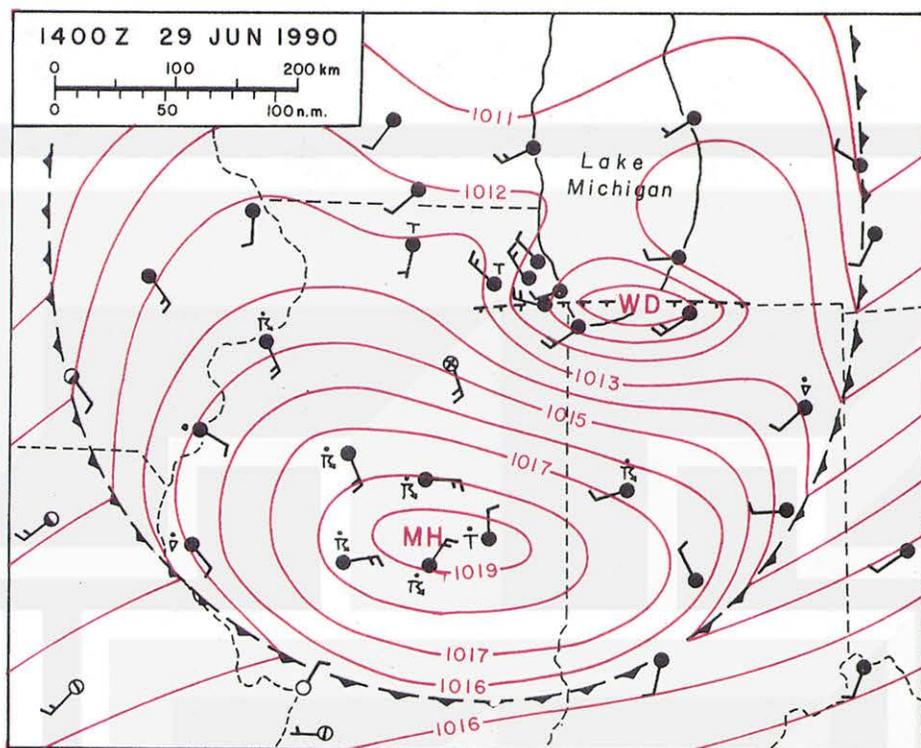
Fig. 22 Surface chart approximately one hour after the Streamwood microbursts.

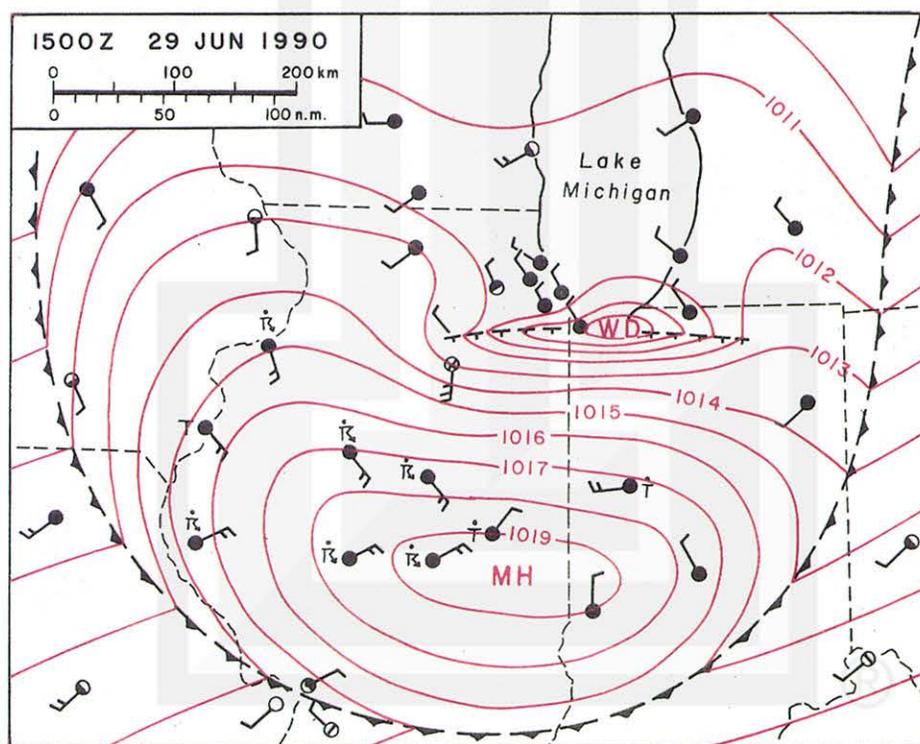
Fig. 23 The MH-WD complex at 1500 GMT, 2 hours after the microbursts.

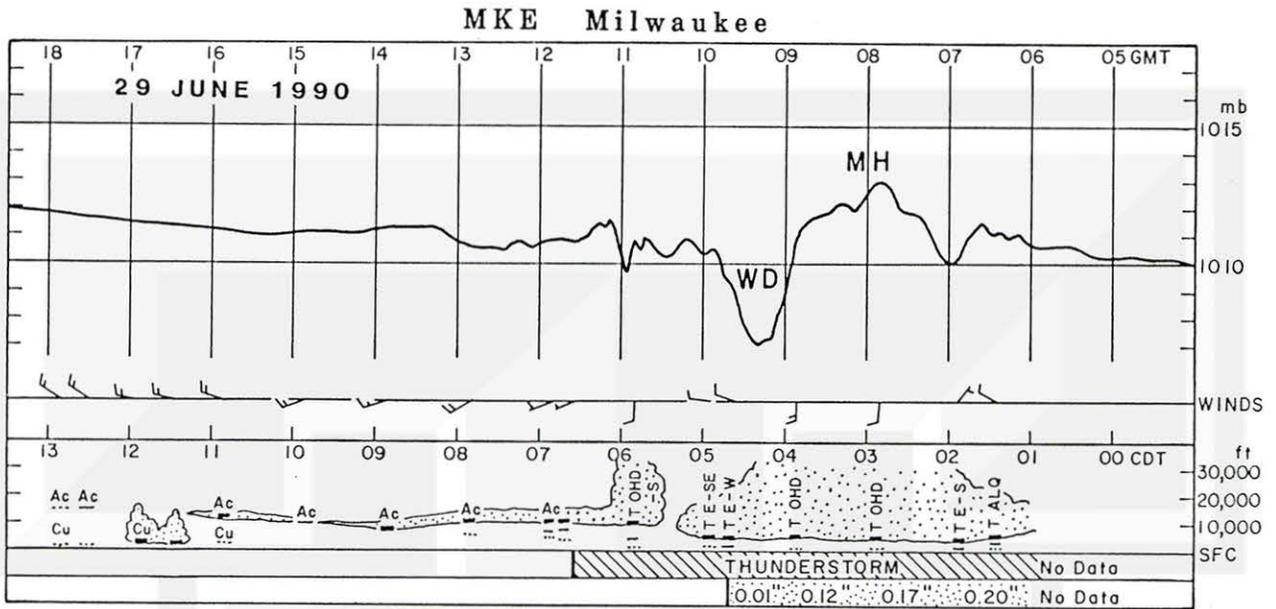
The wake depression at Milwaukee lasted for about one hour during which a 4-mb pressure drop and recovery took place (Fig. 24). At O'Hare airport, located 21 km (13 miles) east-southeast of Streamwood, the WD was characterized by two major pressure drops and two minor drops inside the second major drop. Because the O'Hare barograph was located too far from the microburst area, it is hard to relate these pressure variations with the microburst events. Nevertheless, the microburst time corresponds to that of the first minor pressure drop within the second major drop (Fig. 25). In view of the fact that a microburst is usually associated with a small pressure rise, rather than a dip, the Streamwood microburst could have been associated with a small dome of high pressure seen at the bottom of the second major pressure drop recorded at O'Hare. The time of the small pressure dome was 1315 GMT, 6 minutes later than the microburst time. This time difference could occur due to the distance between the locations of the barograph and microbursts.

Fig. 24 The time cross section of the meteorological parameters from Milwaukee, Wisconsin.

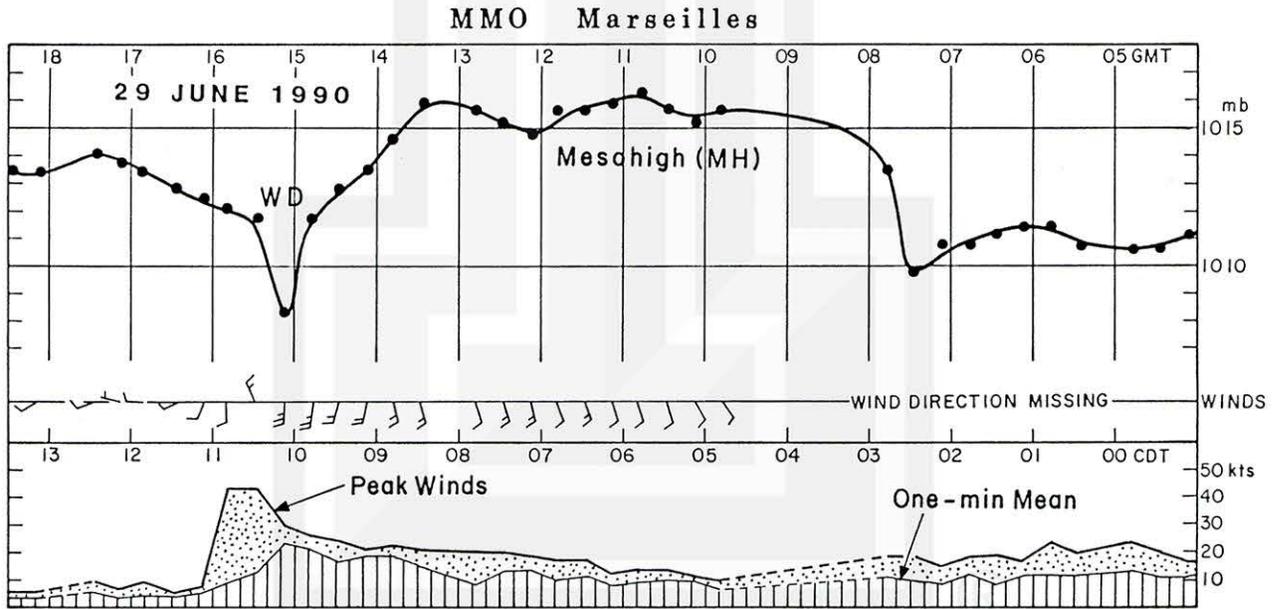
Fig. 29 Time cross section at Marseilles Radar station. It should be noted that peak winds are very high during the recovery period of the wake depression.

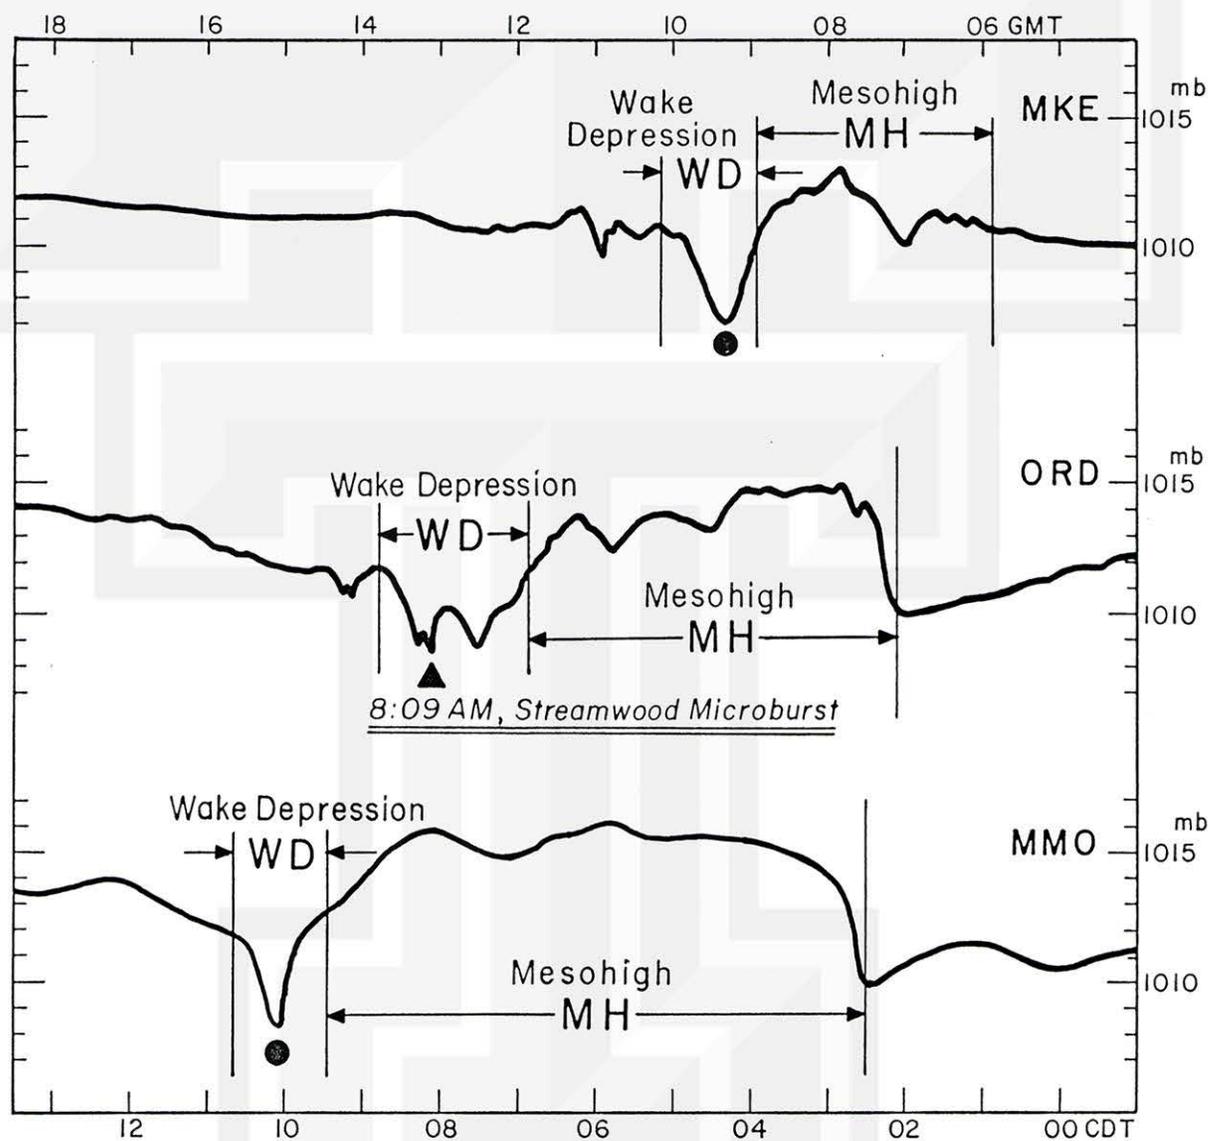
Pressure variations at Milwaukee, O'Hare, and Marseilles (Fig. 34) reveal the progressive increase in the central pressure of MH and its duration. This is usual because the pressure dome of an MH is caused mainly by the accumulation of the cold air generated by successive thunderstorms located inside the region of an MH. As in other cases, the WD traveled at much slower speed than its parent MH. It should be noted that a small pressure dome was not recorded at Milwaukee where no microburst was reported.

Fig. 34 Pressure variations at Milwaukee, Wisconsin, O'Hare airports, and Marseilles Radar station showing the propagation of the wake depression in which the Streamwood microbursts occurred. Because of the 21-km distance between Streamwood and O'Hare airport, it is hard to decide if the microbursts occurred at the time of the pressure dip or the small pressure dome.

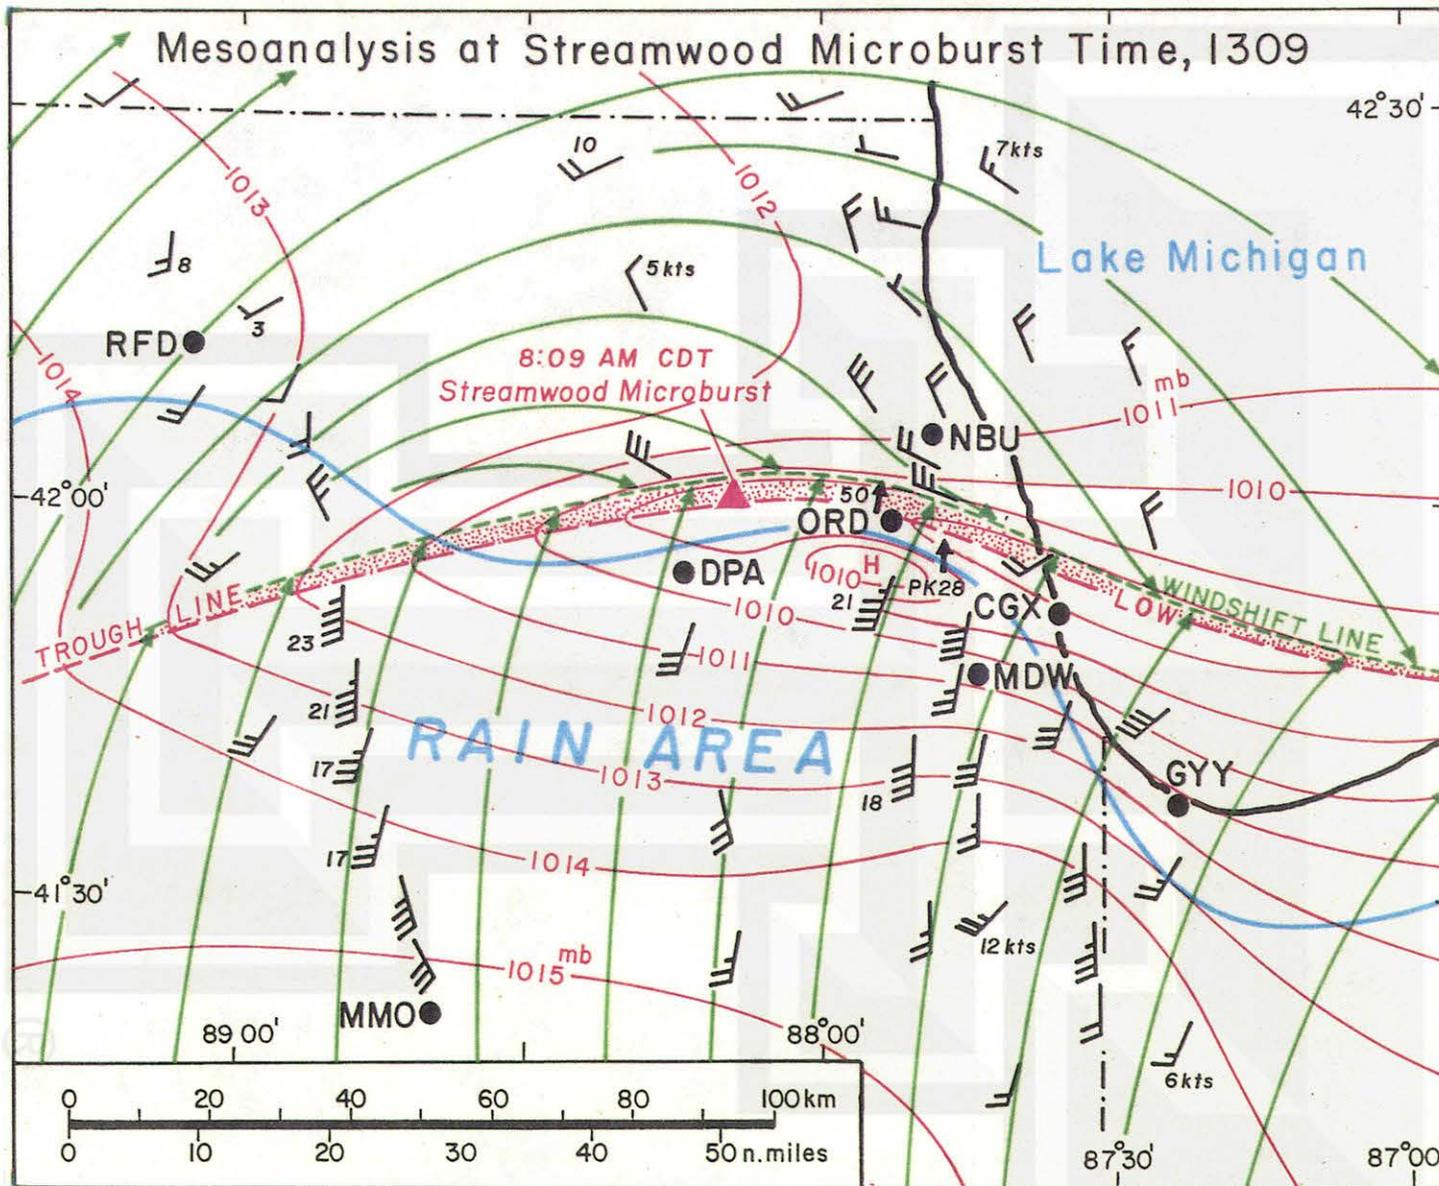
The four-color surface map in Fig. 35 presents a distinct windshift line along the trough line of the wake depression. Seen to the north of the windshift line are weak northwesterly winds which moved down along with the progressive southward movement of the windshift line. The southerly winds on the south side of the windshift line were very strong, with the 50 kt peak wind reported at O'Hare at 1329 GMT, some 20 minutes after the microburst time. These high winds are the outflow from the thunderstorm complex inside the vast area of the mesohigh.

This mesoanalysis suggests that the strong southerly winds crossed the trough line of the wake depression, resulting in the up-gradient winds on the north side of the trough line. In other words, the southerly winds, by virtue of its large horizontal momentum, along with the cool temperature of the outflow air, kept pushing northward while undercutting the northwesterly wind blowing toward the trough line. The zone of the expected up-gradient winds in the mesoanalysis map is stippled. Unfortunately, no wind reports are available to determine the nature of the up-gradient flow. The Marseilles winds (Fig. 29) reveal, however, that the peak winds are significantly higher than the mean winds in the up-gradient zone, suggesting that it could be a zone of turbulent winds.

This evidence indicates that the microbursts occurred inside the narrow zone of the up-gradient winds to the north of the trough line of the advancing wake depression. Because the up-gradient winds are strong, the parent downdraft descending into the turbulent southerly could receive an additional momentum in deviating and accelerating the microburst winds northward. Needless to say, the Streamwood microburst was entirely different in mechanism from those studied during NIMROD (1978), JAWS (1982), and MIST (1986) in which Fujita was involved.

Fig. 35 A mesoanalysis surface map produced by converting time sections into spatial data. A narrow zone between the trough line of the wake depression and the windshift line is stippled in red. It is likely that the strong southerly winds pushed northward against the adverse pressure gradient.
