MESOSCALE DAMAGE PATTERNS OF HURRICANE FREDERIC IN RELATION TO ENHANCED SMS IMAGERY

T. Theodore Fujita, Roger M. Wakimoto, and Duane J. Stiegler

The University of Chicago
Chicago, Illinois

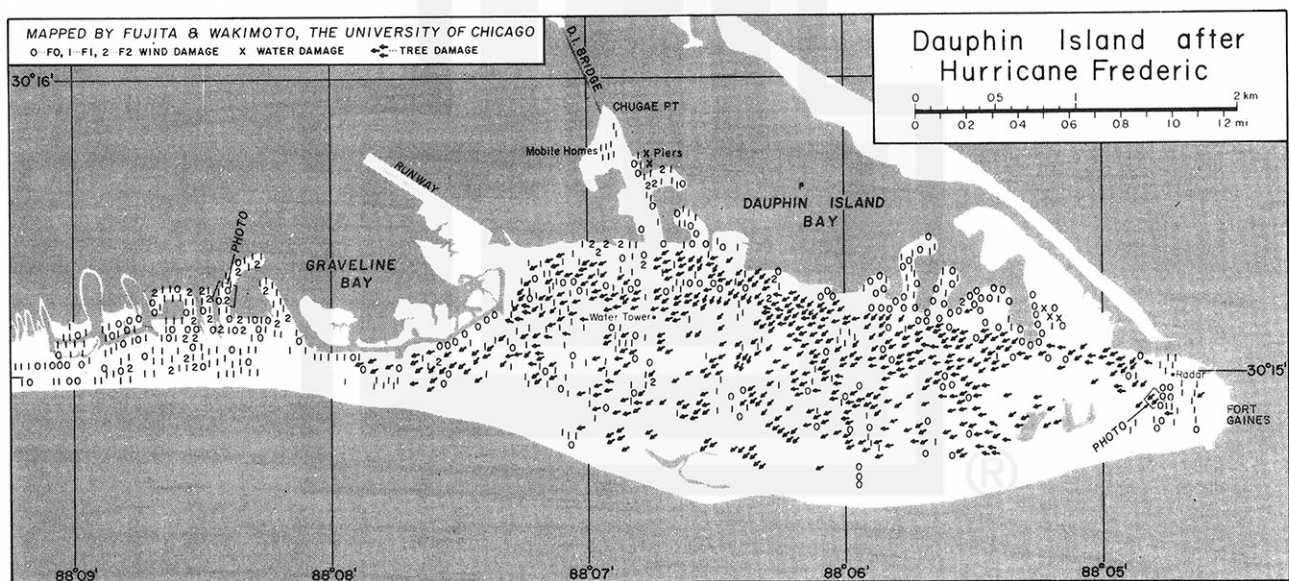
Figure 4. Dauphin Island map.

Aerial photos by Fujita and by NHEML and a ground survey by Wakimoto and Stiegler were the basis for assessing the wind damage on Dauphin Island (see Figure 4).

Numerous summer and year round houses are located along the shore line south of the island. Most of these houses escaped water damage because of the building code established after Hurricane Camille of 1969, which stated that the floor must be 10 feet above the mean high water level (see Figures 5A and 5B).

Wind effects on the beach houses were minimal, and were rated from aerial surveys as being F0 or F1. If there were no recorded wind traces from the Dauphin Island Sea Lab and bridge, the estimated wind speeds based on the damage would have been less than 100 mph.

Dauphin Island provided an excellent example of estimating peak windspeeds based on hurricane damage. An F-scale assessment of 775 frame houses on the island was made from the air (see Figure 3). The resulting breakdown by scale is: 37% F0, 56% F1, and 7% F2.
