# **Streamwood Microburst of**

**29 June 1990**

**by T. Theodore Fujita**

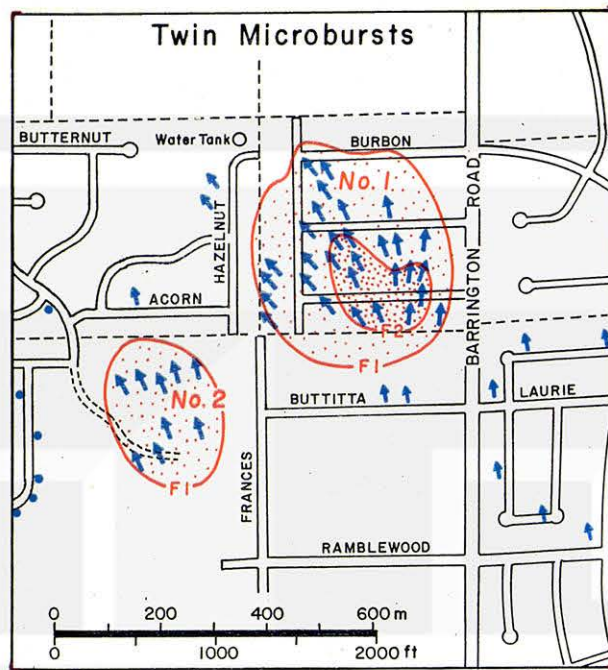
This study revealed that there were two microbursts in Streamwood, Illinois in the early morning of 29 June. They are identified as No.1 over the industrial park and No.2 over a nearby forest. The former was rated as F2 with estimated 130 mph maximum windspeed and the latter, as F1 with estimated windspeed of 90 mph. The average horizontal dimensions were 400 m (1,300') and 250 m (800'), respectively (Fig. 1). They were rather small in size, but Microburst No.1 could endanger aircraft operations at critical altitude by reducing IAS down to less than 50 kts if it occurs at the wrong time at the wrong location.

Fig. 1 Twin Microbursts No.1 and No.2 which descended in Streamwood over the industrial park and over a small forest, respectively.

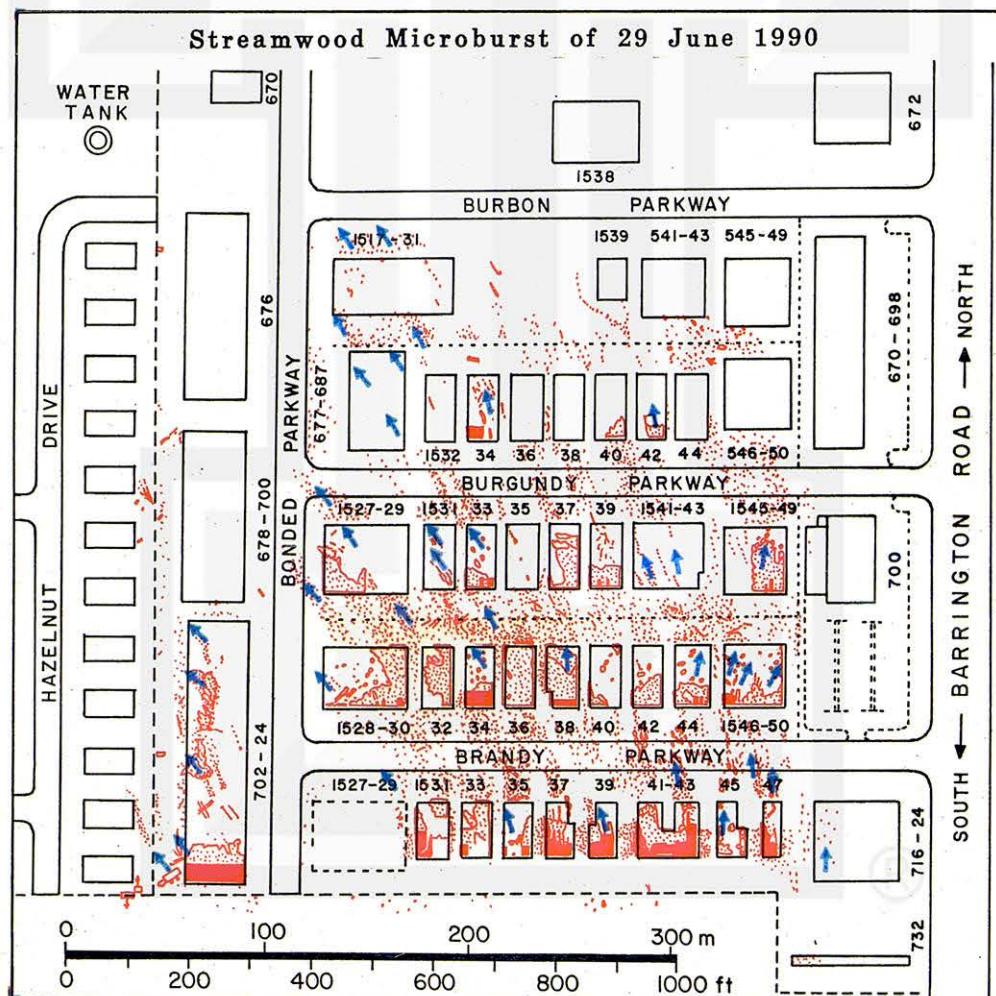
In order to substantiate the nature of the microburst winds, both direction and speed, five aerial photographs, A through F, used in producing the damage map (Fig. 2) were located on the detailed map of the industrial park. The overall photo A (Fig. 3) reveals the abrupt increase in the southerly winds at the south edge of the industrial park. Photos B and C show the southwest section of the industrial park damaged by the 100 to 120 mph winds from the south-southeast (Figs. 4 and 5).

Fig. 2 Detailed damage map of the industrial park.

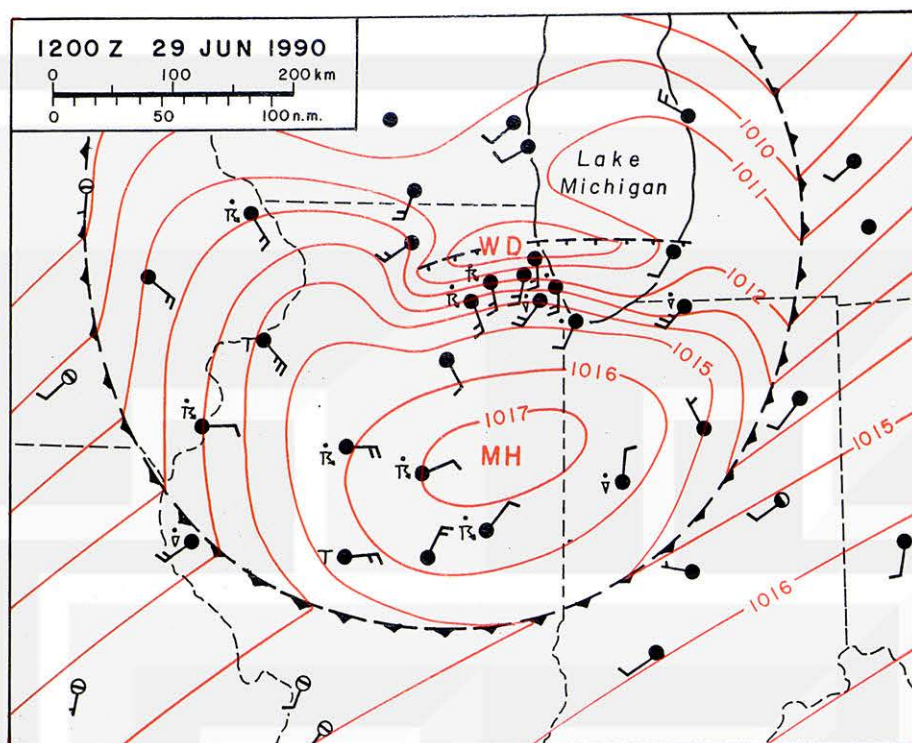
The sequence of four hourly maps clearly show the evolution of the squall-line system consisting of a mesoscale high pressure, mesohigh (MH) and a wake depression (WD). As expected, most thunderstorms occur on the front side of an MH and practically no thunderstorm is expected to occur on the rear side where a WD is located.

Fig. 20 The parent mesohigh (MH) of the Streamwood microbursts located over east-central Illinois at 1200 GMT. The wake depression (WD) was moving toward the O'Hare area.

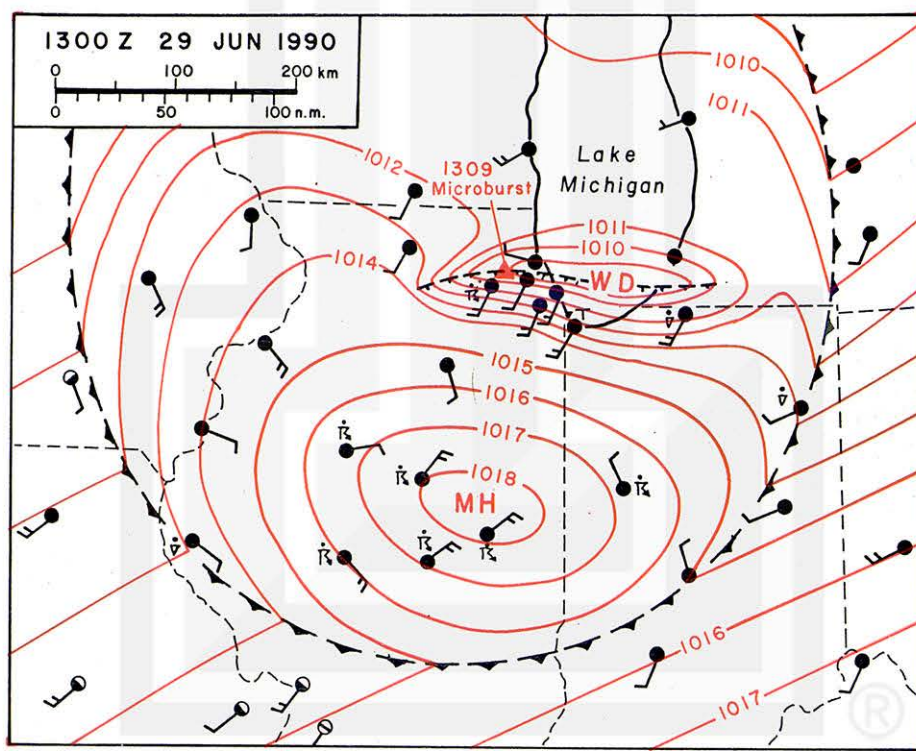
Fig. 21 The wake depression at 1300 GMT several minutes before the onset of the microbursts.

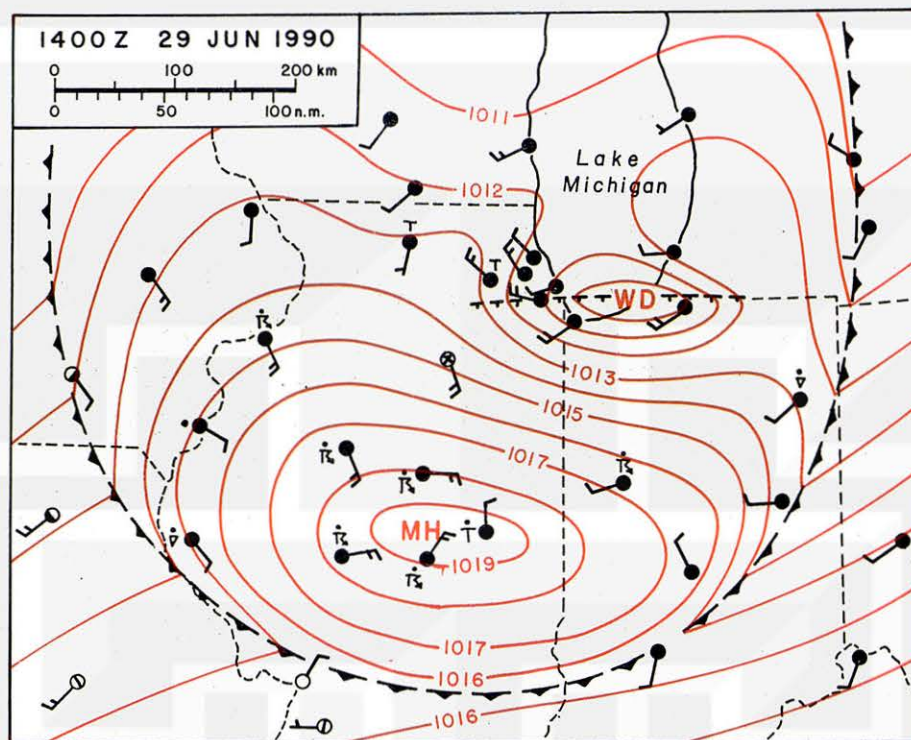
Fig. 22 Surface chart approximately one hour after the Streamwood microbursts.

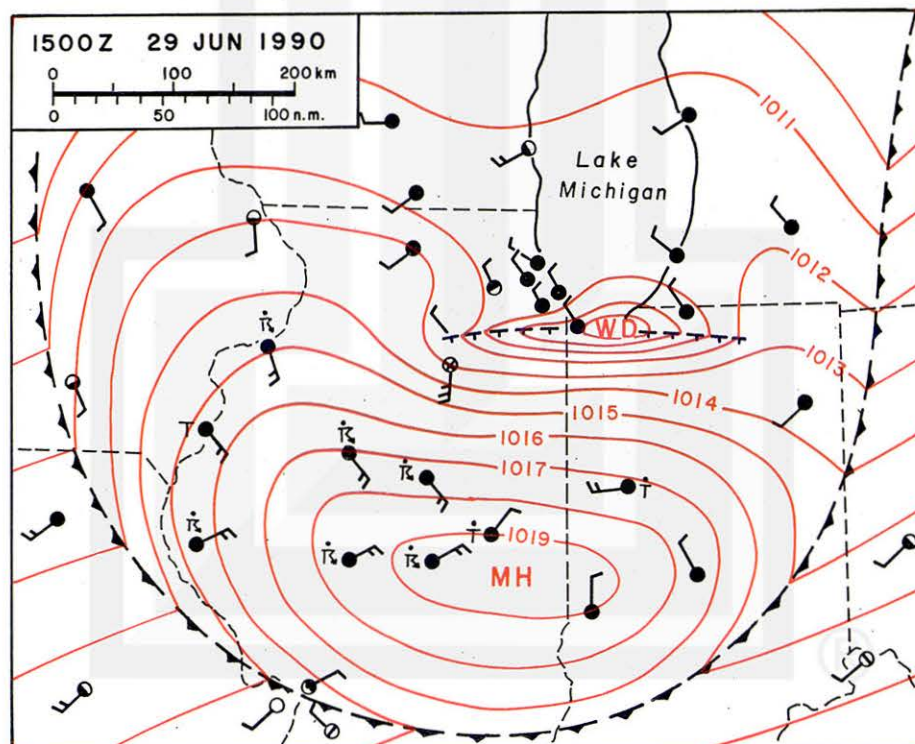
Fig. 23 The MH-WD complex at 1500 GMT, 2 hours after the microbursts.

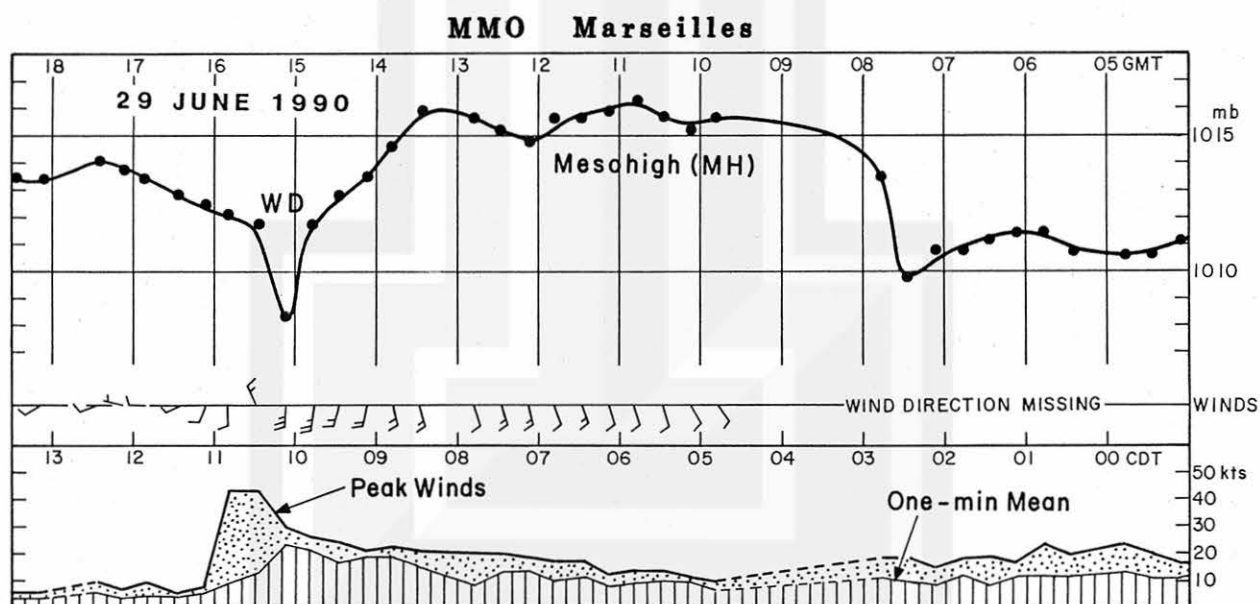
Fig. 29 Time cross section at Marseilles Radar station. It should be noted that peak winds are very high during the recovery period of the wake depression.

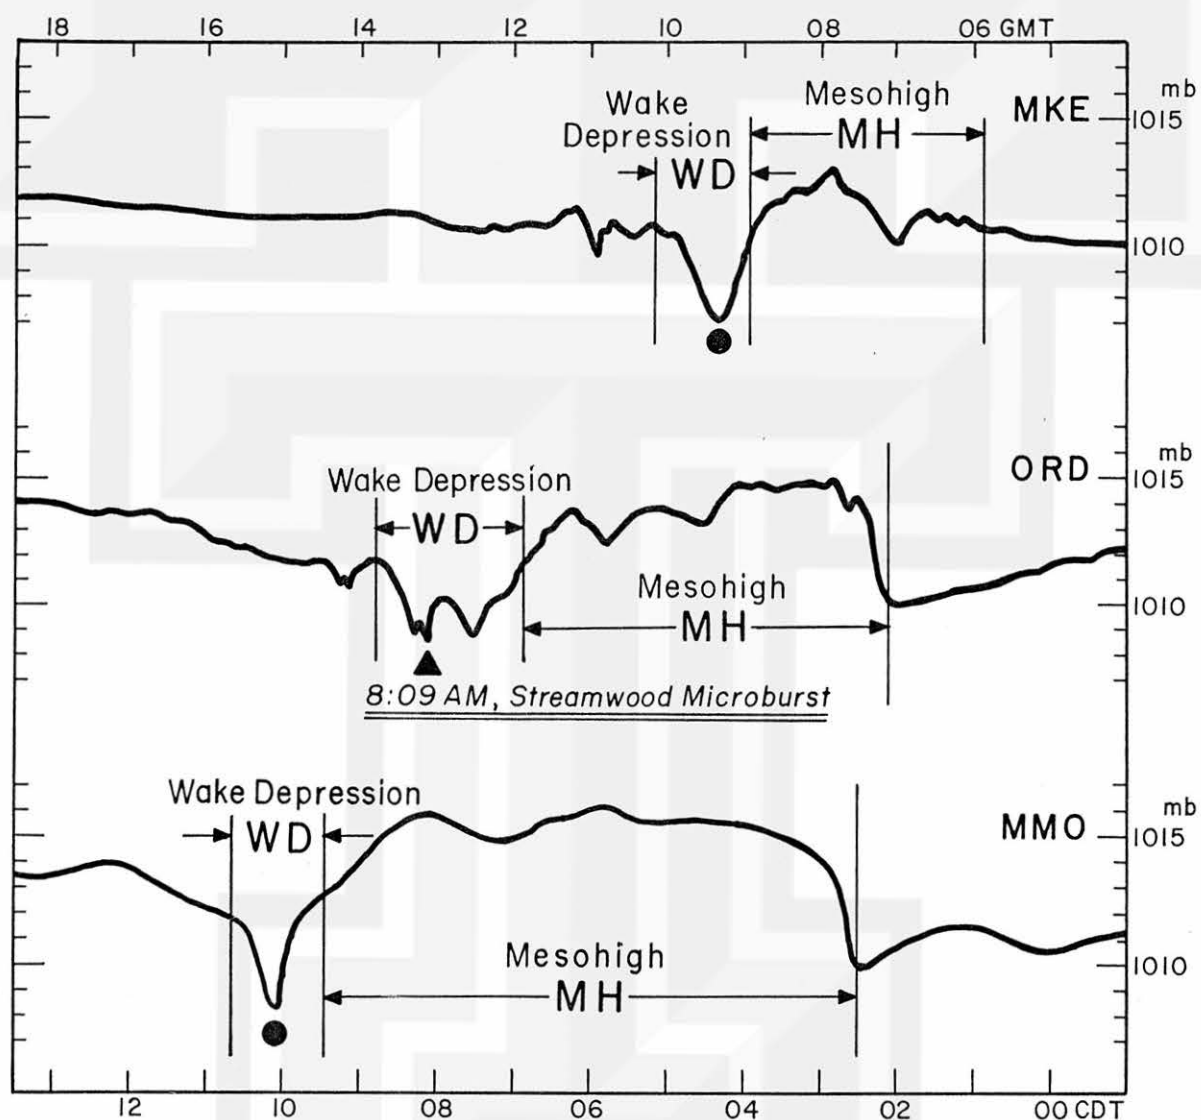
Pressure variations at Milwaukee, O'Hare, and Marseilles (Fig. 34) reveal the progressive increase in the central pressure of MH and its duration. This is usual because the pressure dome of an MH is caused mainly by the accumulation of the cold air generated by successive thunderstorms located inside the region of an MH. As in other cases, the WD traveled at much slower speed than its parent MH. It should be noted that a small pressure dome was not recorded at Milwaukee where no microburst was reported.

**Fig. 34** Pressure variations at Milwaukee, Wisconsin, O'Hare airports, and Marseilles Radar station showing the propagation of the wake depression in which the Streamwood microbursts occurred. Because of the 21-km distance between Streamwood and O'Hare airport, it is hard to decide if the microbursts occurred at the time of the pressure dip or the small pressure dome.

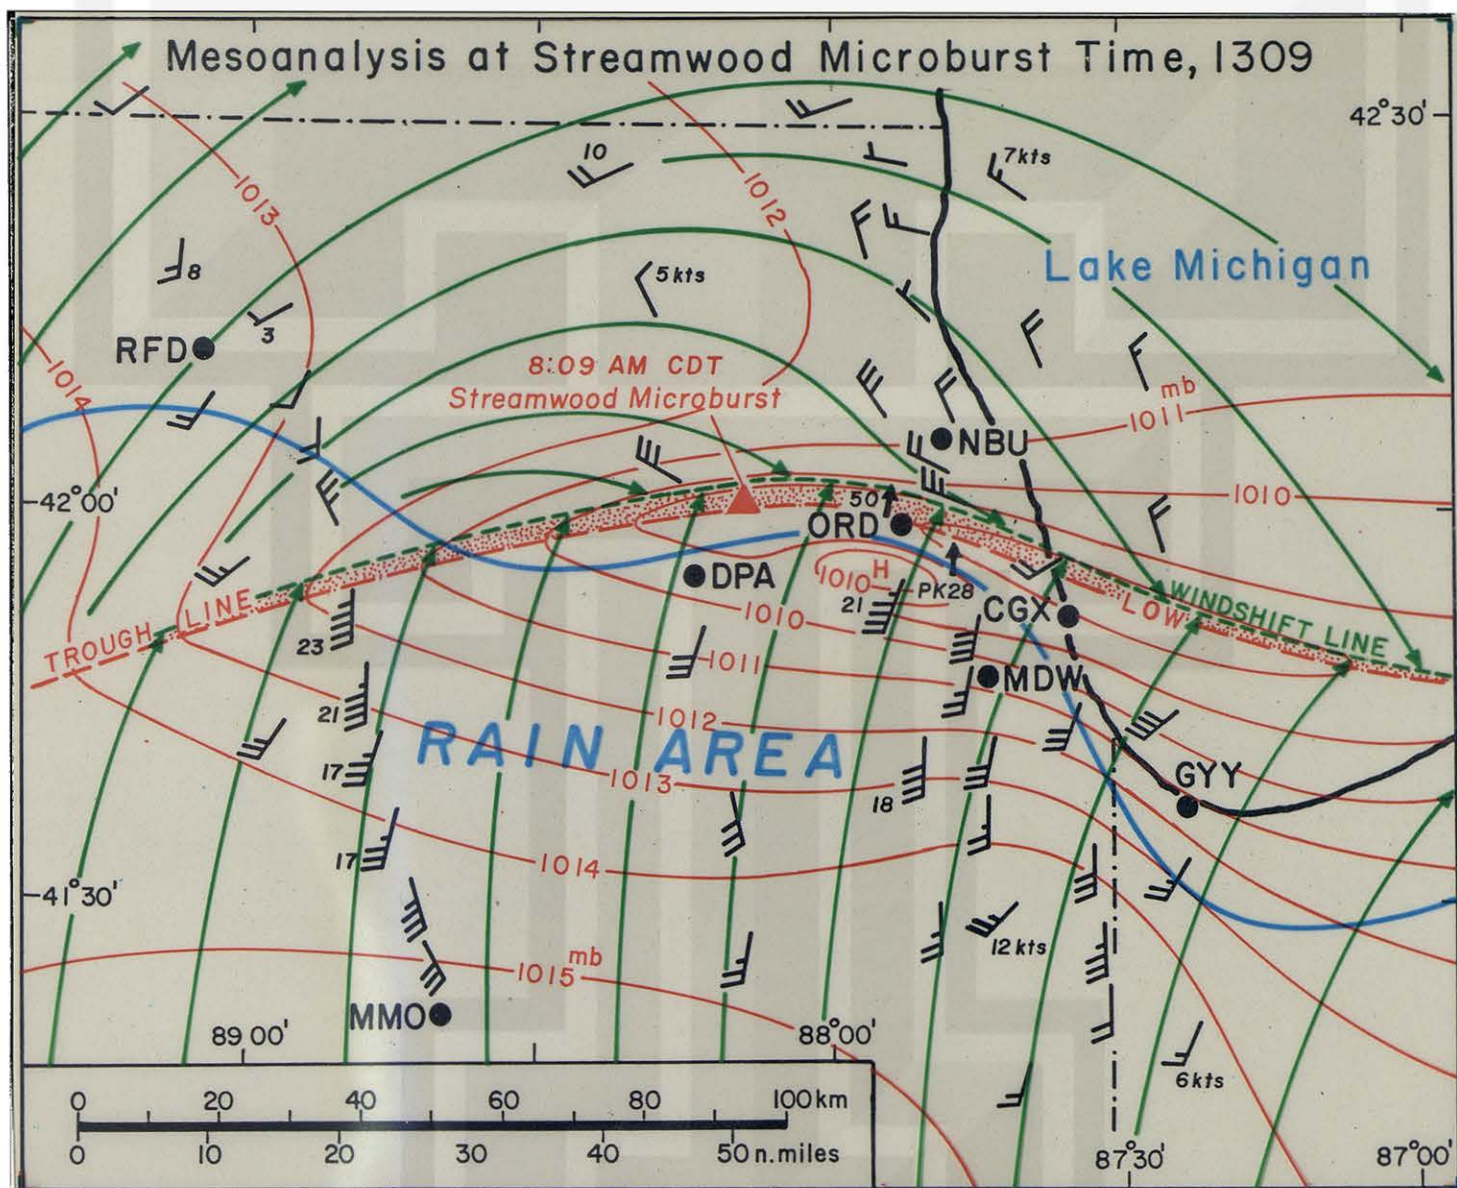
The four-color surface map in Fig. 35 presents a distinct windshift line along the trough line of the wake depression. Seen to the north of the windshift line are weak northwesterly winds which moved down along with the progressive southward movement of the windshift line. The southerly winds on the south side of the windshift line were very strong, with the 50 kt peak wind reported at O'Hare at 1329 GMT, some 20 minutes after the microburst time. These high winds are the outflow from the thunderstorm complex inside the vast area of the mesohigh.

This mesoanalysis suggests that the strong southerly winds crossed the trough line of the wake depression, resulting in the up-gradient winds on the north side of the trough line. In other words, the southerly winds, by virtue of its large horizontal momentum, along with the cool temperature of the outflow air, kept pushing northward while undercutting the northwesterly wind blowing toward the trough line. The zone of the expected up-gradient winds in the mesoanalysis map is stippled. Unfortunately, no wind reports are available to determine the nature of the up-gradient flow. The Marseilles winds (Fig. 29) reveal, however, that the peak winds are significantly higher than the mean winds in the up-gradient zone, suggesting that it could be a zone of turbulent winds.

This evidence indicates that the microbursts occurred inside the narrow zone of the up-gradient winds to the north of the trough line of the advancing wake depression. Because the up-gradient winds are strong, the parent downdraft descending into the turbulent southerly could receive an additional momentum in deviating and accelerating the microburst winds northward. Needless to say, the Streamwood microburst was entirely different in mechanism from those studied during NIMROD (1978), JAWS (1982), and MIST (1986) in which Fujita was involved.

**Fig. 35** A mesoanalysis surface map produced by converting time sections into spatial data. A narrow zone between the trough line of the wake depression and the windshift line is stippled in red. It is likely that the strong southerly winds pushed northward against the adverse pressure gradient.
