Research Paper No.1

Detailed Analysis of Hurricane Andrew of 24 August 1992

ONR Grant N00014-J1136 STORM DATA PROJECT

T. Theodore Fujita, PI

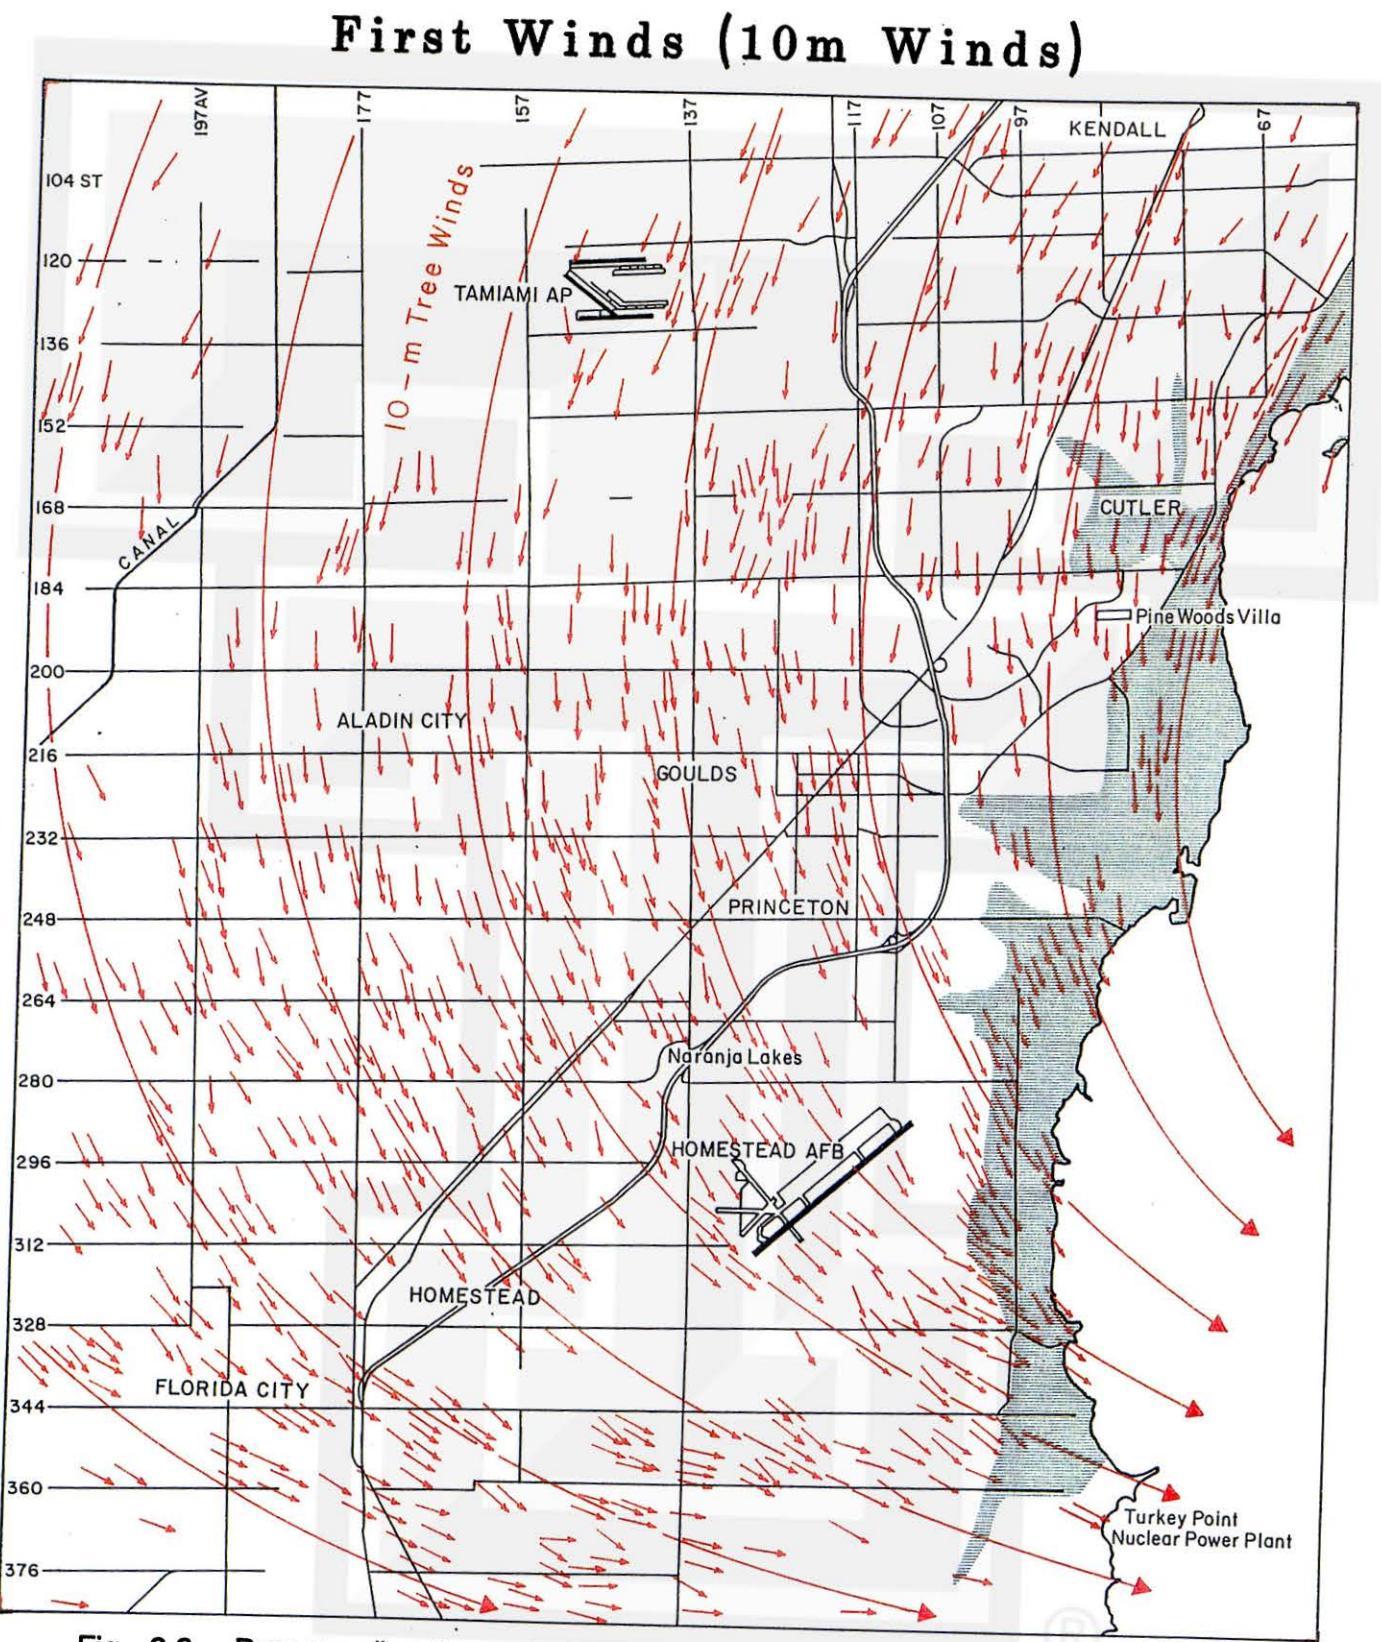
Fujita estimated the flow pattern of Andrew's first winds by determining the fall directions of either uprooted or snapped trees of approximate 10-meter height. As shown in Figure 3.2, the flow pattern is similar to the expected inflow pattern. Converging flows are seen along the shoreline north of the hurricane center.

Fig. 3.2 Damage directions of tall (10 m) trees occurring during the first wind of Hurricane Andrew.

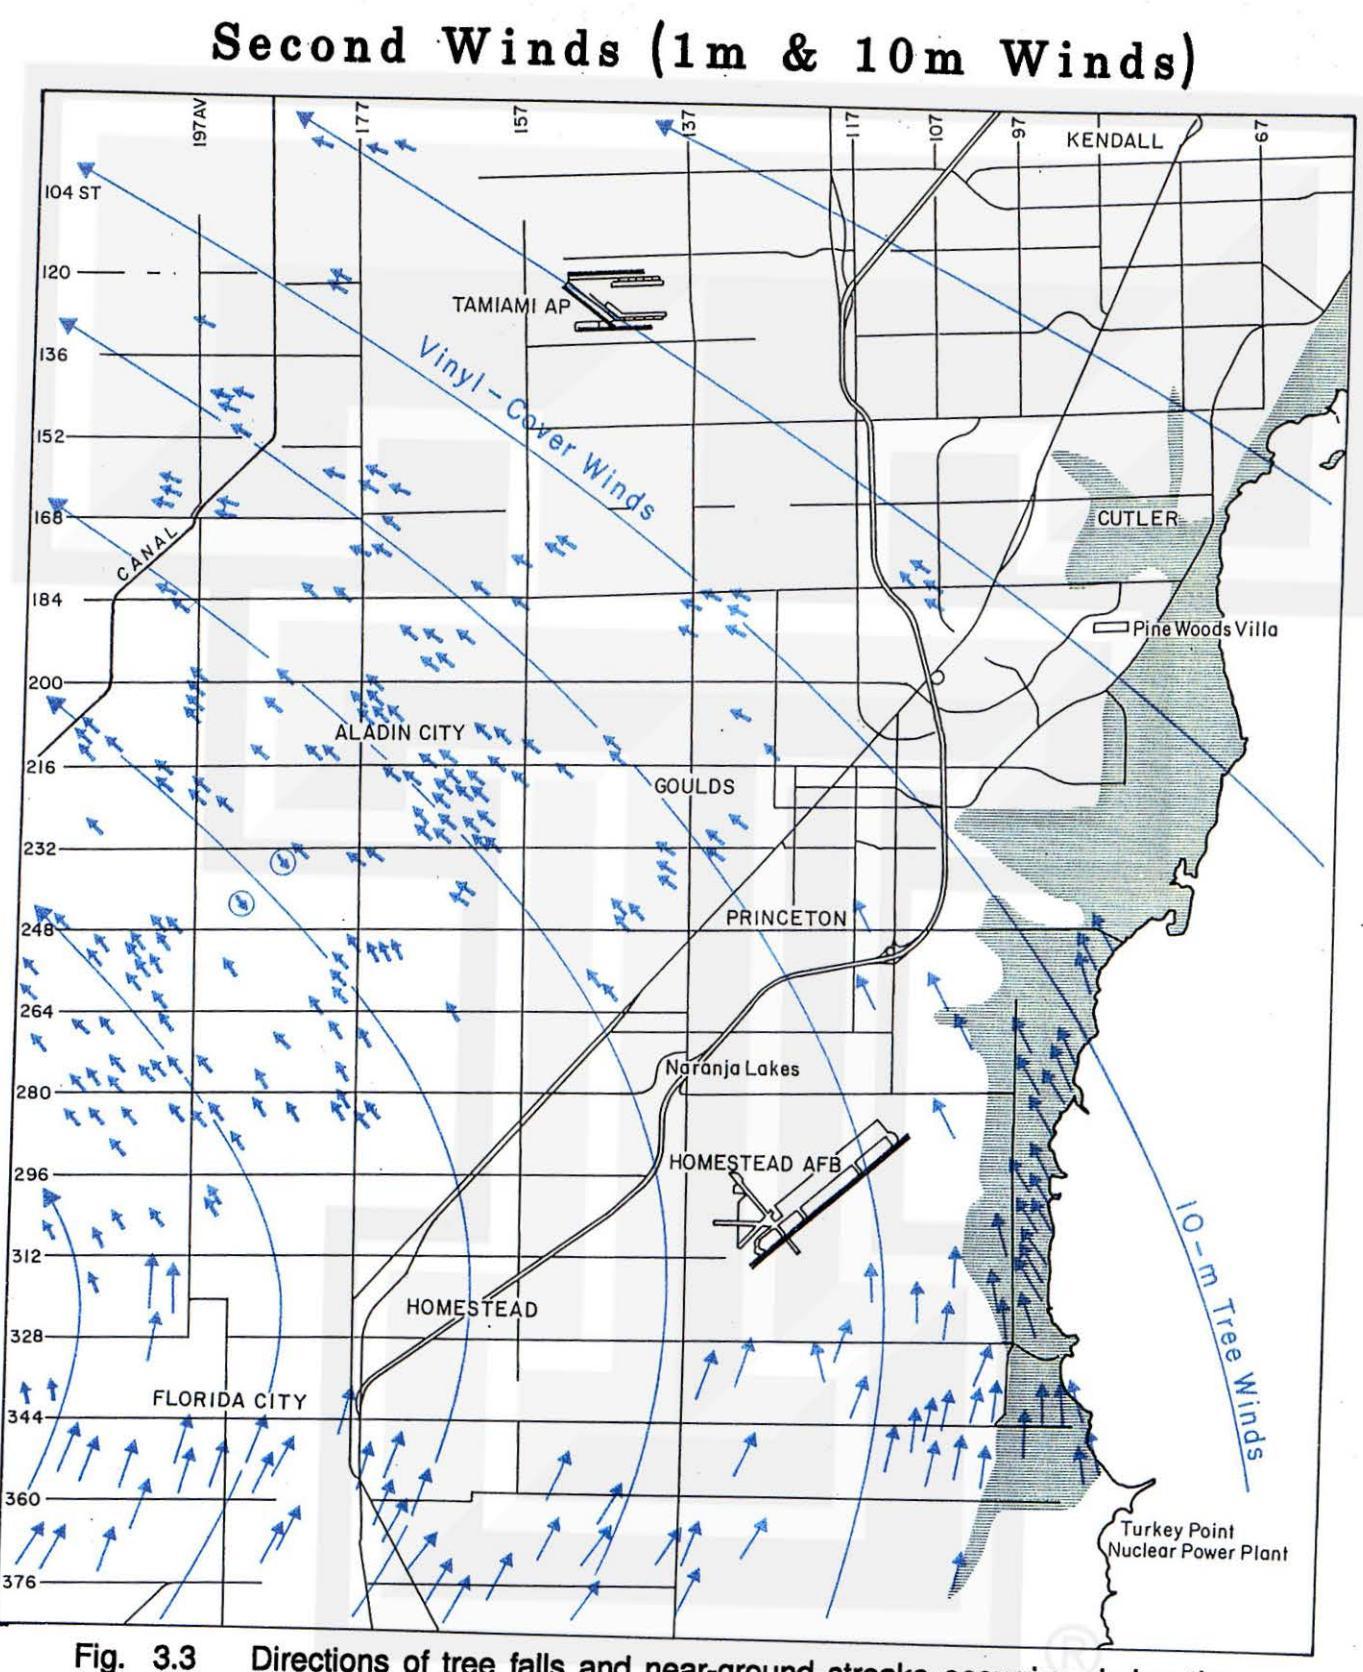
The damage direction of Andrew's second wind was hard to determine because most of the damageable tall trees were already downed during the first wind. The damage vectors in Figure 3.3 were determined by carefully mapping sand drift and the streaks of plastic covers from large numbers of greenhouses scattered in south Florida.

Fig. 3.3 Directions of tree falls and near-ground streaks occurring during the second wind of Andrew.

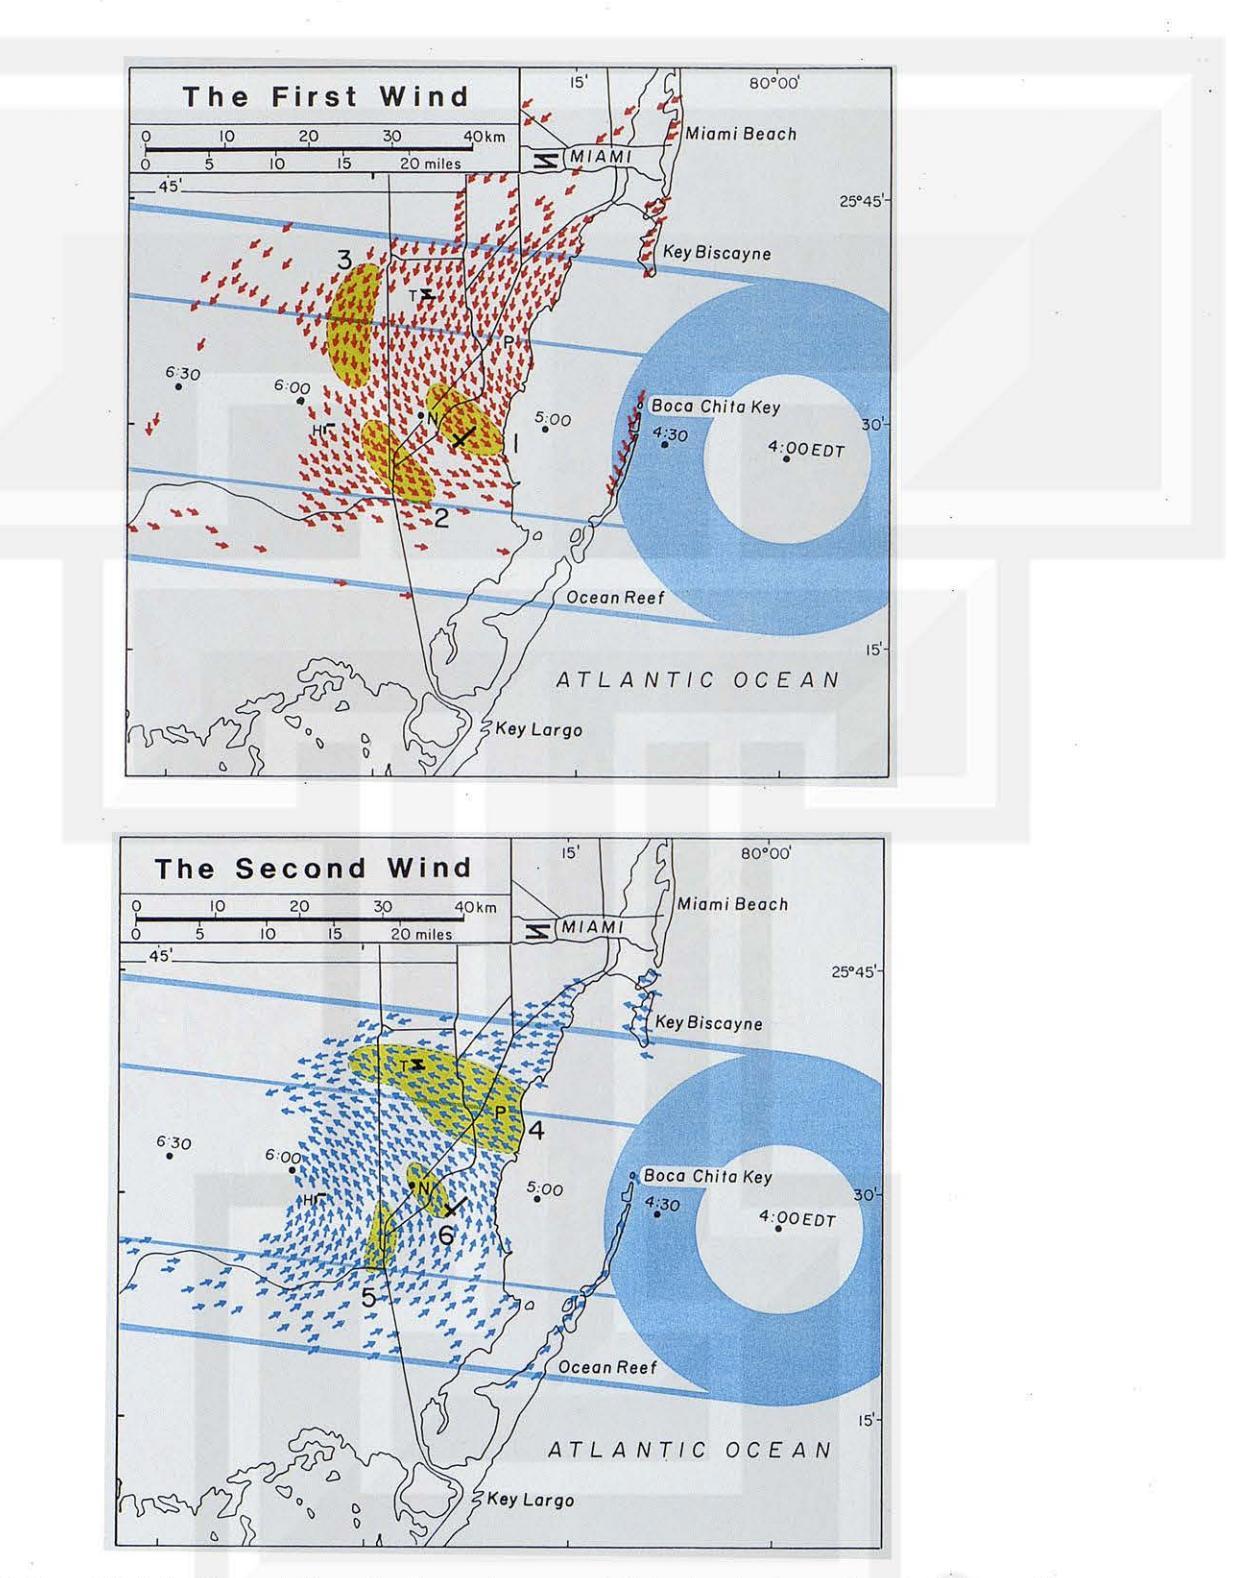
Both first and second winds were mapped inside a large area extending into the Everglades. Unexpectedly, three (3) areas of strong first winds were identified — in the Everglades, near Homestead Air Force Base, and in Homestead (see green areas in top panel of Figure 3.5). Similar areas, identified as 4, 5 and 6 in the lower panel of Figure 3.5, were located in the second winds. This evidence denotes that there were localized high winds inside Andrew, creating damage swaths 2 to 7 miles wide and 5 to 15 miles long. Windspeeds in these areas were estimated to be 20 to 30 mph higher than the overall Andrew winds of 140 mph. The force of the resultant wind is proportional to the square of the total wind, $(140 + 30)^2 = 1.47 \times 140^2$, or approximately 50% larger. The difference in damage caused by 140 mph and 170 mph winds can be identified easily in aerial photographs.

Fig. 3.5 Distribution of first (red) and second (blue) winds estimated from the damage direction determined by aerial photographs. The path of Andrew's eye moving from east to west is shown by black dots at 30-minute intervals.

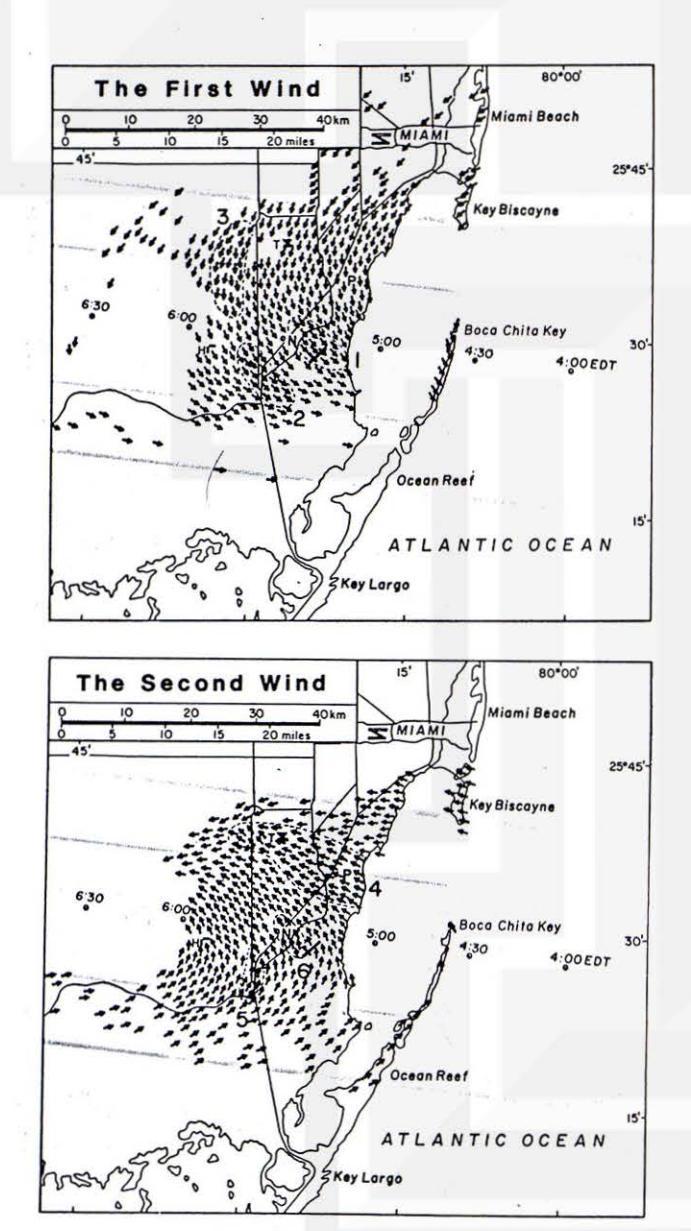
Above: Direction of the first damaging wind occurring during the approach phase of Andrew. Below: Damage by the second wind, during the receding phase.

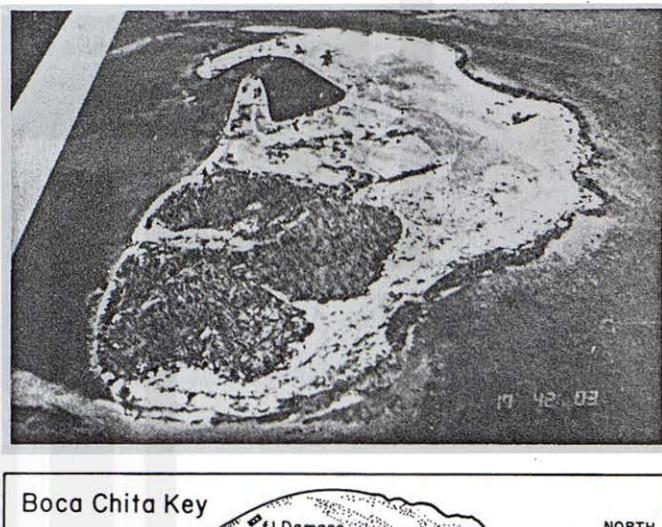
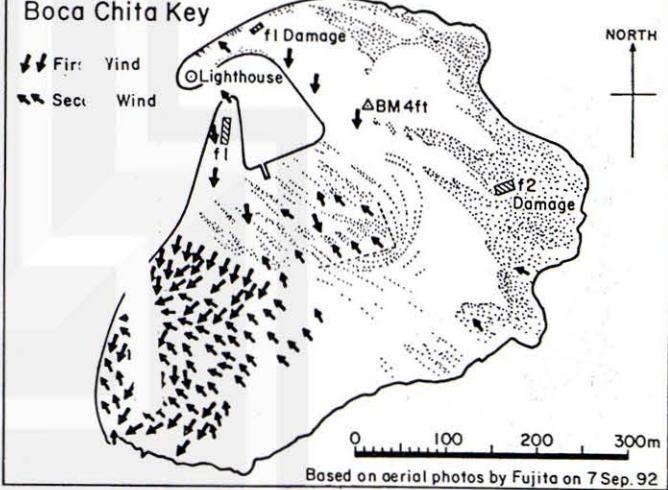
Above: Boca Chita Key, 2 to 3 miles north of the eye center, received the first storm fury. Fujita photo 1742 EDT 9/7/92. Below: Damage map showing the average direction of the first wind from 10° and the second wind from 125° .

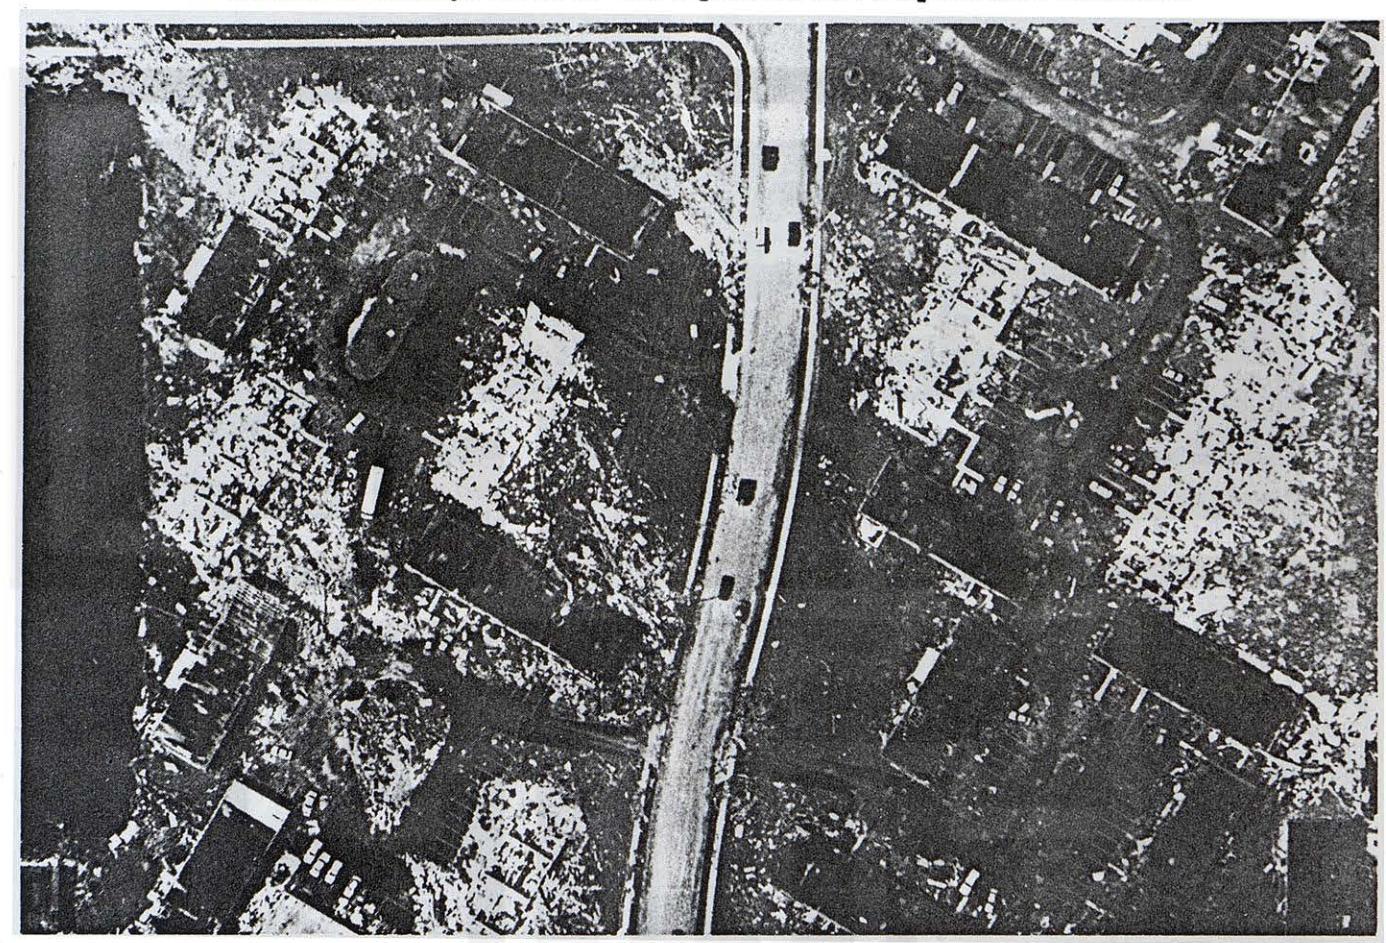
Condos at Naranja Lakes in Wind-parallel and Perpendicular Directions

Center of Andrew's eye passed directly over Naranja Lakes, resulting in a 180° shift of the first wind from NNW into the second wind from SSE. Many buildings oriented WSW-ENE (wind-perpendicular) direction received the f3 damage while those in the NNW-SSE (wind-parallel) direction were spared. Enlargement of a Continental Aerial Survey photo taken on 8/26/92.

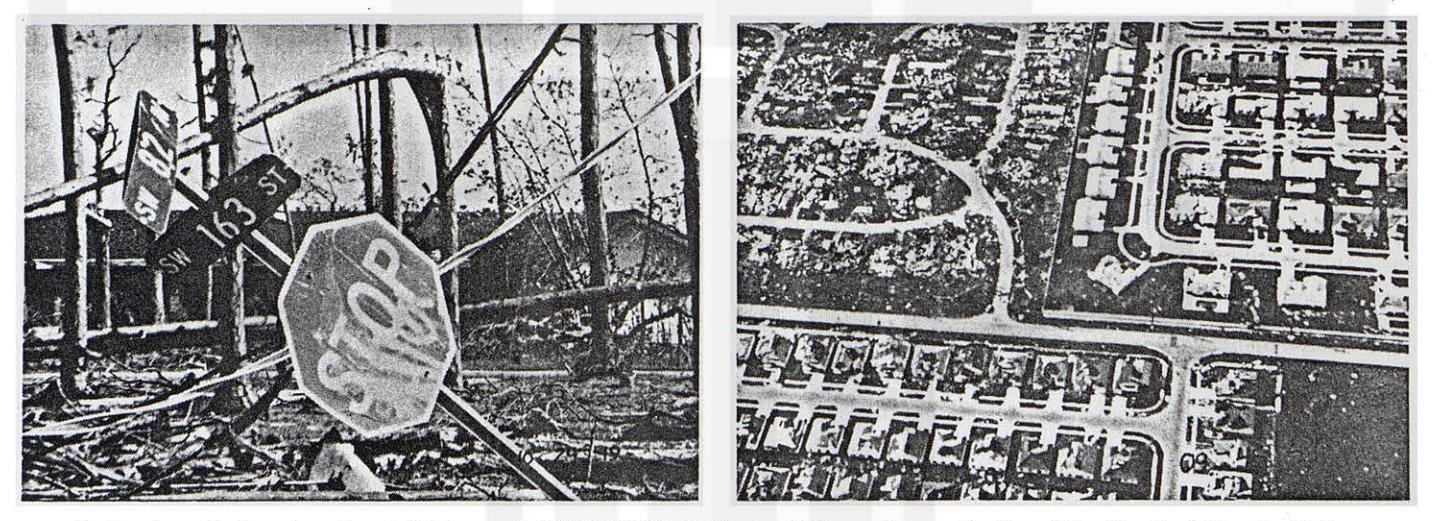
Left: A confusing stop sign at 82 Ave and 163 St SW in Cutler located near the north edge of the Tamiami Swath. Fujita photo 1024 EDT 9/16/92. Right: Triple junction of f-scale damages. An f4 damage at a trailer park (upper left), f2 at the lower-left subdivision, and f0 to f2 at the upper right subdivision. Relatively uniform peak winds (F-scale winds) expected at the junction caused a wide range of f-scale damages between f0 and f4. Fujita photos 0945 EDT 9/8/92. Note that the Fujita Scales, now applied to both tornadoes and hurricanes, refer to the Fujita Wind Speed scale (F scale) and Damage scale (f scale), because an F-scale wind would cause different f-scale damages to different types of structures. See examples.

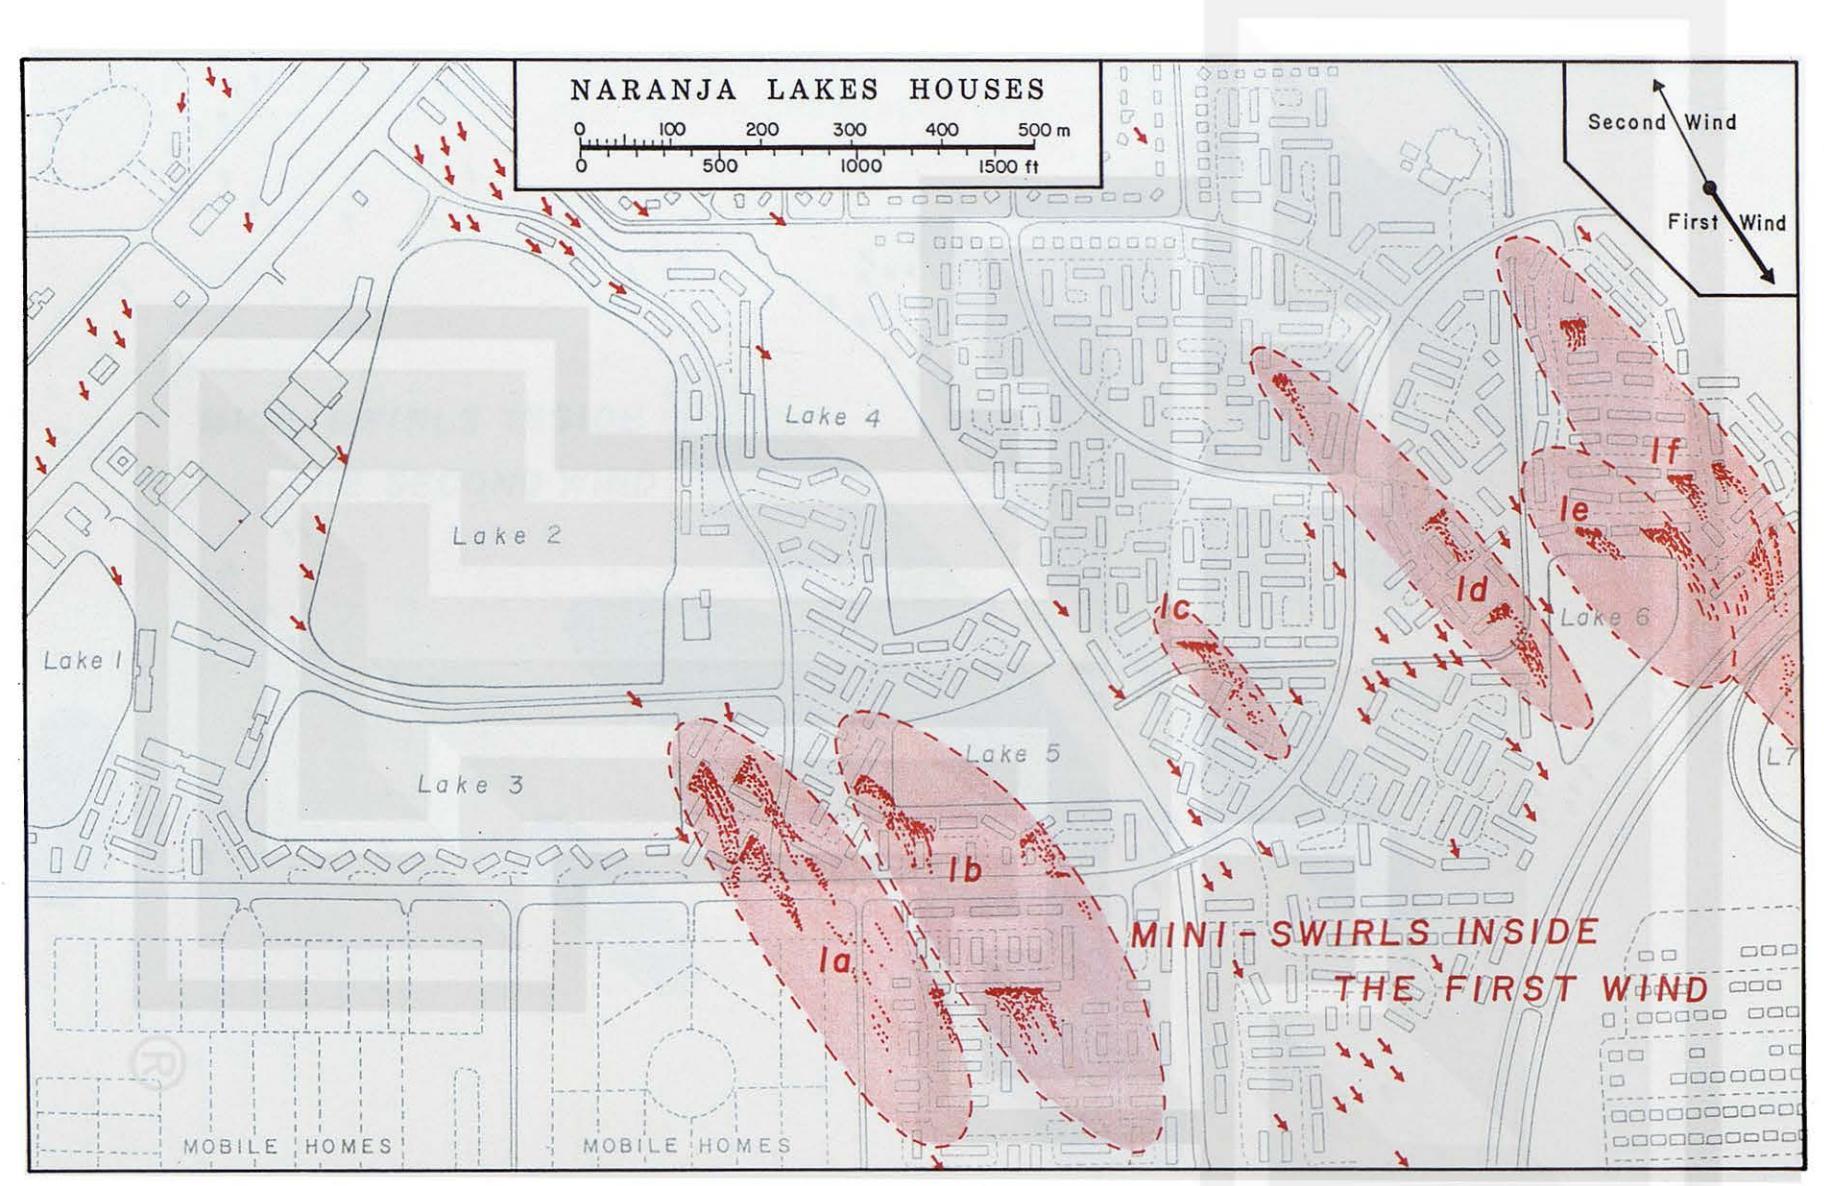
Detailed aerial photographs revealed that six (6) mini-swirls (1-a through 1-f in Figure 5.1) damaged the Naranja Lakes area during the first wind. All of the mini-swirls embedded inside the first wind traveled from northwest to southeast. Most of the mini-swirls rotated anticyclonically, inducing the strongest total wind on the northeast side of their swaths which were 200 to 400 feet wide and 500 to 2,000 feet long.

Fig. 5.1 Six swaths of the mini-swirls in the Naranja Lakes area. All of the swirls rotated anticyclonically.

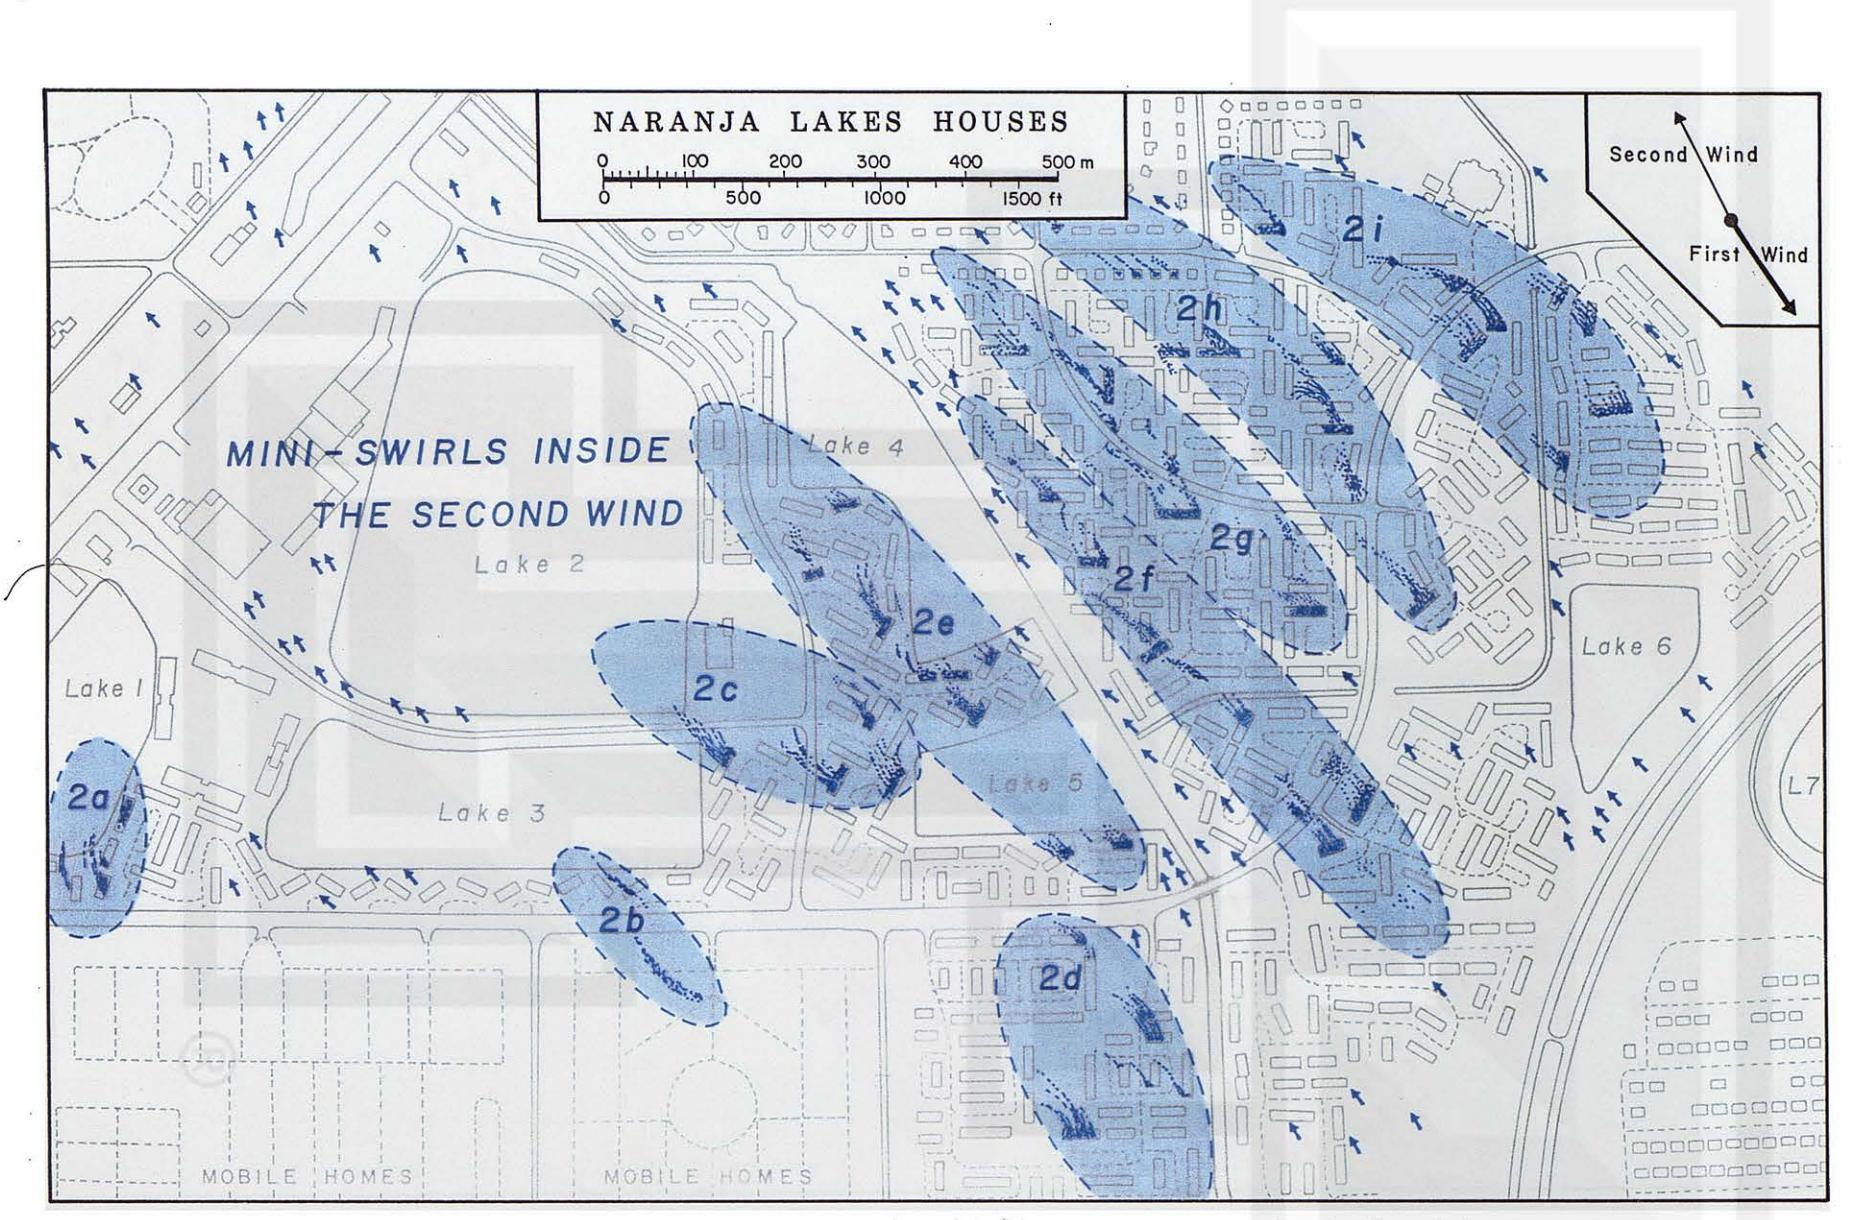
Nine (9) mini-swirls occurred at Naranja Lakes during the second wind, all of which moved from southeast to northwest (see Figure 5.2). Six (6) rotated cyclonically, while three (3) others rotated anticyclonically. As expected, the 6 cyclonic mini-swirls induced the maximum wind on the northwest side of their swaths, and the anticyclonic mini-swirls induced the maximum wind on the southeast side of their swaths.

Fig. 5.2 Six (6) cyclonic mini-swirls (2d, 2f-2i) and three (3) anticyclonic miniswirls embedded inside the second wind blowing from the southeast.

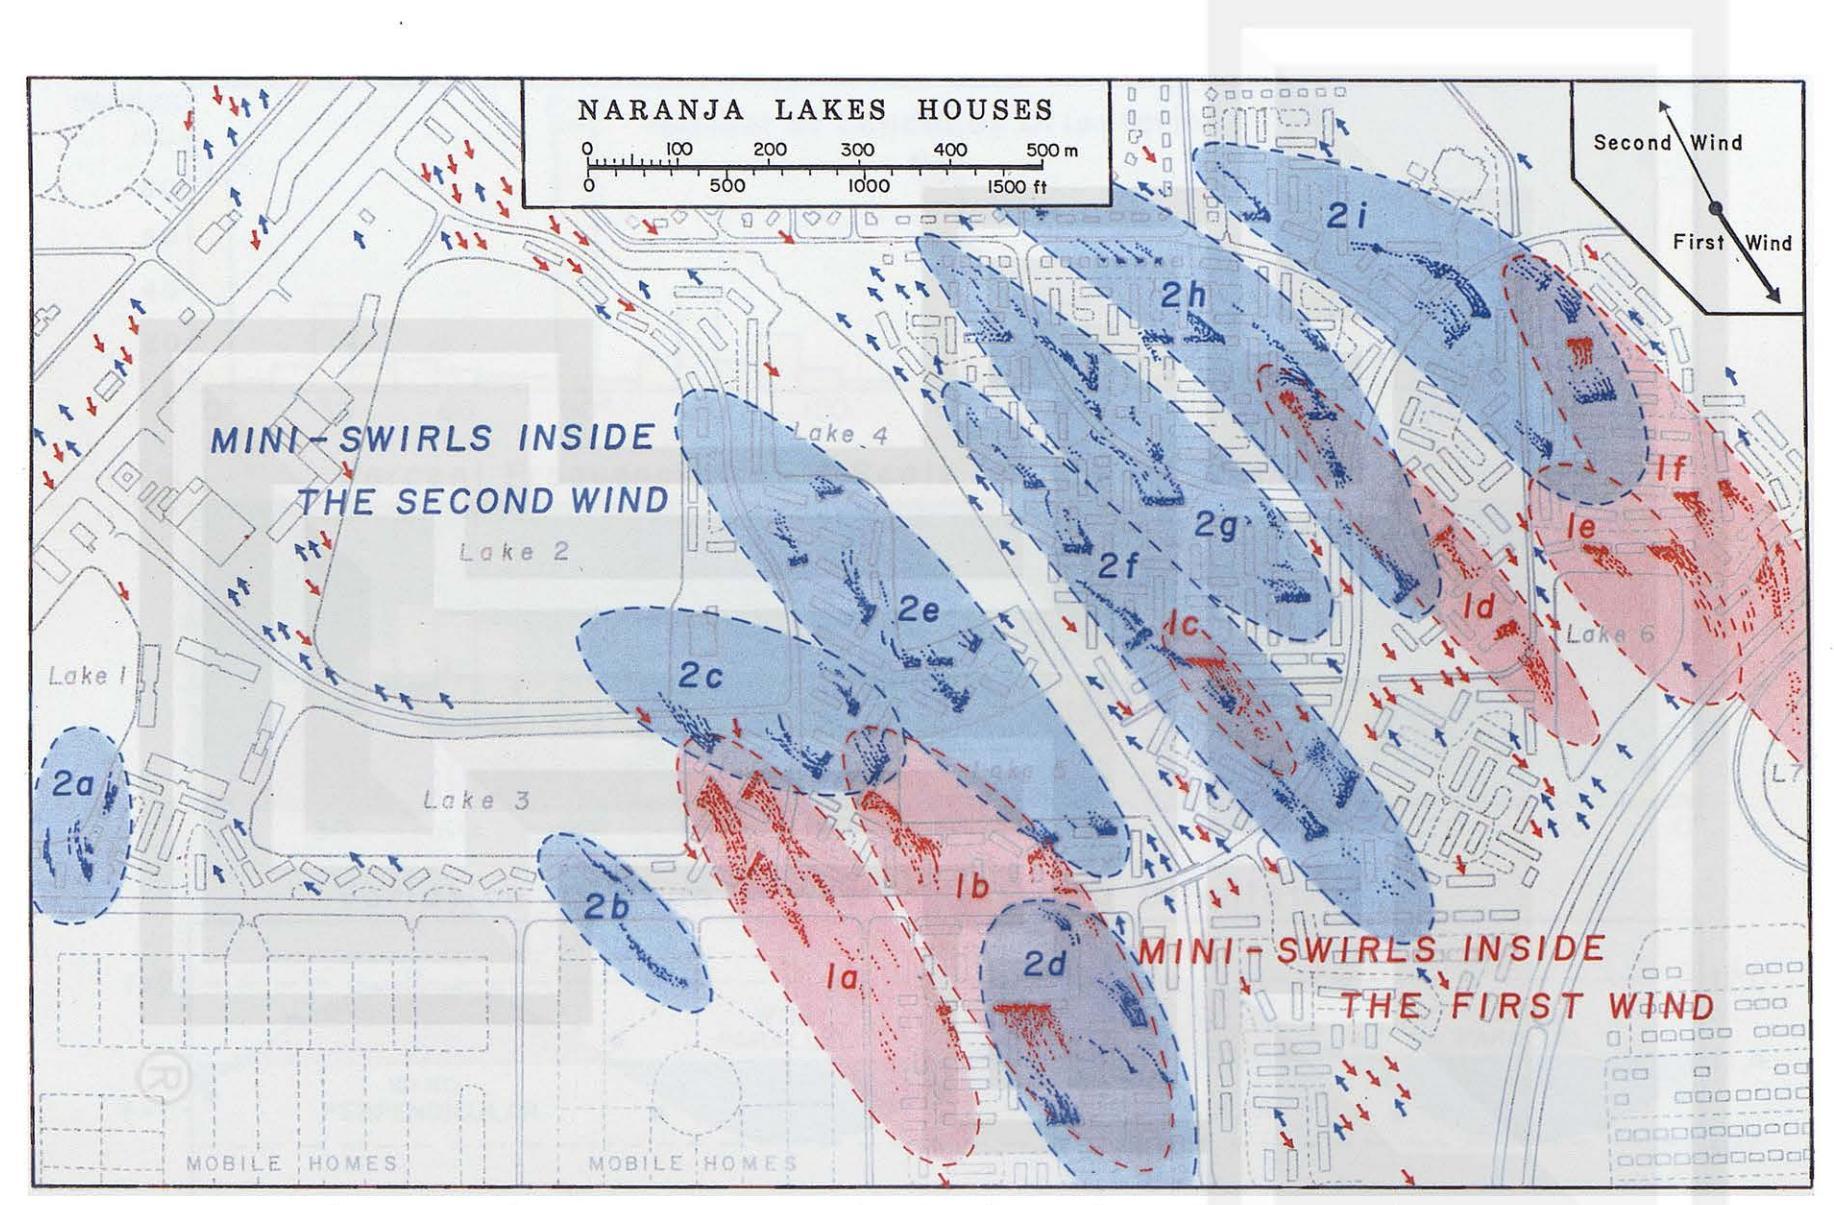
In all, fifteen (15) mini-swirls were confirmed inside the Naranja Lakes subdivision. 1-a through 1-f occurred during the first wind and 2-a through 2-i, during the second. It is seen in Figure 5.3 that the first-wind and second-wind swirls are co-located. "Is this accidental?" Close examination reveals that the initial points of the second-wind swirls are often located inside the damage areas of the first-wind swirls. This means that these
structures (condos), already damaged or weakened by first-wind swirls, became easy targets for destruction by the second-wind swirls. In fact, some condos received dual damage caused by both first- and second-wind swirls.

Fig. 5.3 Swaths of the 15 mini-swirls induced by Andrew at Naranja Lakes. Note that the damage of second-wind mini-swirls 2c, 2h and 2l occurred inside the damage areas of first-wind mini-swirls.

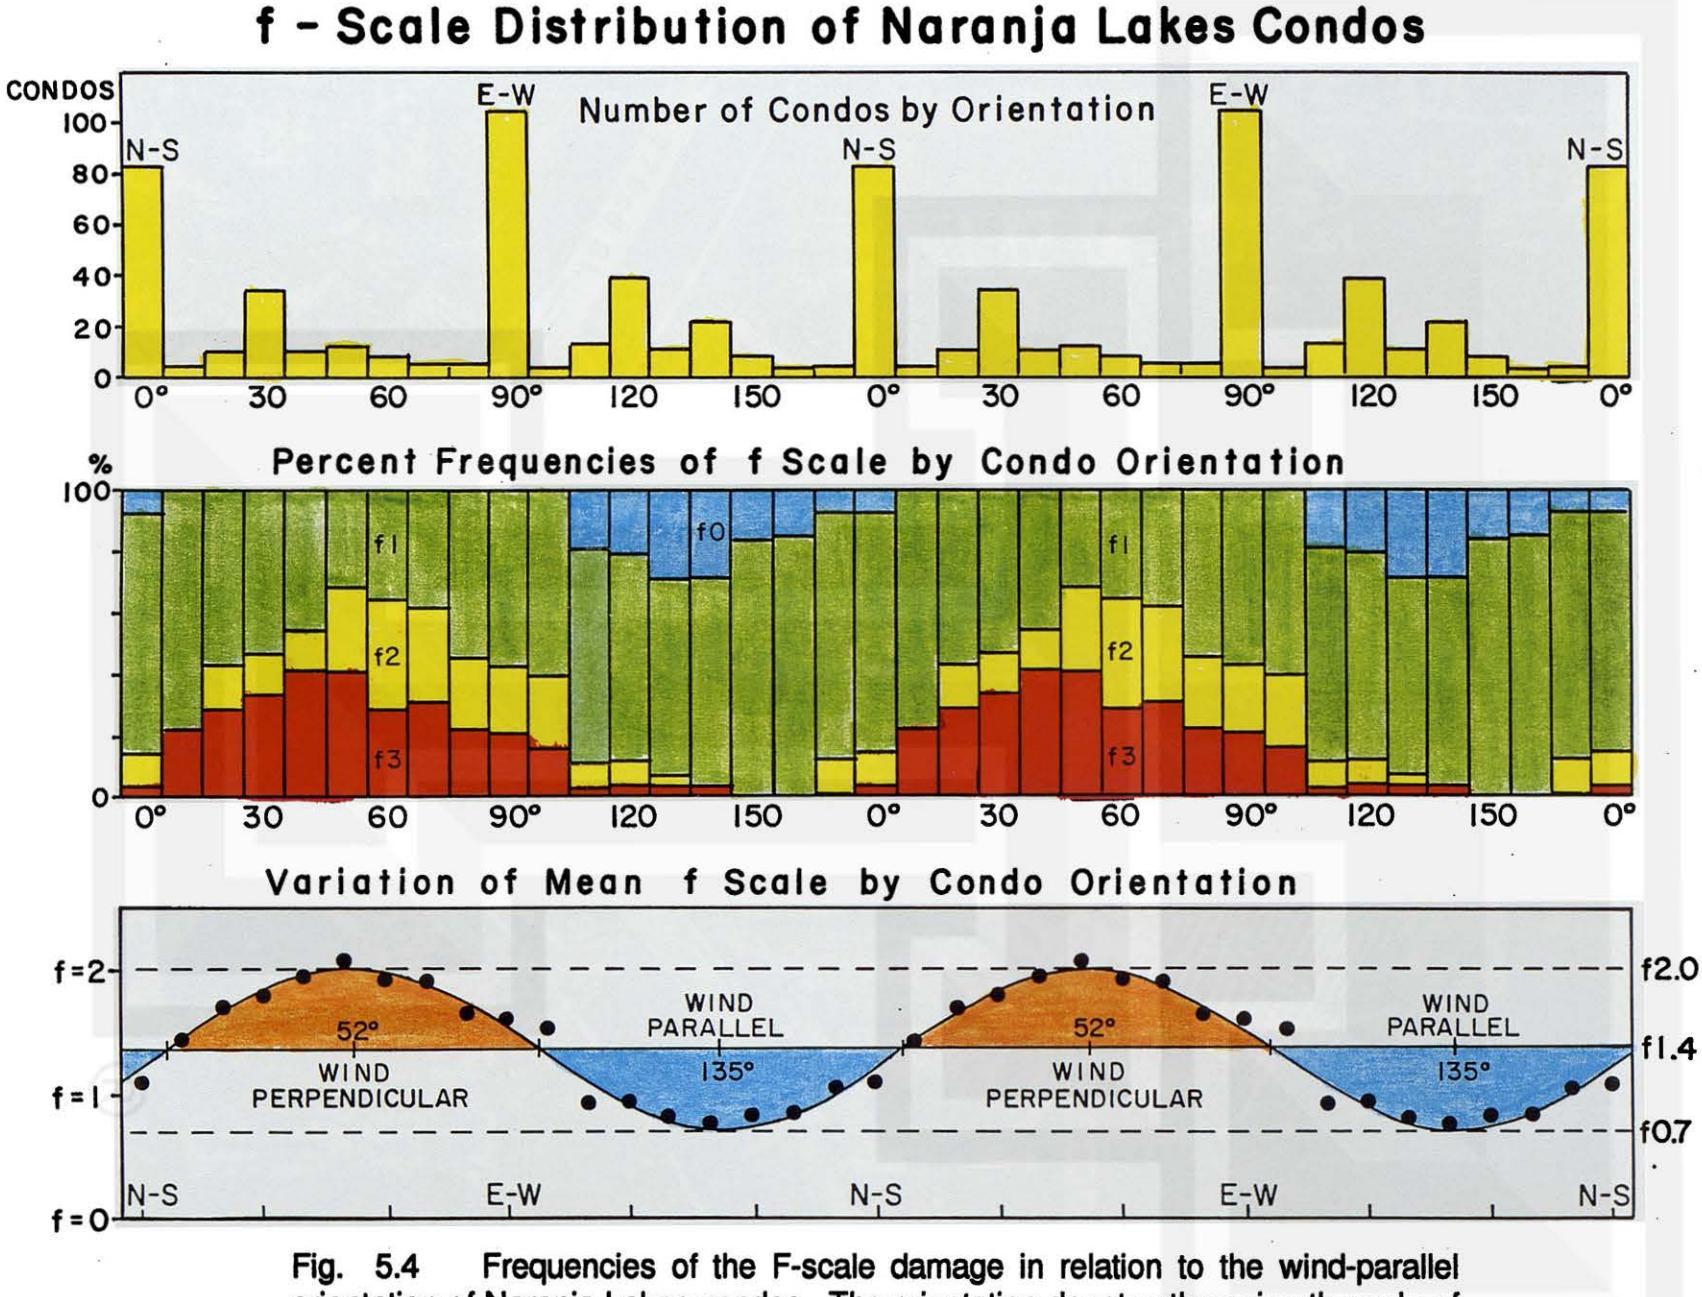
Most of the damaged condos lost their roofs which were lifted and turned upsidedown. Naturally, the overturning moment is largest in the wind-parallel direction and smallest in the wind-perpendicular direction. Consequently, wind-perpendicular condos received the worst damage. The variation of damage is more or less sinusoidal (see Figure 5.4), with the maximum occurring at 52° and the minimum at 135°. Wind-perpendicular orientations during the first wind from 325° and the second wind from 155° are 55° and 65°, respectively. This means that condos in 55° and 65° orientations could receive severe damage. These orientations are within 15° of the 52° orientation shown in Figure 5.4. The difference could be the result of the mini-swirl rotation and the predominant orientation of condos at 0° and 90°.

Fig. 5.4 Frequencies of the F-scale damage in relation to the wind-parallel orientation of Naranja Lakes condos. The orientation denotes the azimuth angle of the long axis of each condo.

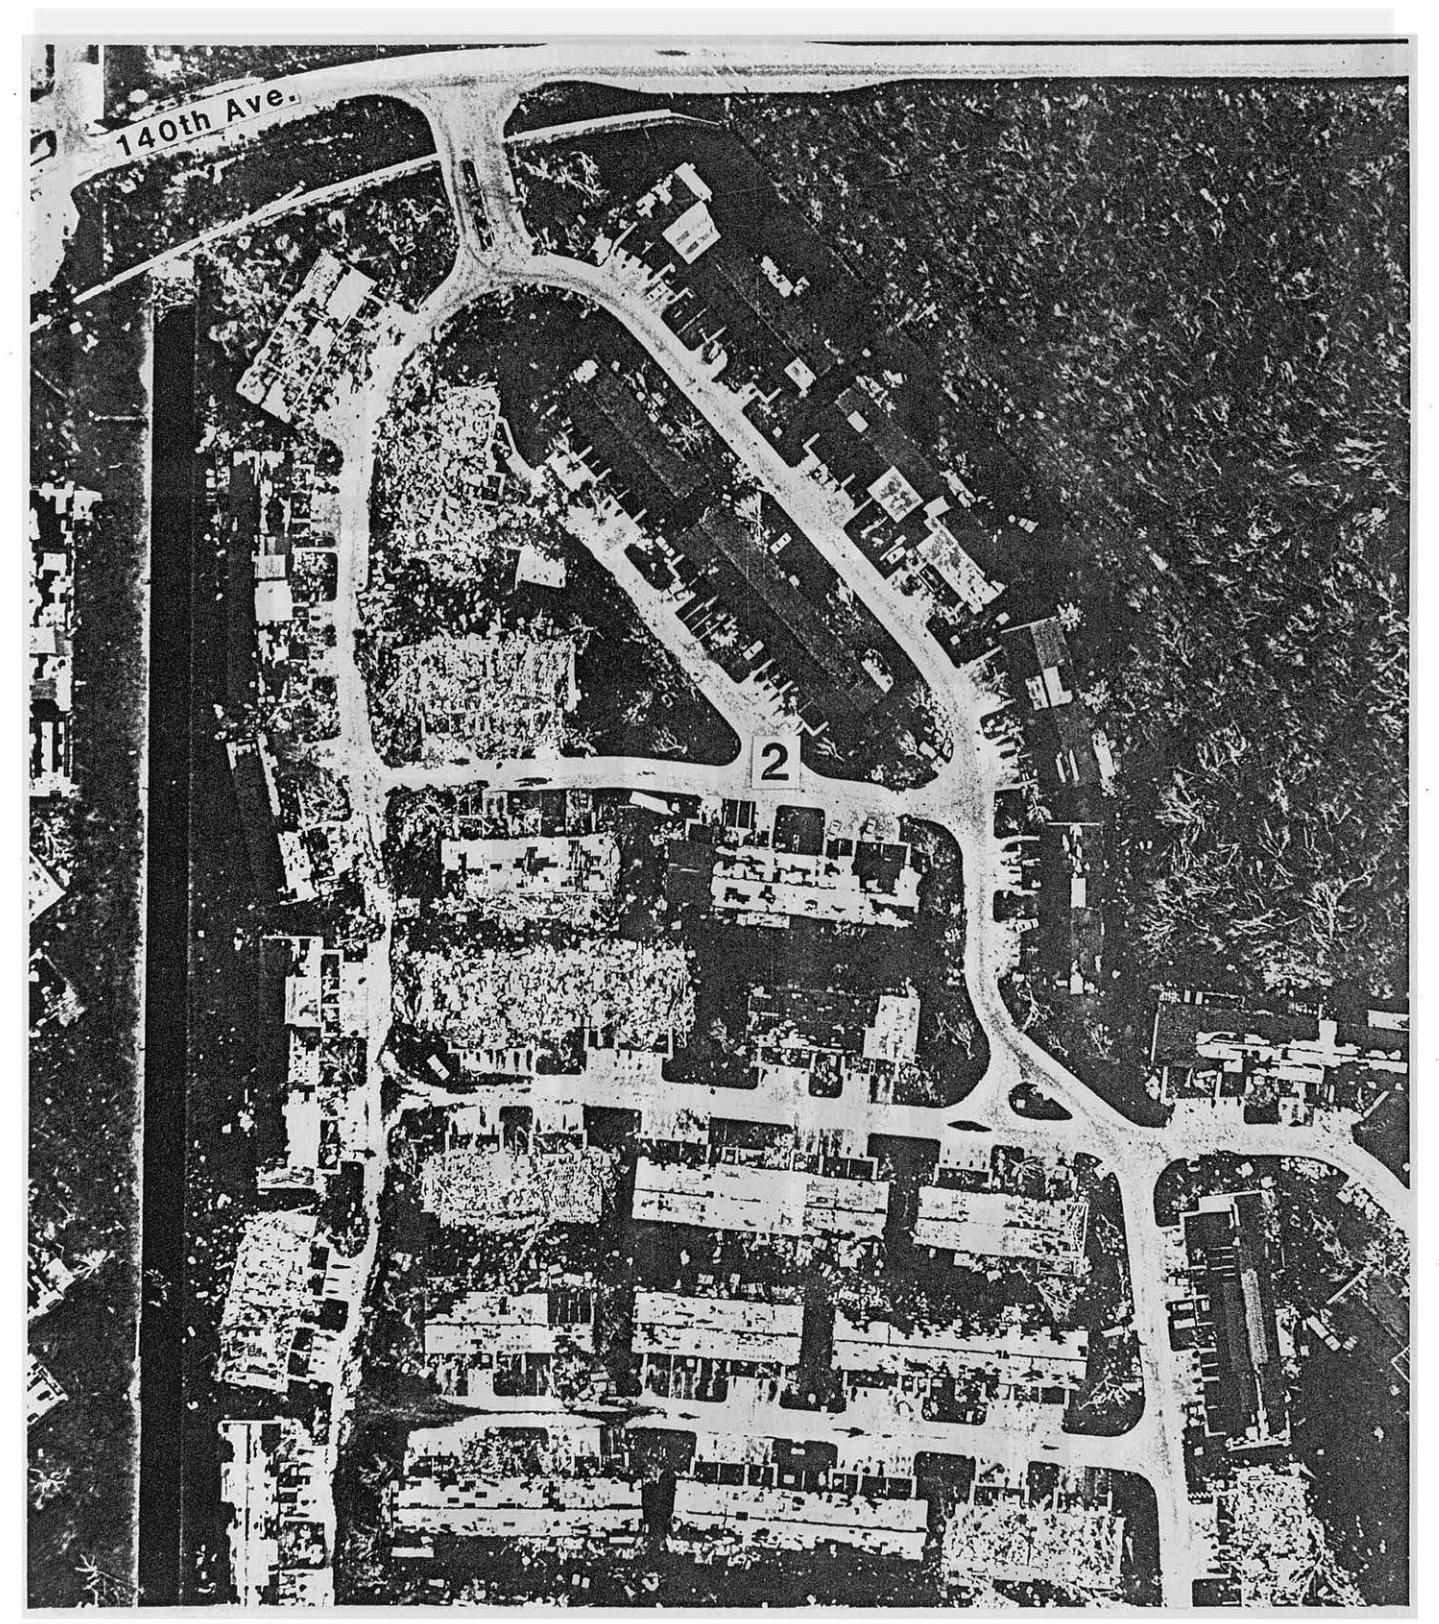
Fig. 5.6 A residential area southeast of Chapman Elementary School. Effects of both first and second winds are visible.
