Research Paper No.1

Detailed Analysis of Hurricane Andrew of 24 August 1992

ONR Grant N00014-J1136 STORM DATA PROJECT

T. Theodore Fujita, PI

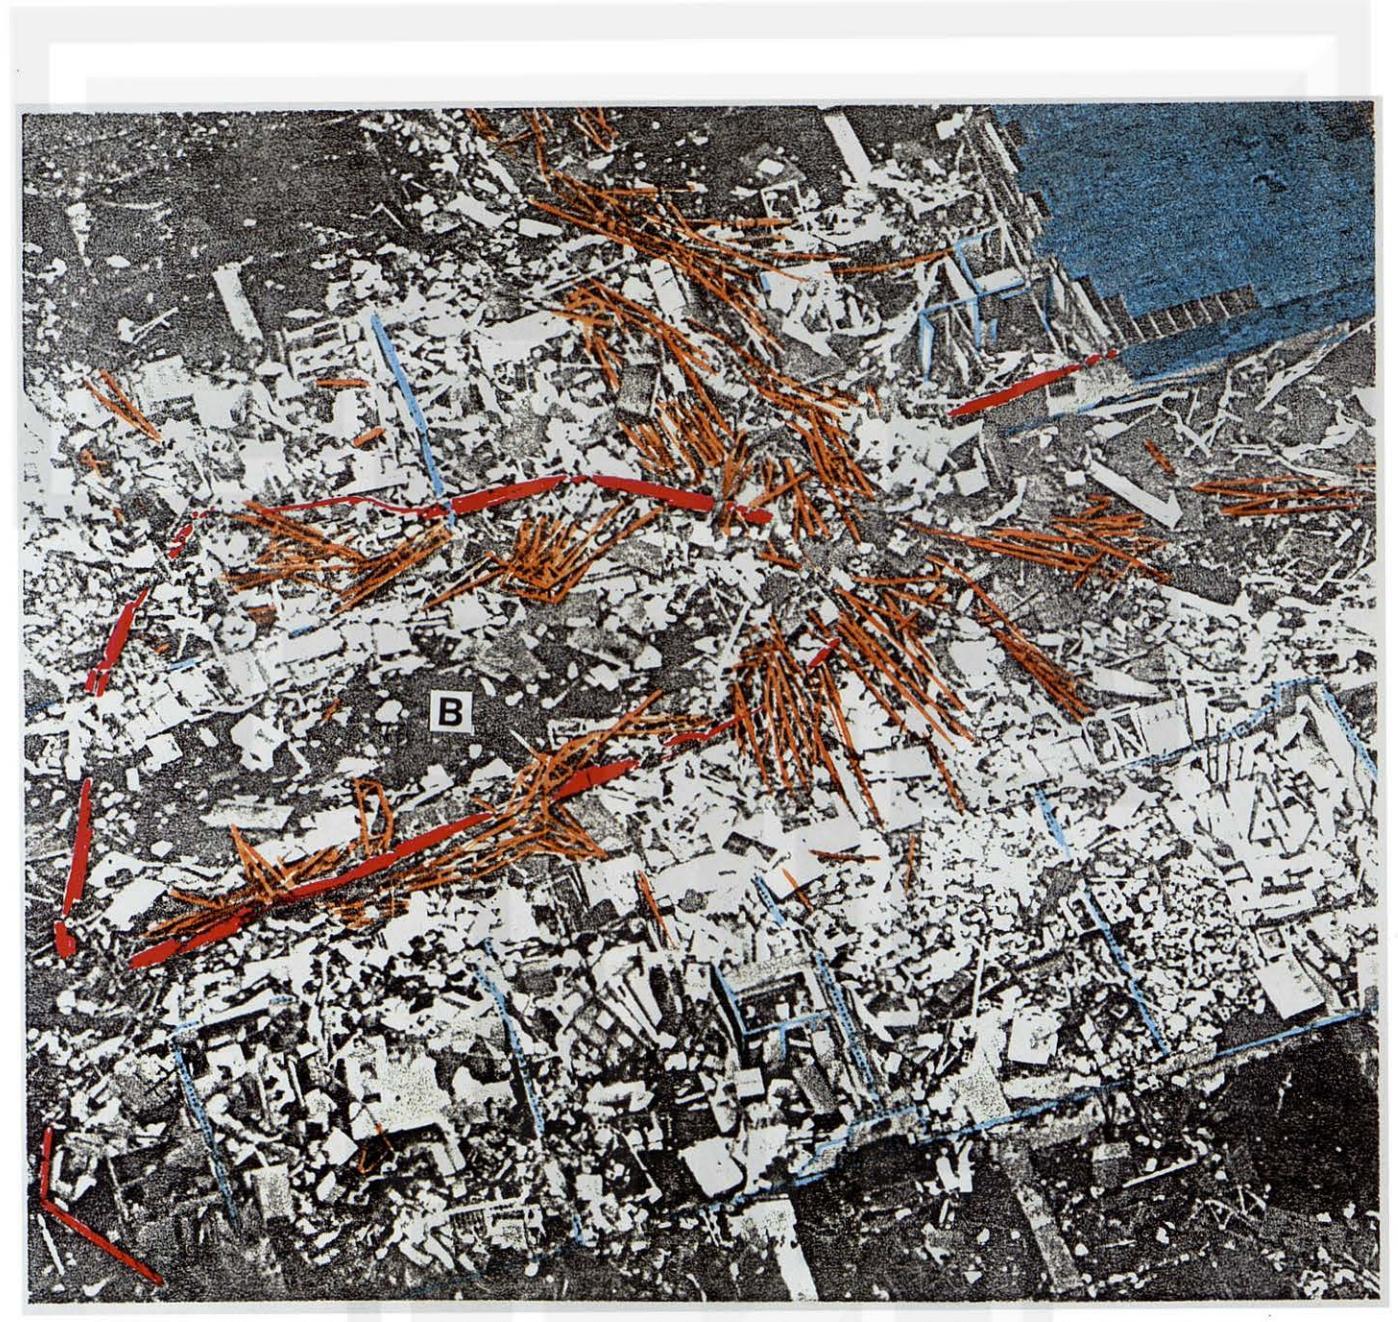
Fig. 5.10 Fujita's aerial photo of the twin condos. Two tie beams (colored in red), one on the north side and the other on the south side, landed in an upside-down position and broke.

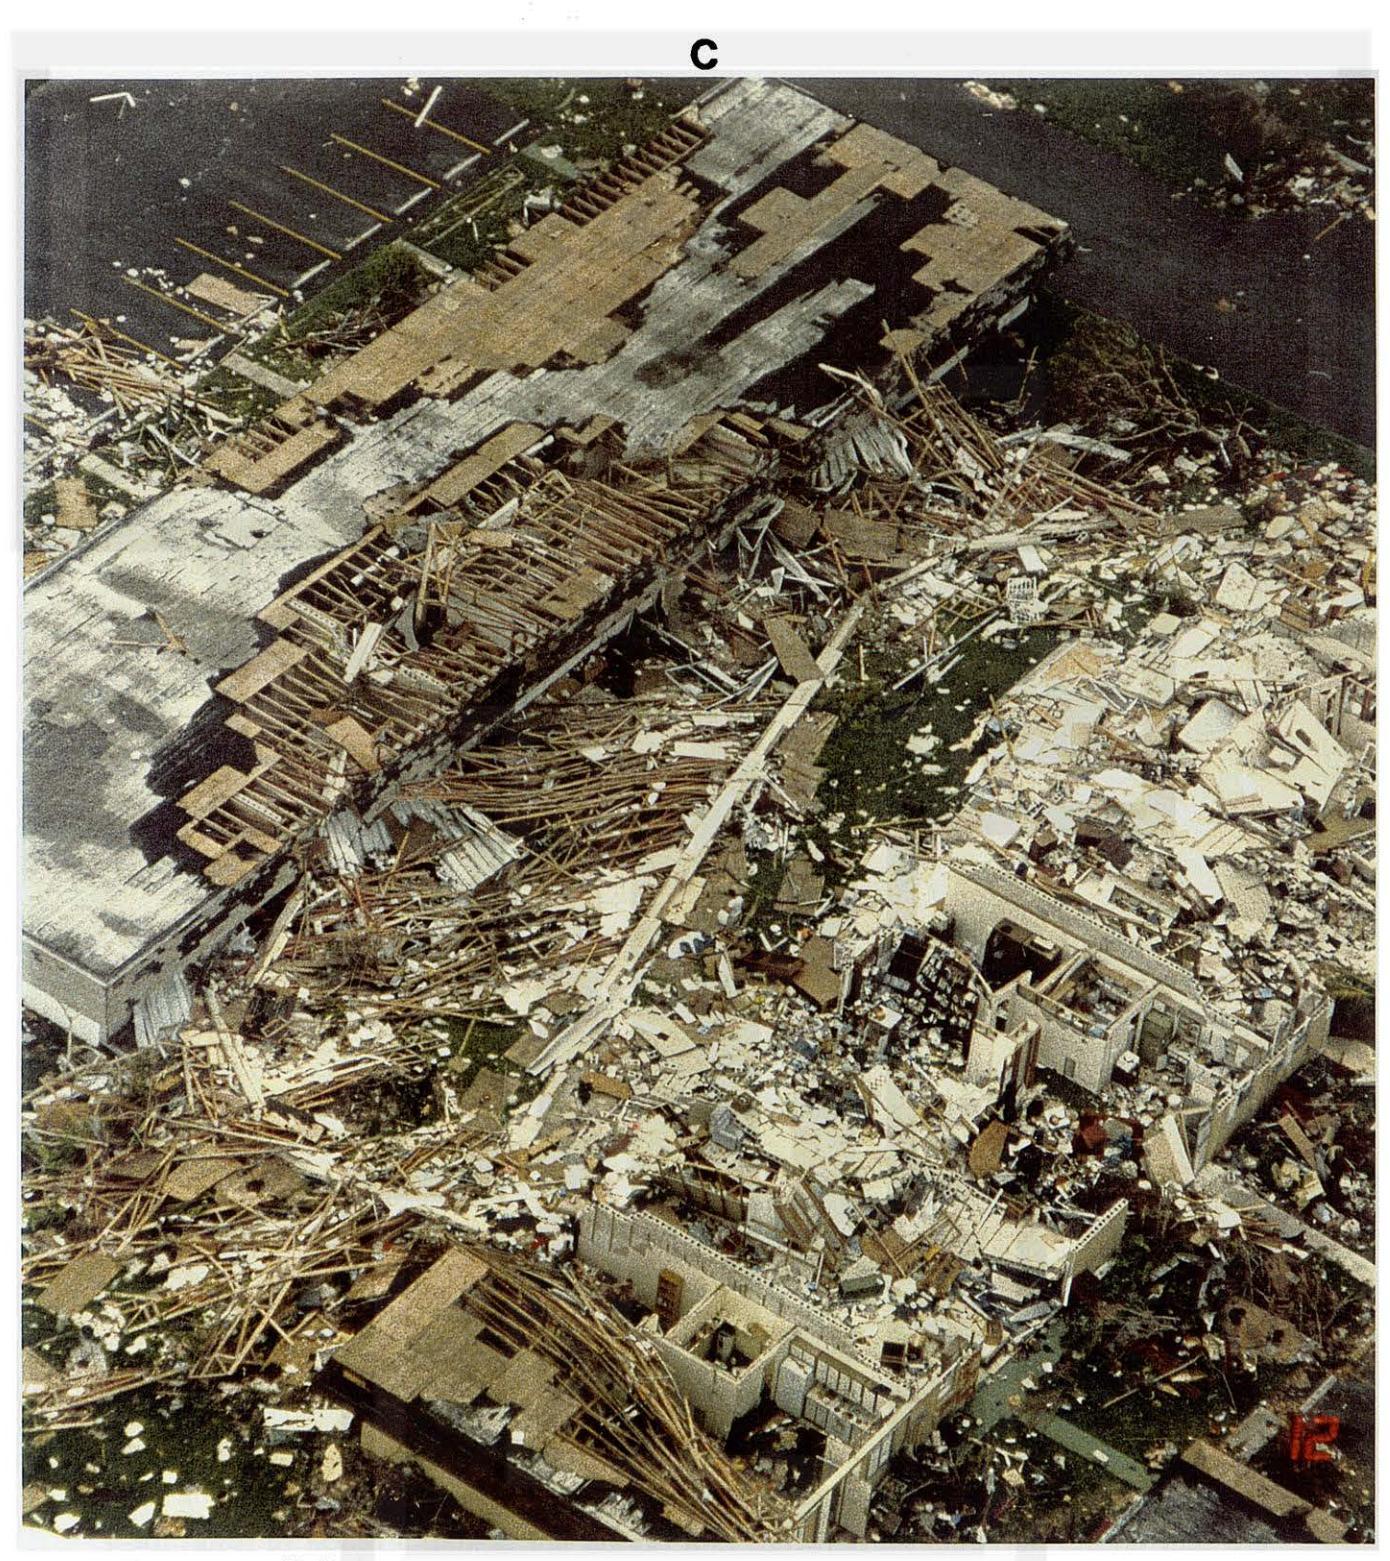
Fig. 5.14 Fujita's aerial photo showing the detailed pattern of damage.

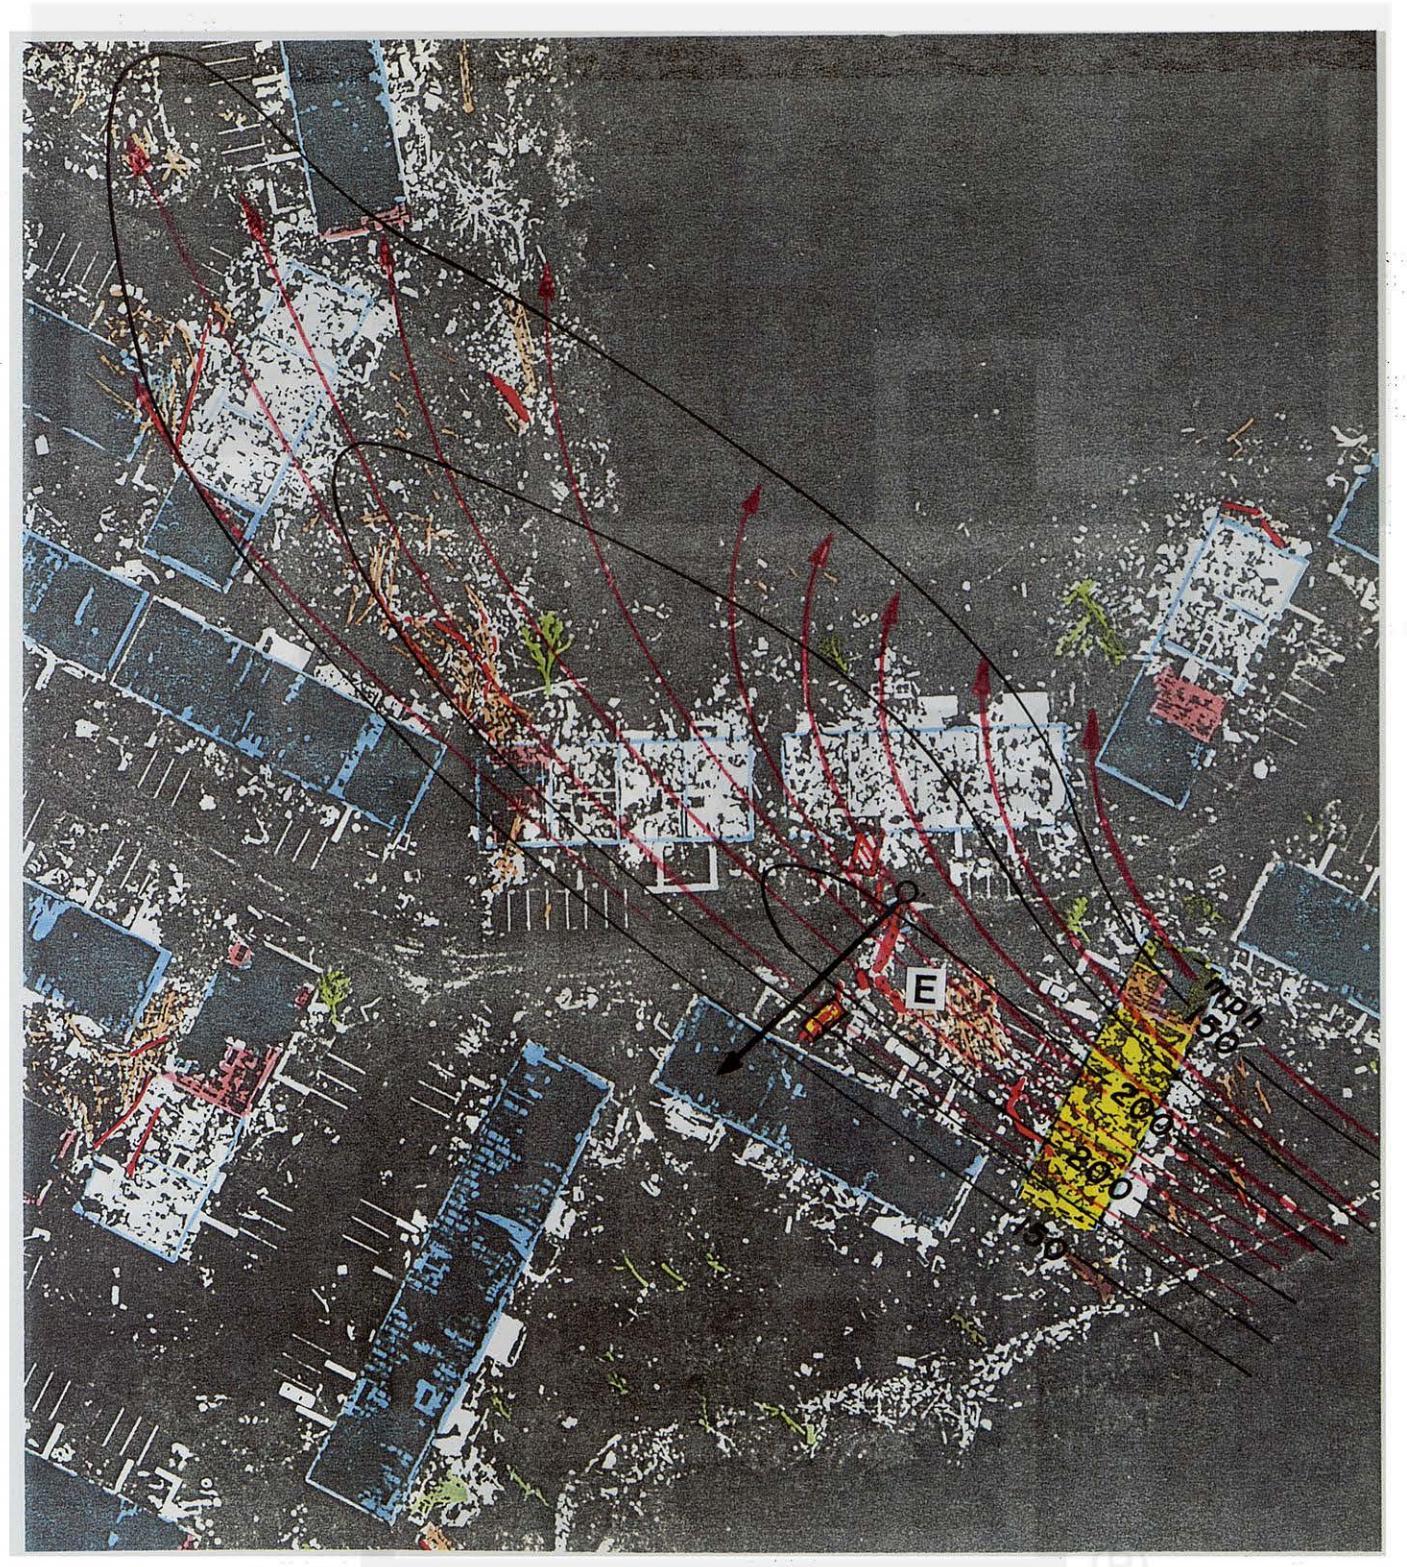
Fig. 5.18 Schematic streamlines and estimated windspeed of 200 mph which caused the broken-up tie beam to be thrown 250 feet onto a parked car (Figure 5.19).

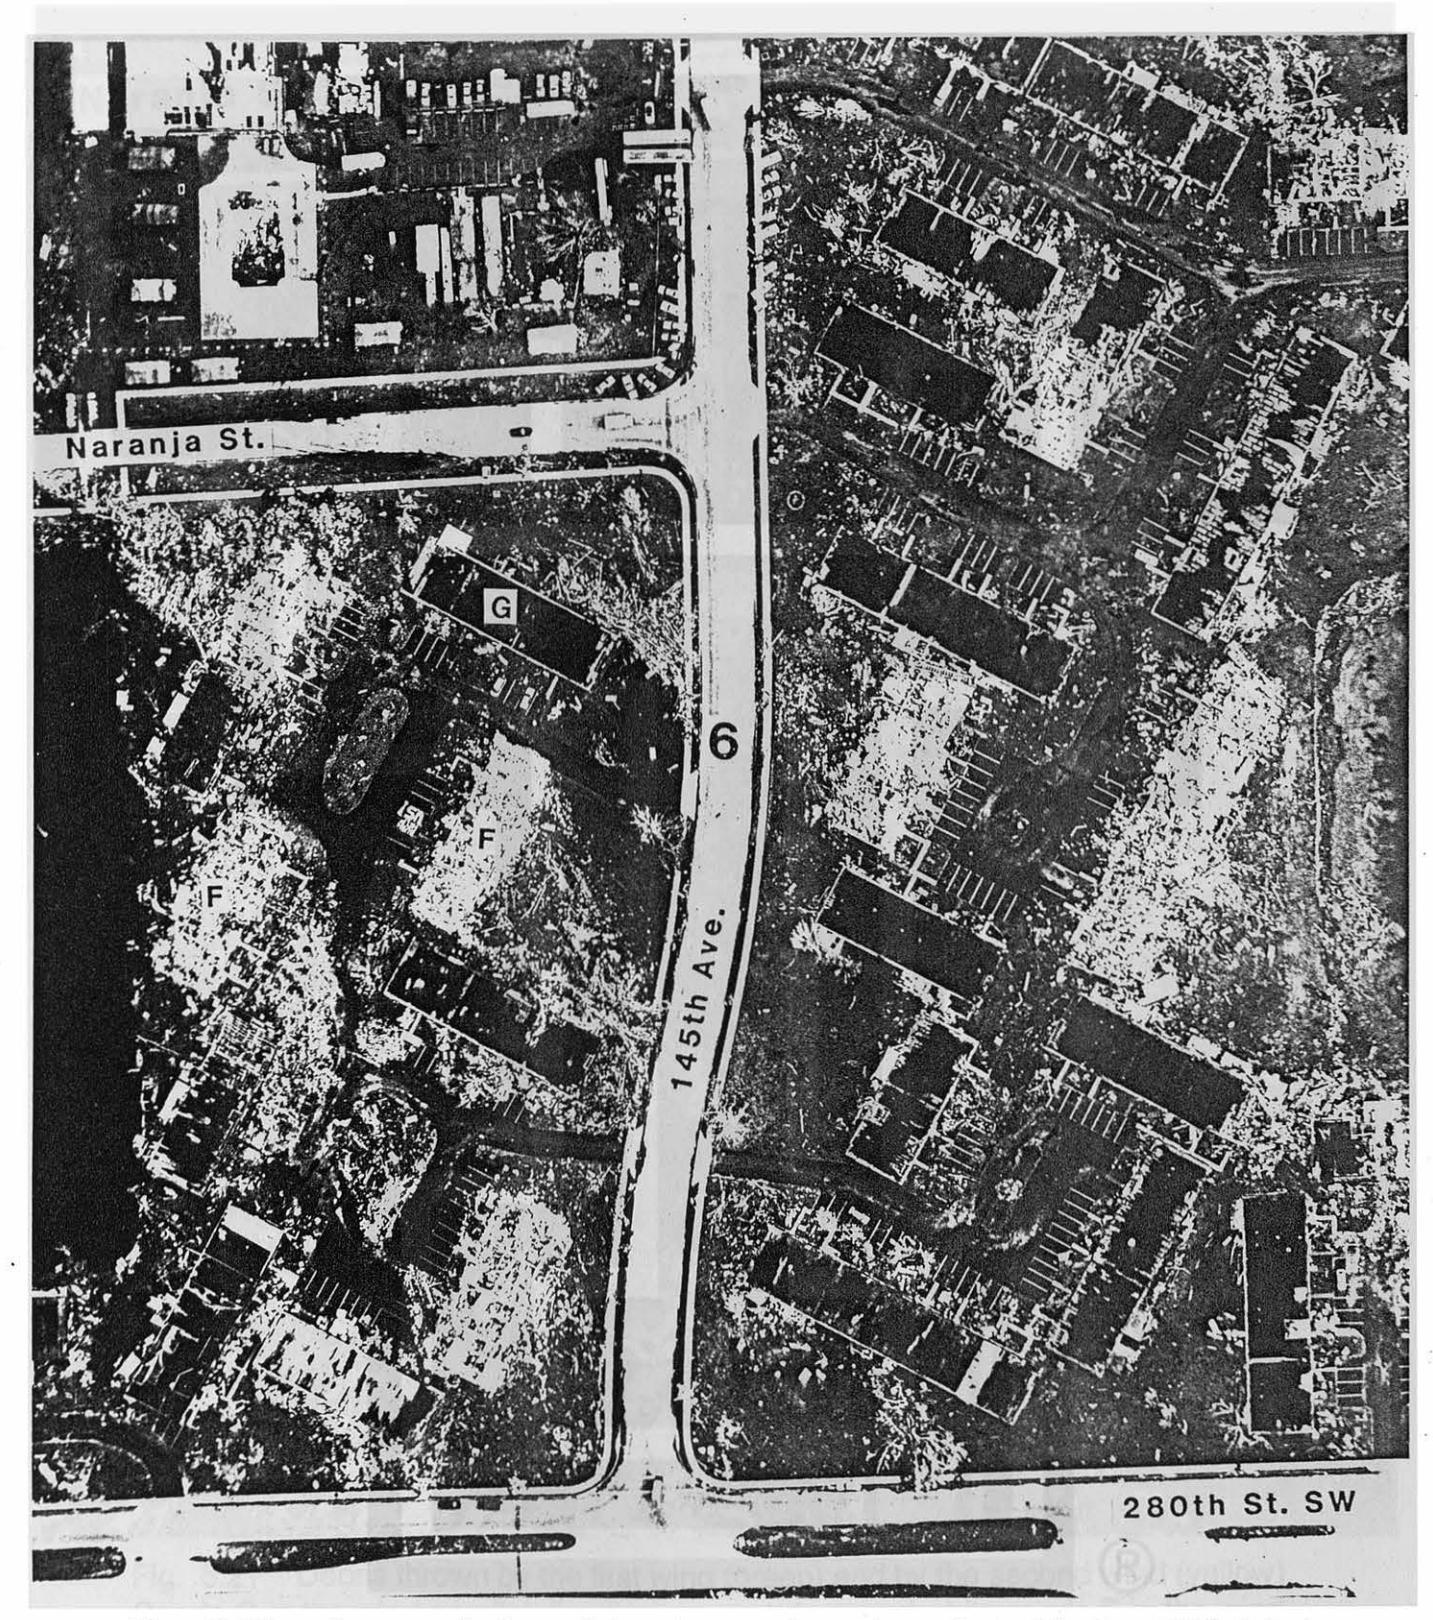
Fig. 5.20 An overall view of the damaged condos oriented in the 120° (wind parallel) and 30° (wind perpendicular) directions.

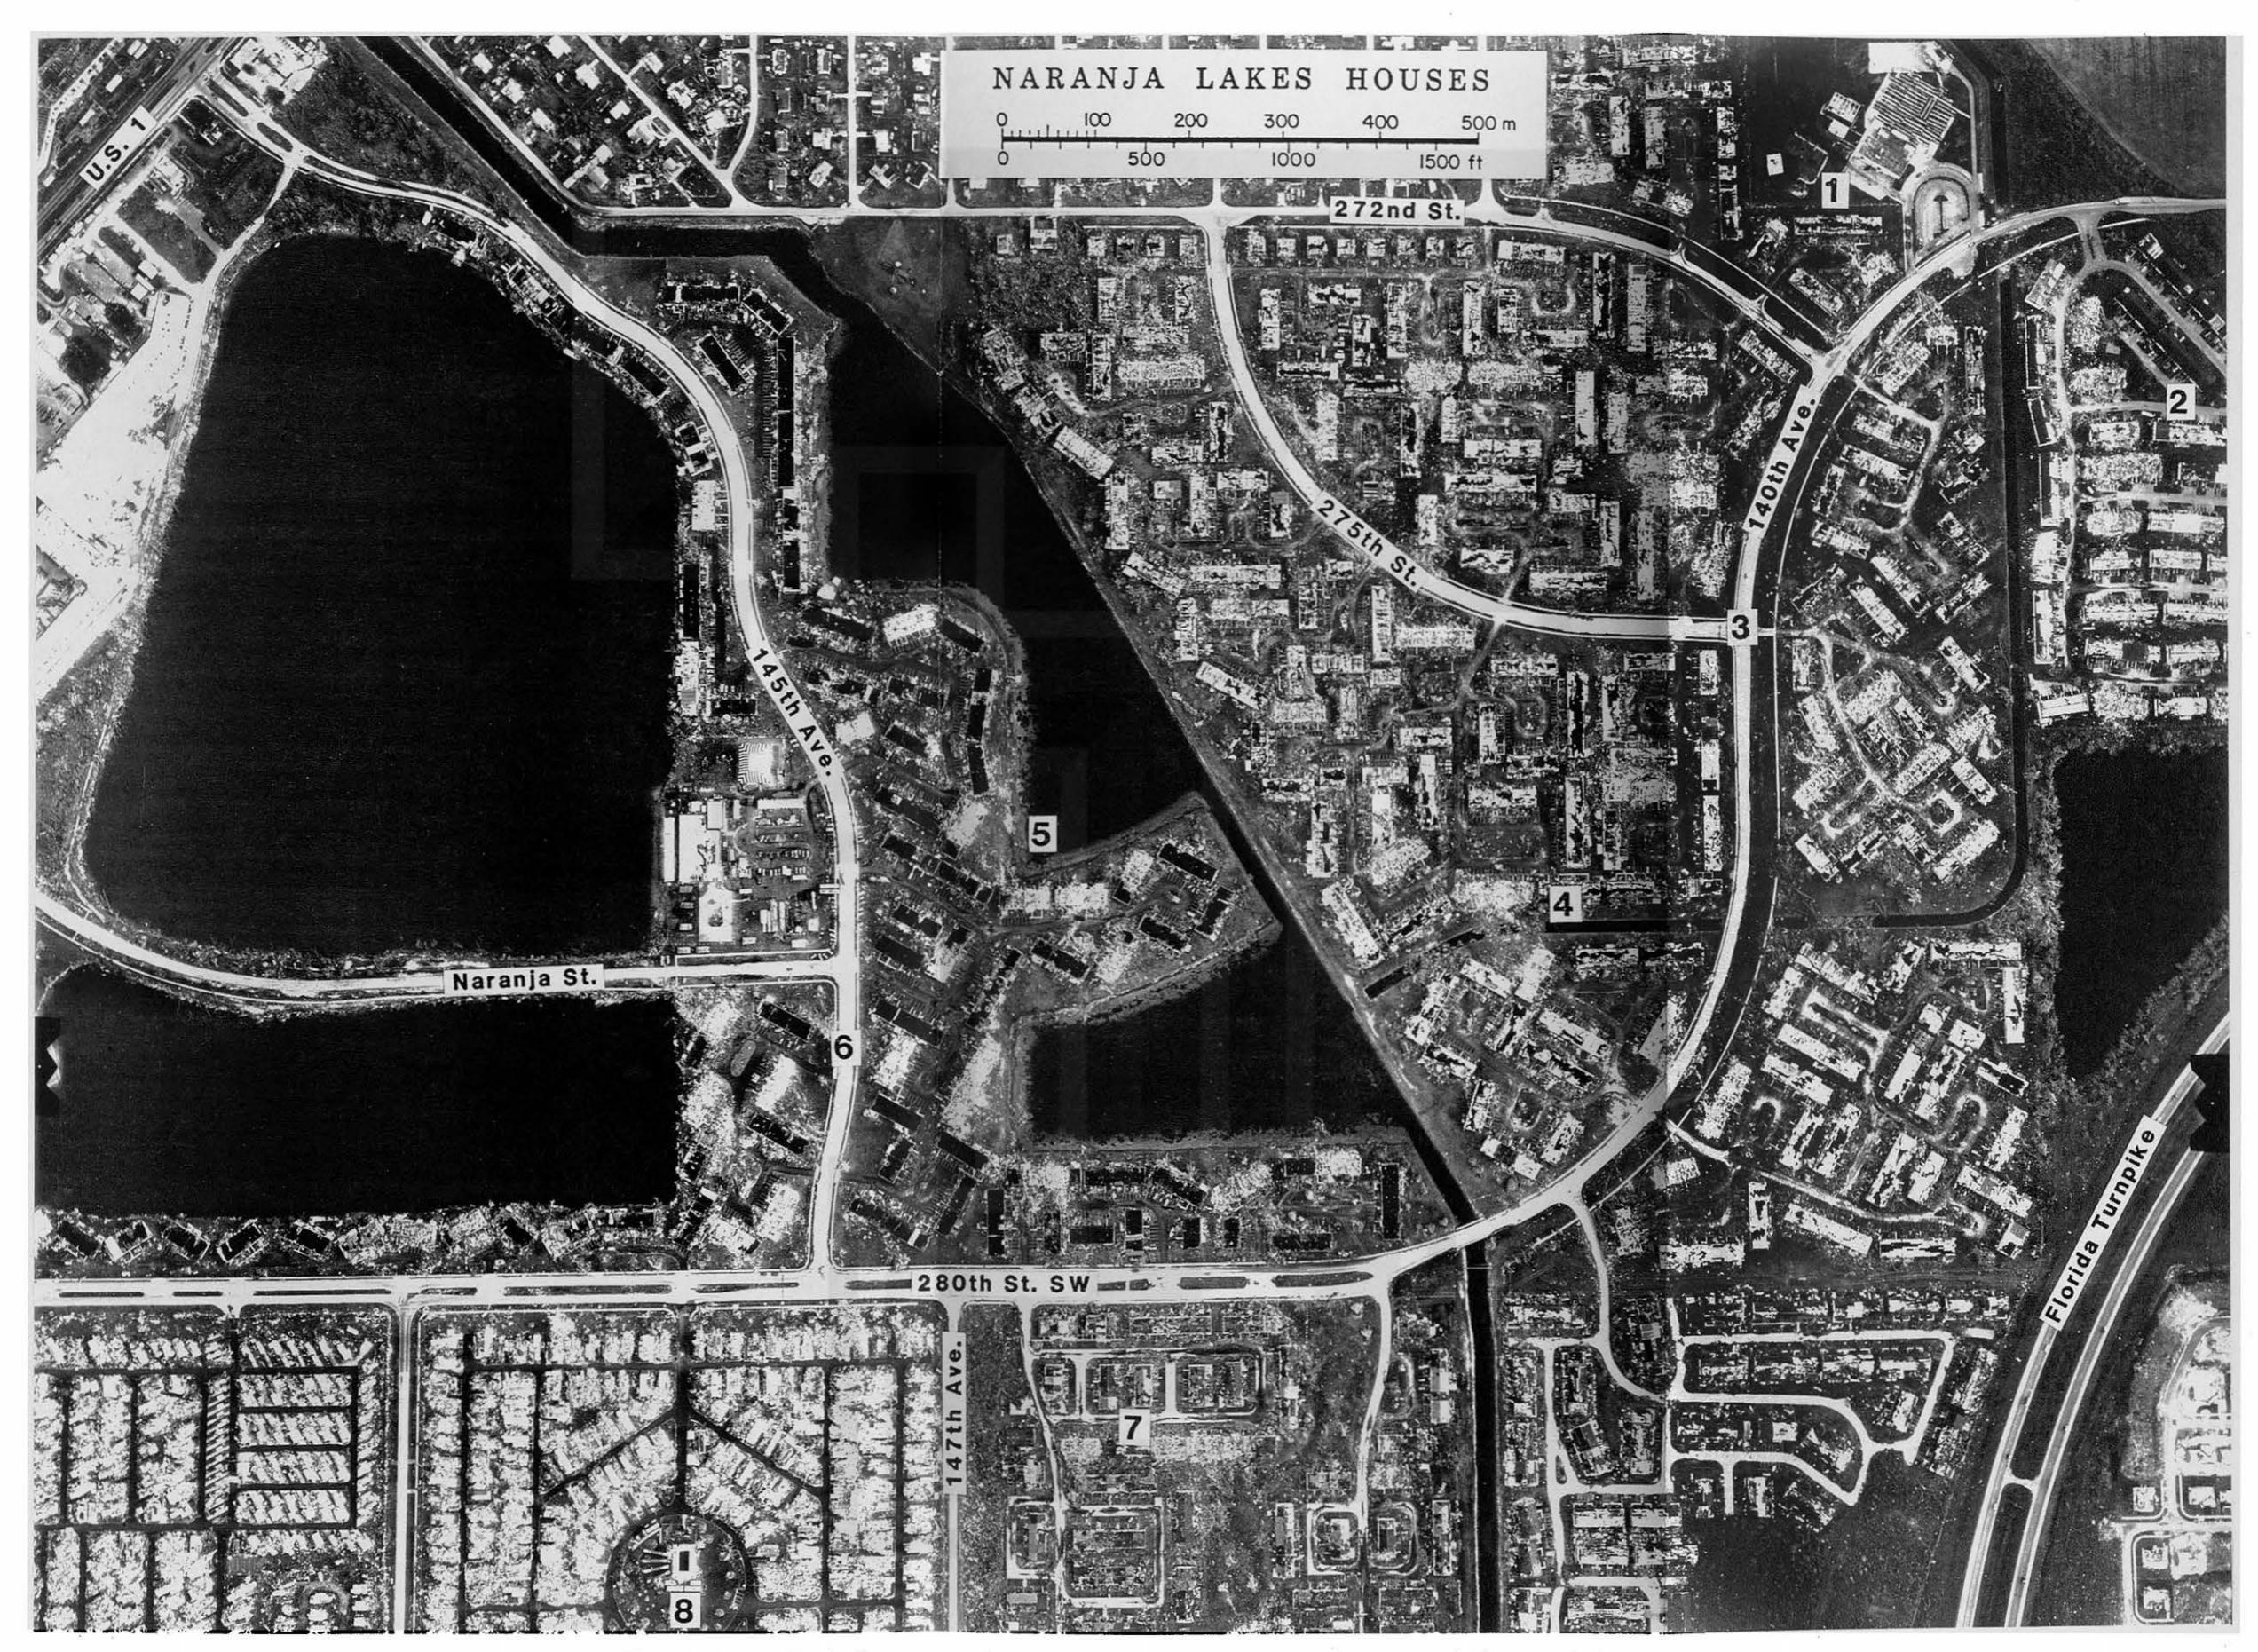
Fig. 5.24 An index map of the Naranja Lakes subdivision, consisting mainly of single-story condos. Areas 1 through 8 were enlarged.

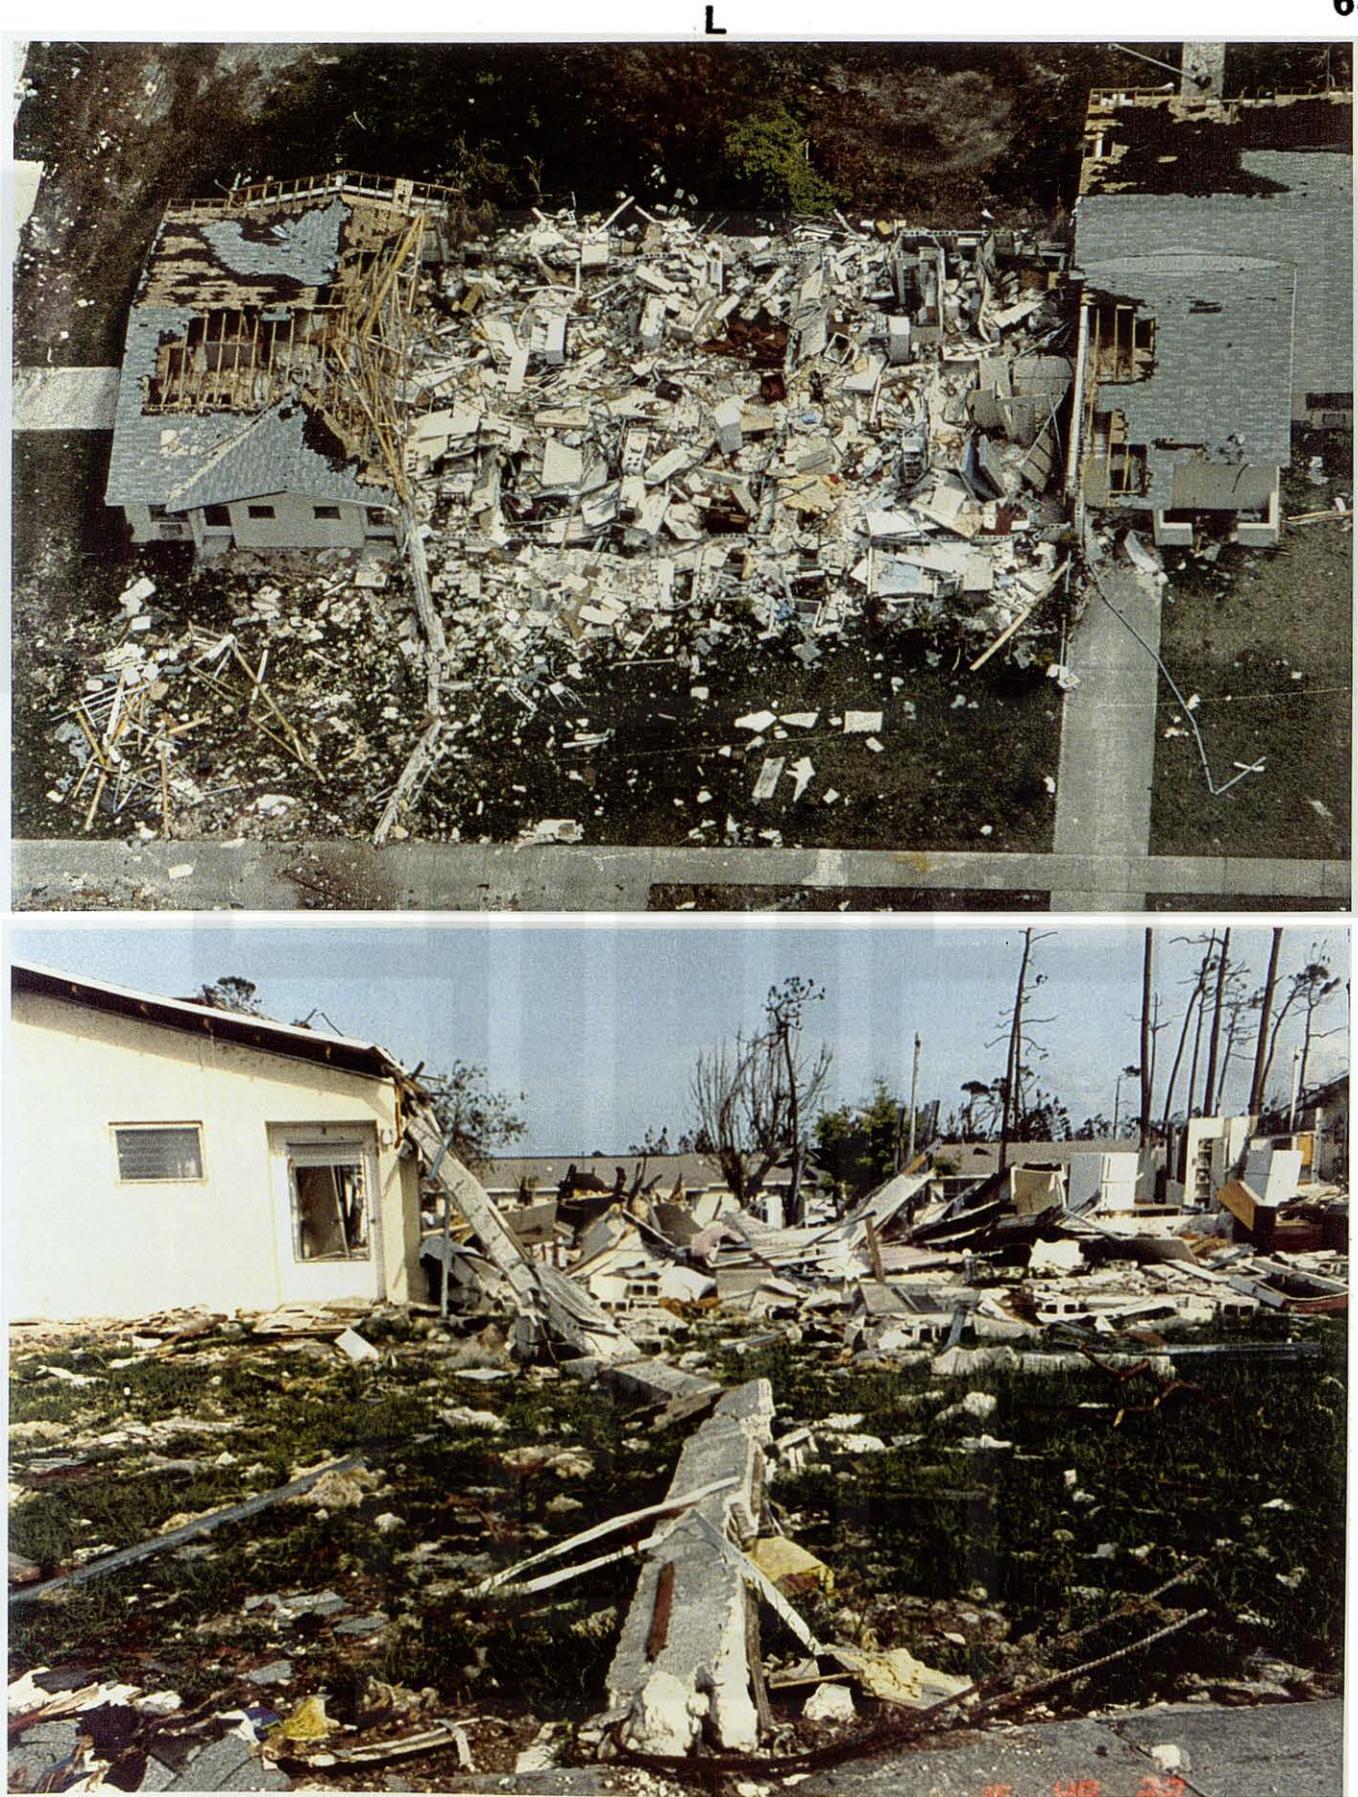
Fig. 6.1 A tie beam from condo L photographed from the air and on the ground by Fujita. A mini-swirl in the first wind caused this damage (see index map, Figure 6.10).

Fig. 6.2 Color pictures of Figure 6.1 taken by Fujita.

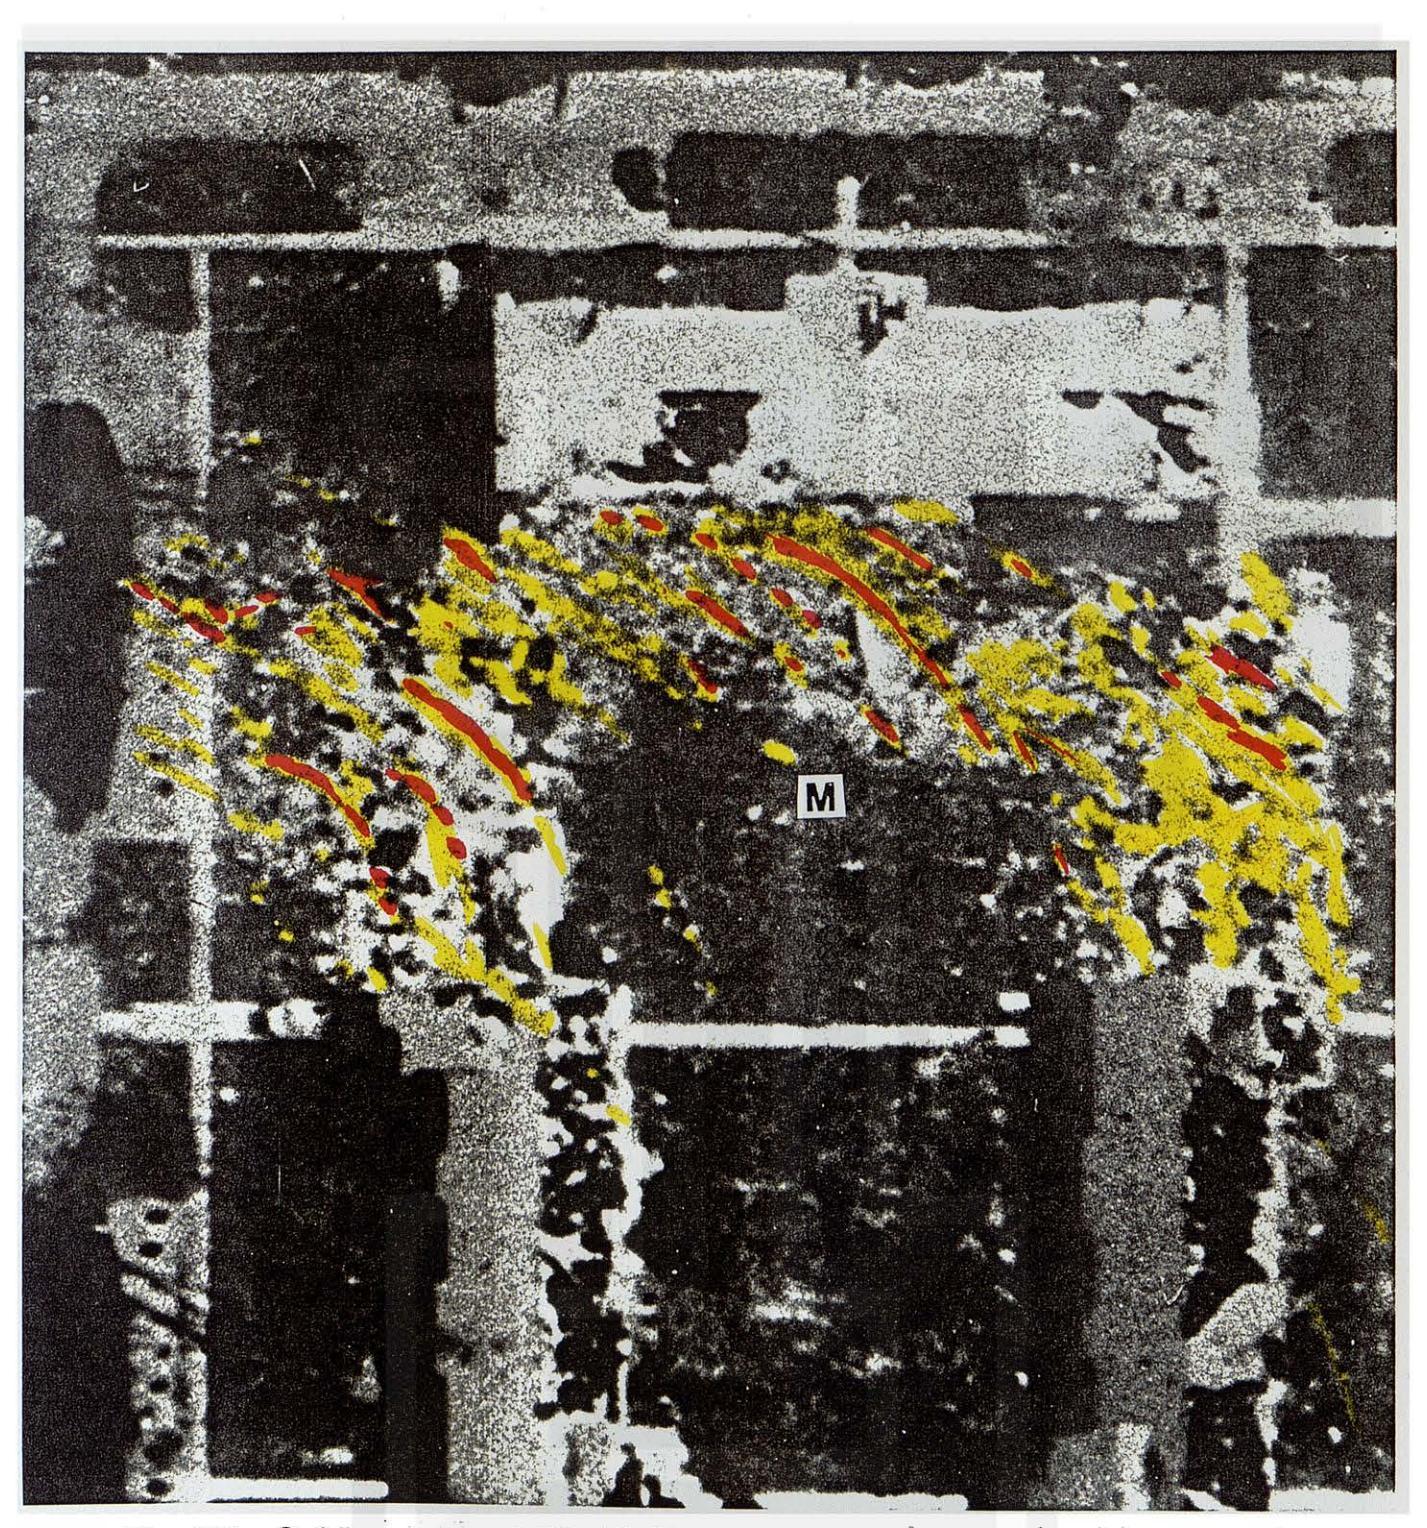
Fig. 6.3 Swirling patterns left behind by a mini-swirl in the first wind. Red streaks denote the streamlines of the swirl.

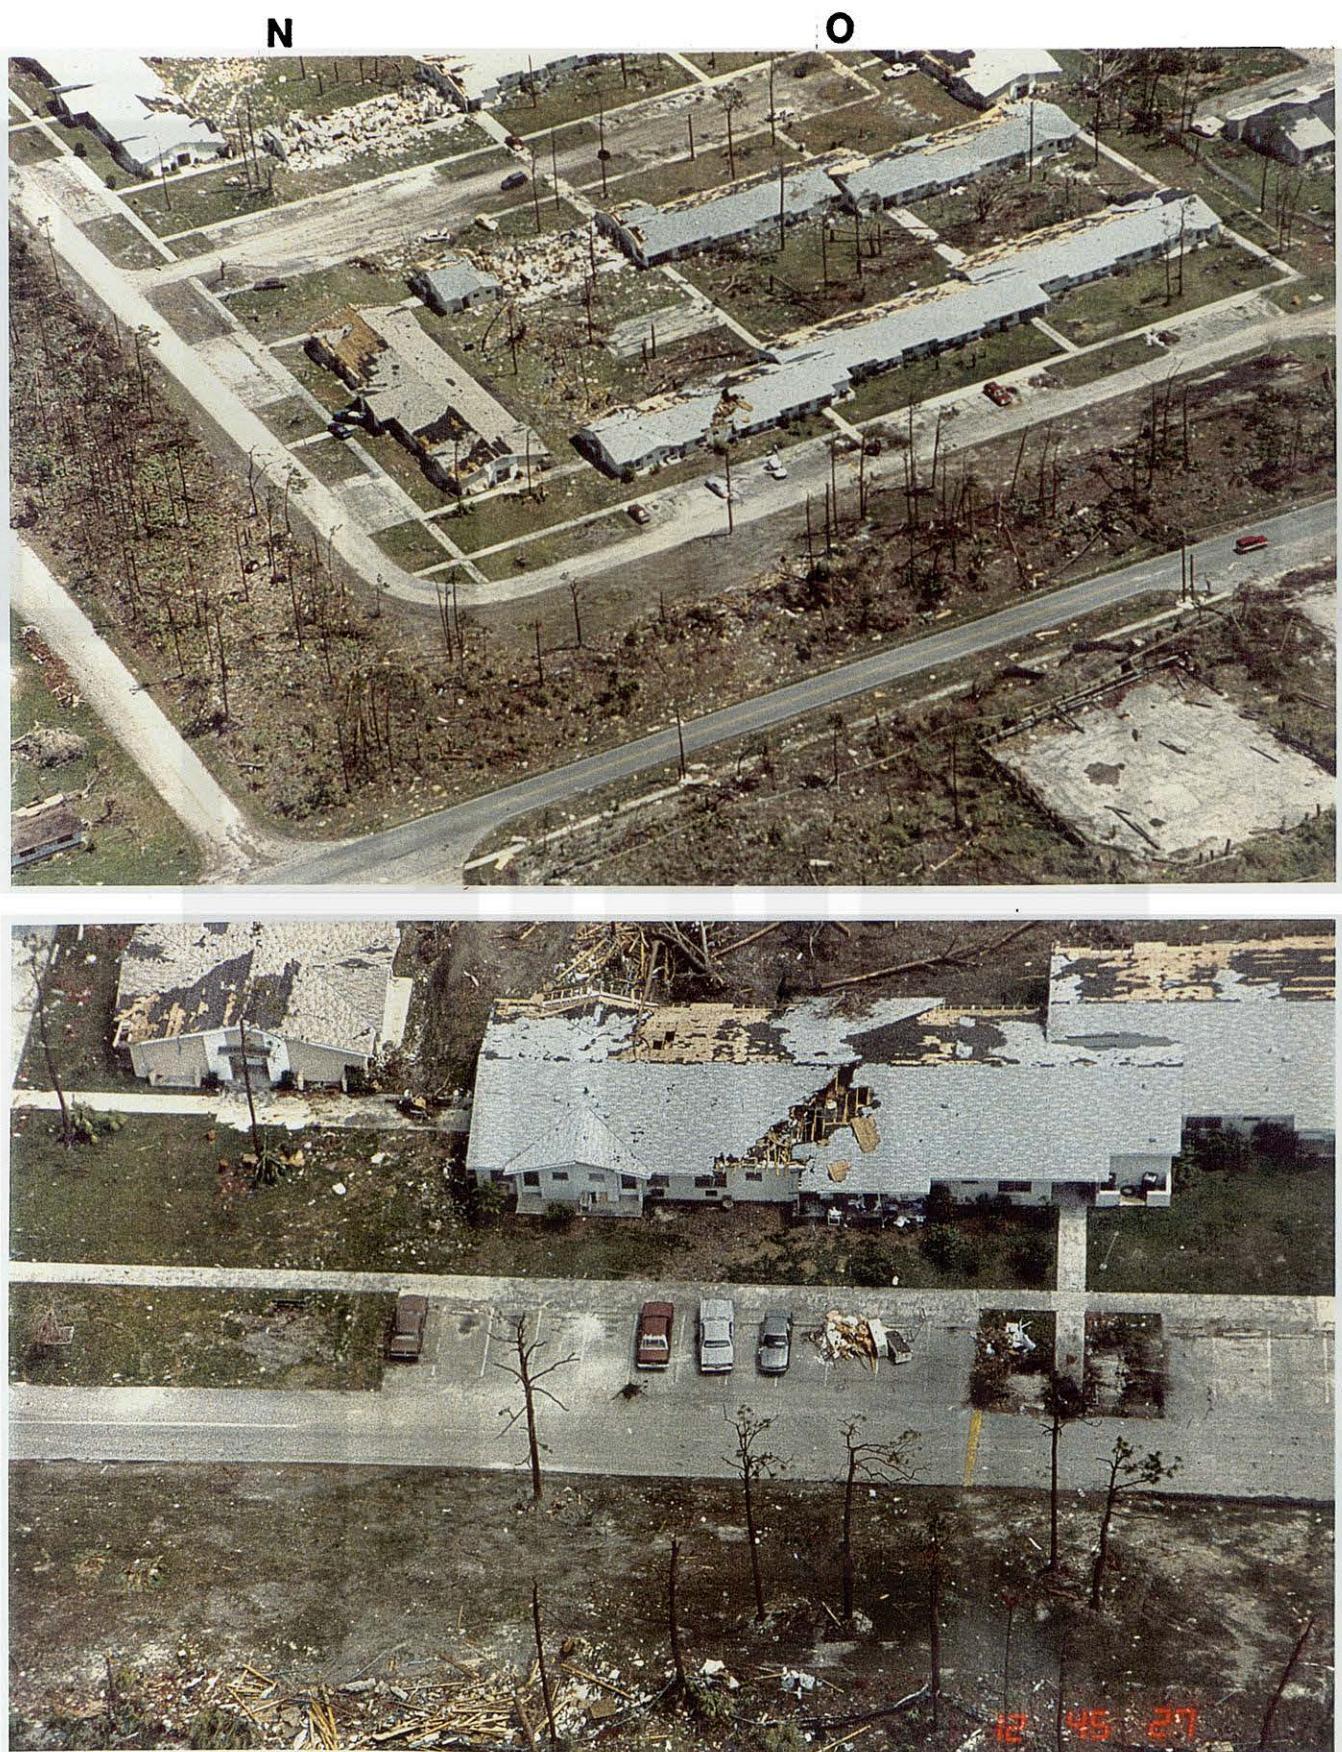
Fig. 6.5 Aerial photo of the debris and a dumpster from N. A sharp cut by a falling tie beam is seen at O.

Fig. 6.6 Aerial color pictures of Figure 6.5 taken by Fujita.

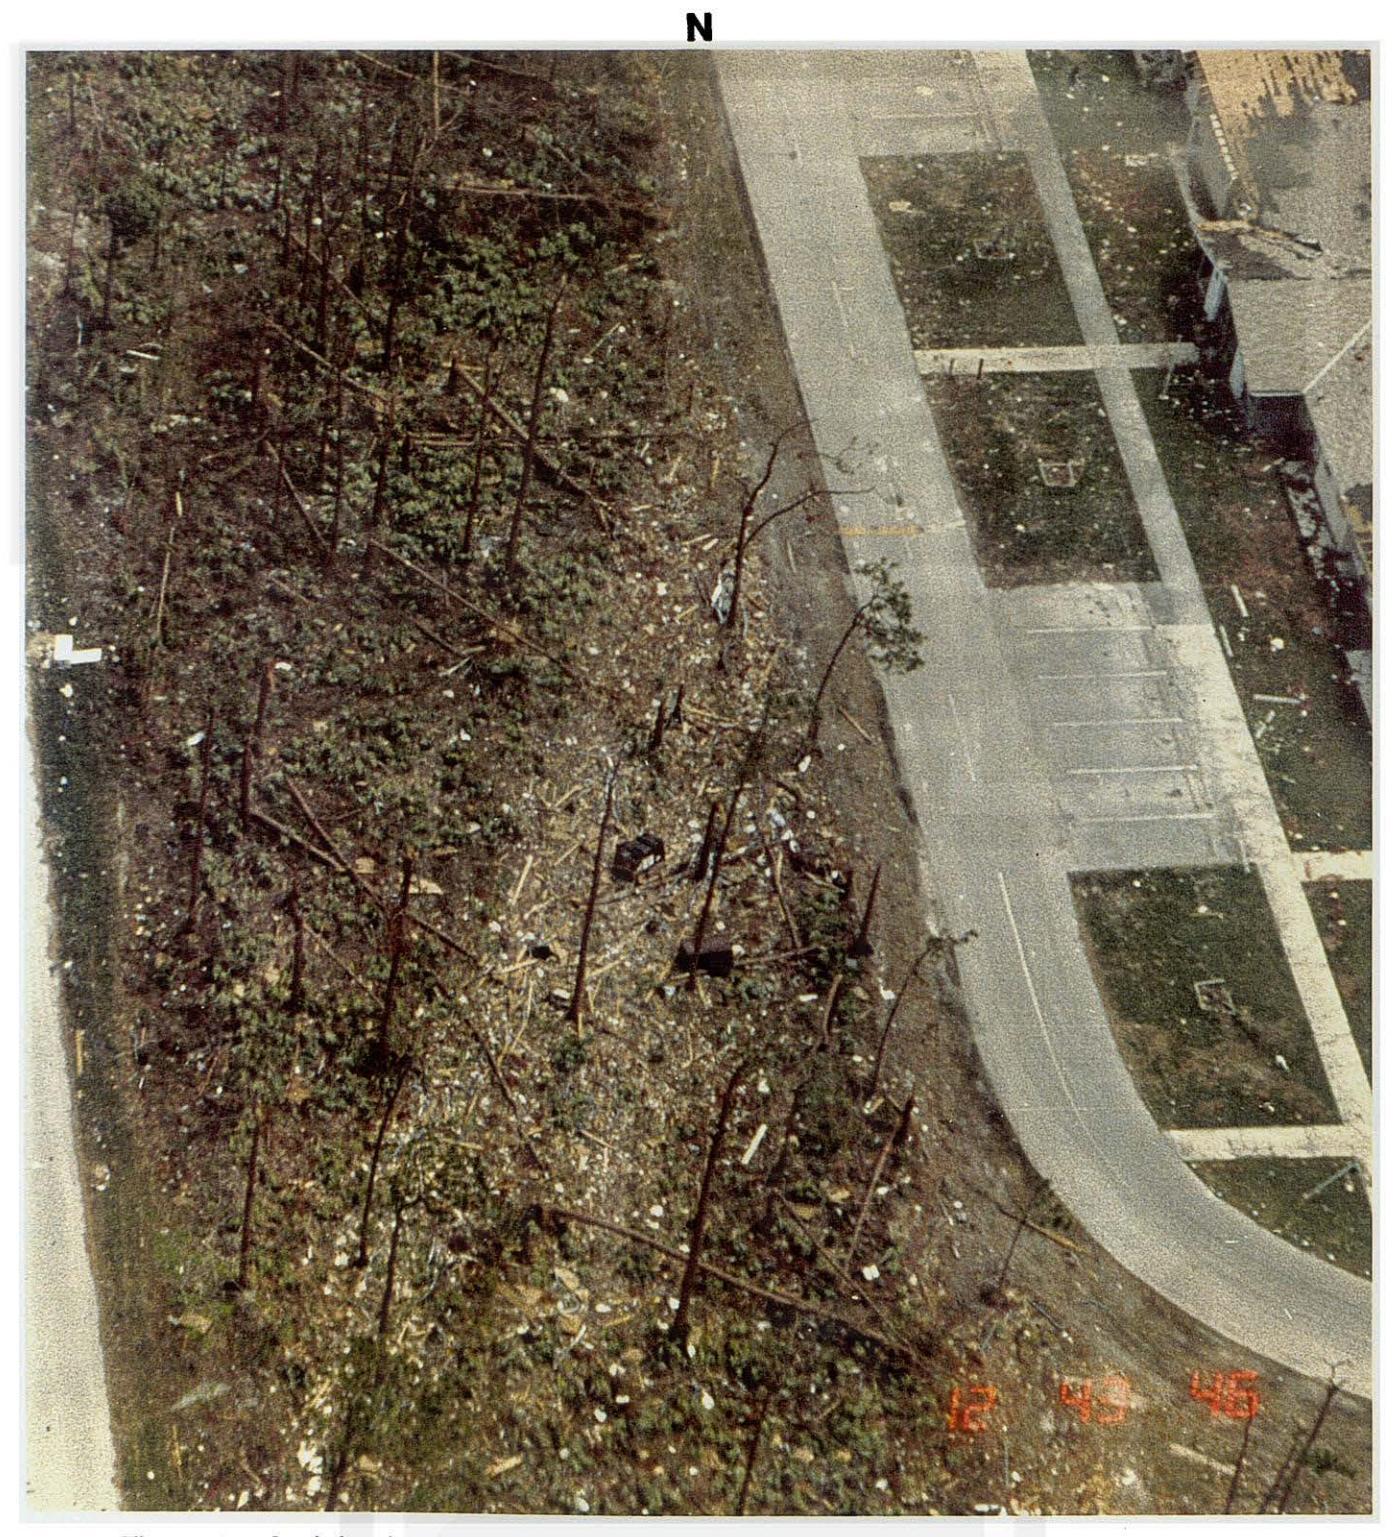
Fig. 6.7 Estimated trajectory of dumpster **N** which flew through an estimated distance of 110 meters (360 feet). The winds were induced by an anticyclonic mini-swirl inside the first winds.

Fig. 6.8 Aerial color photo of Figure 6.7 taken by Fujita.
