Research Paper No.1

Detailed Analysis of Hurricane Andrew of 24 August 1992

ONR Grant N00014-J1136 STORM DATA PROJECT

T. Theodore Fujita, PI

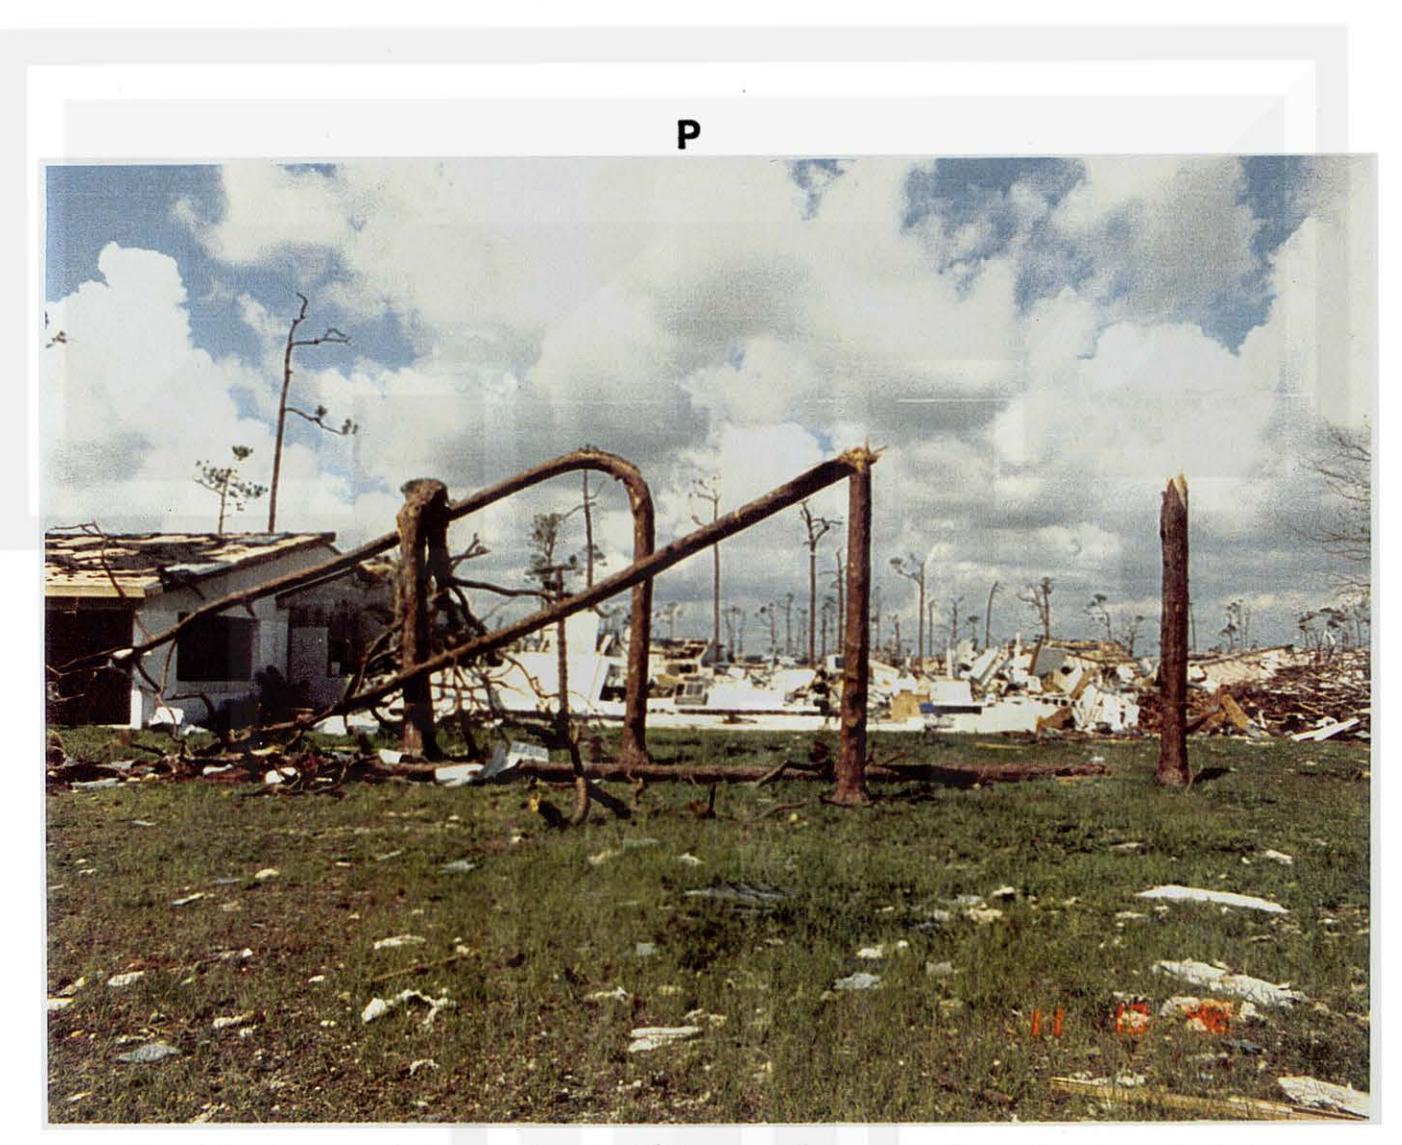
Fig. 6.9 A ground picture taken by Fujita, showing a complicated pattern of winds. For the picture location, refer to the index picture in Figure 6.10. The photo was taken facing toward the west-southwest.
